ADDENDUM 2

Contract: 23-C-00013; Morris Bridge Filter Building Improvements ReBid

**COMPREHENSIVE PRE-DEMOLITION SURVEY REPORT FOR:
MORRIS BRIDGE WATER PUMPING FACILITY**

PROJECT NO. 22009-0142

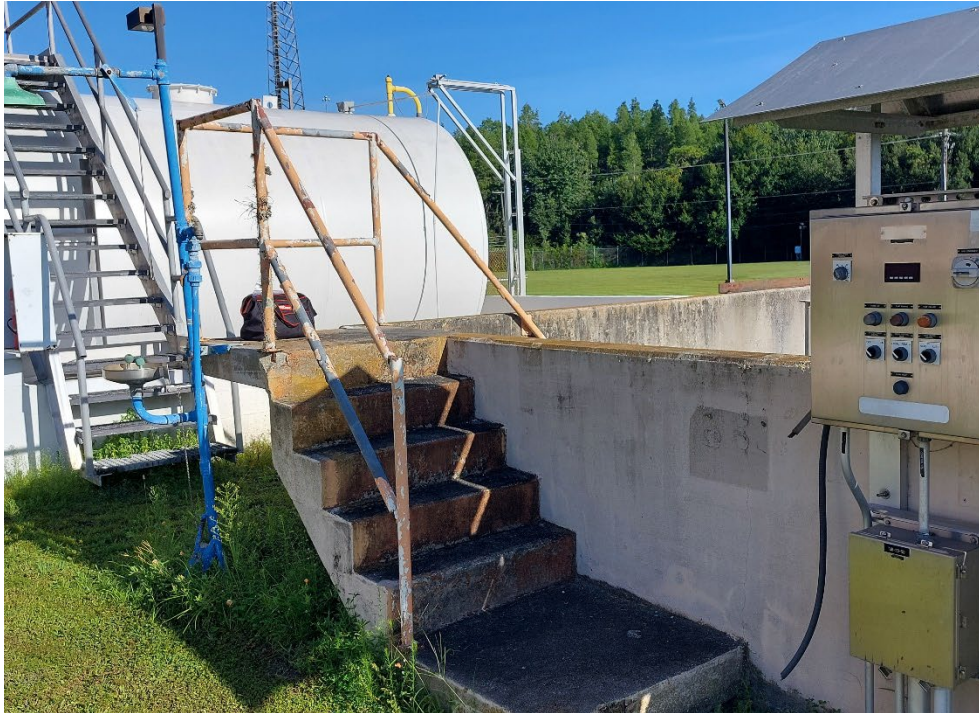
Photo 3 – LBP orange metal handrail on Structure 3

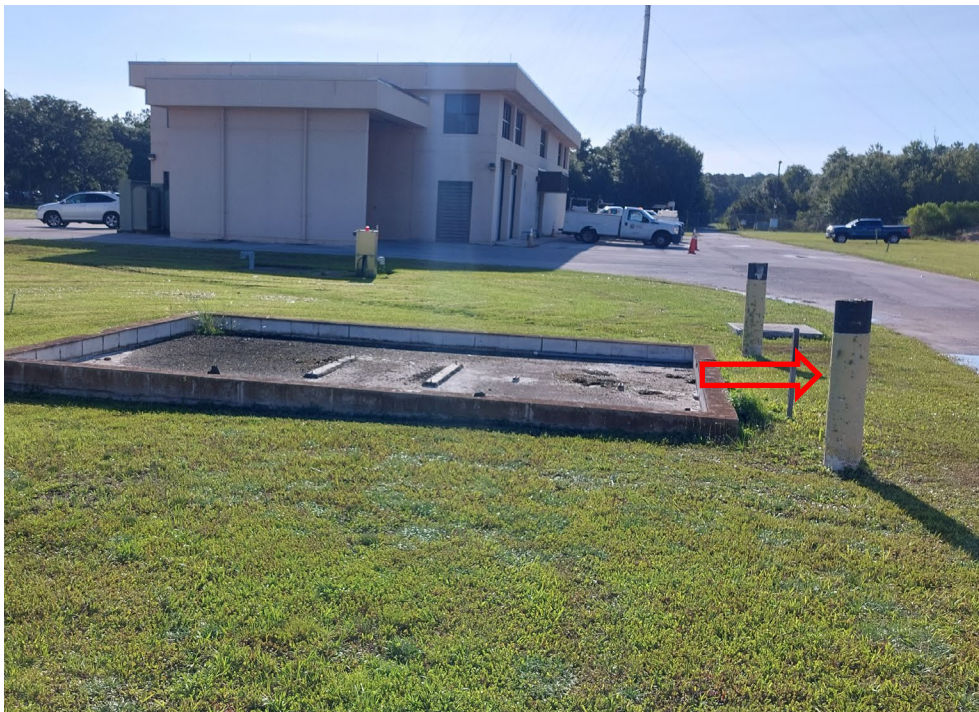
Photo 4 – LBP yellow metal parking bollards on Structure 5

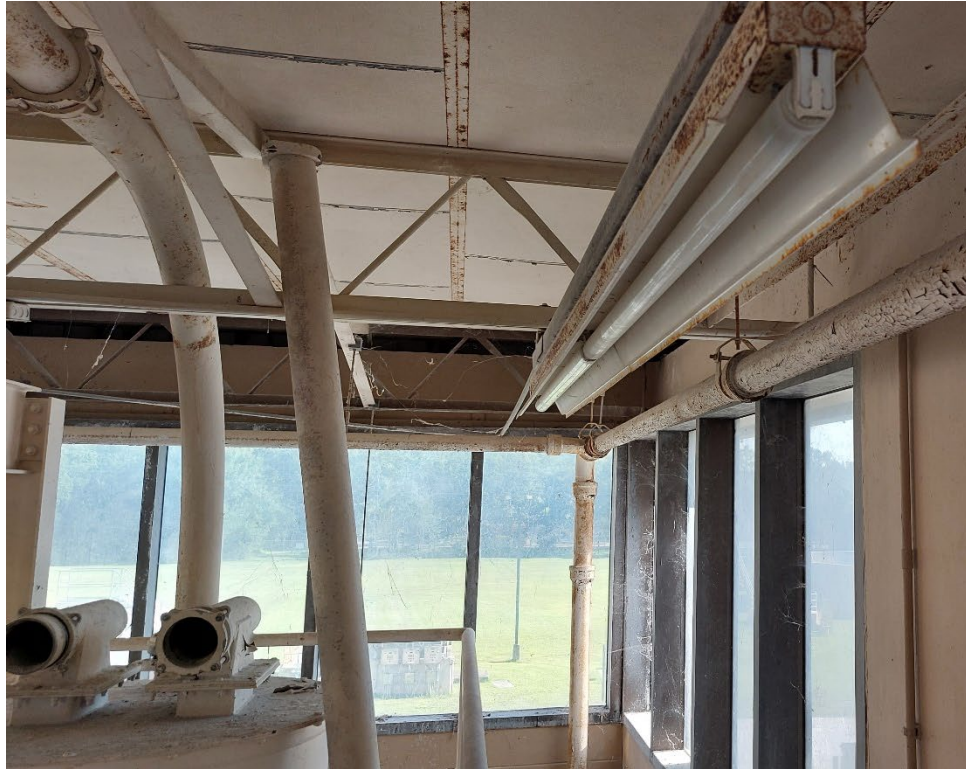
Photo 15 – Fluorescent light fixture with four-foot bulb

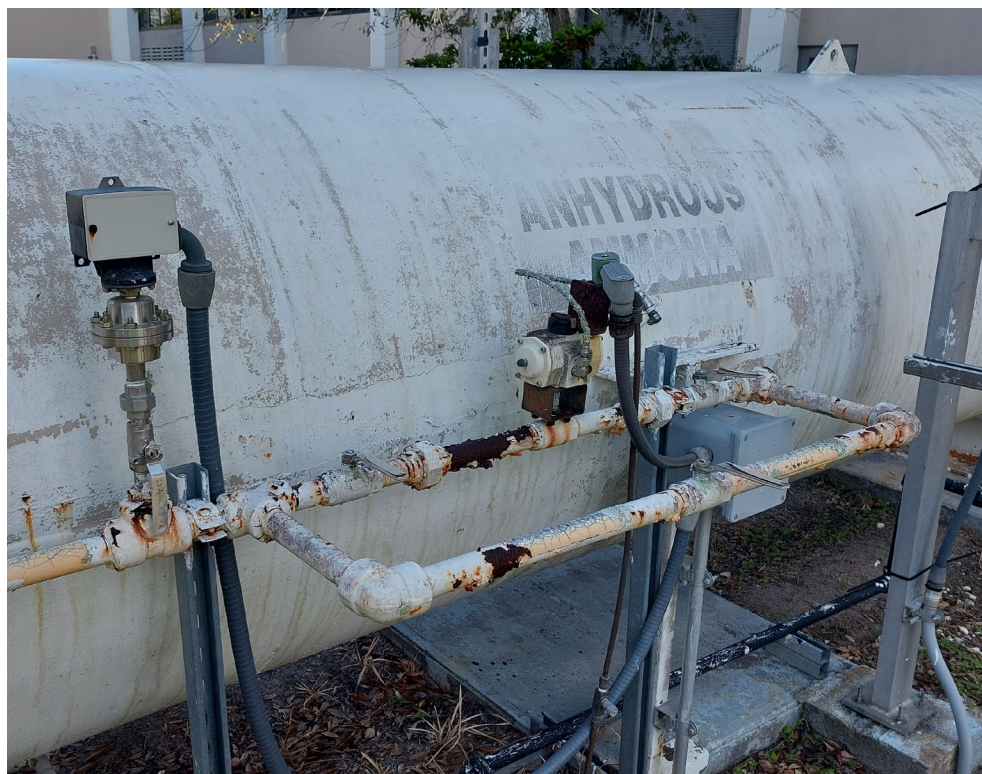
Photo 22 – “Chlorine Tank” labeled “Anhydrous Ammonia” in field
