ABOVEGROUND WATER STORAGE TANK INSPECTION REPORT

**CITY OF TAMPA
INTERBAY**

**5,000,000 GALLON ABOVEGROUND
WATER STORAGE TANK**

RE: Interbay Aboveground Storage Tank
163' dia. x 33' high – 5 Million Gallons

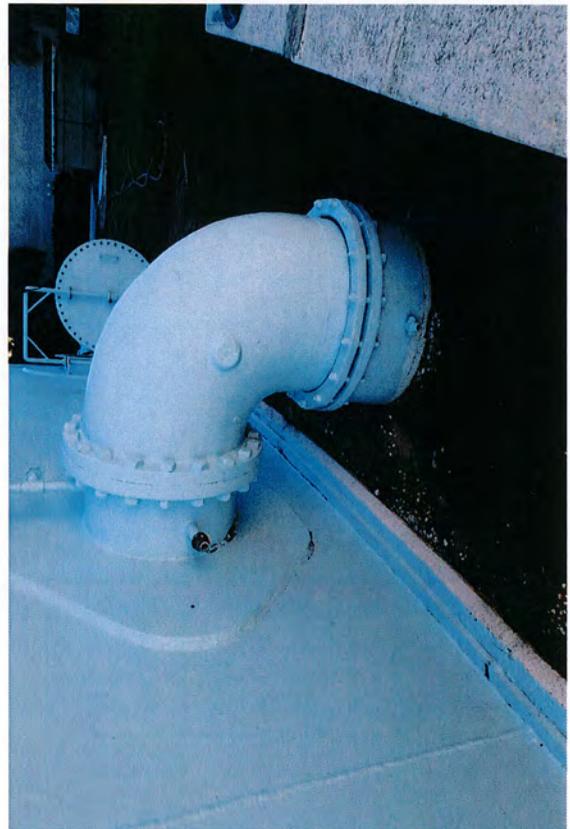
1. INLET PIPE: One (1) 24" steel pipe. The pipe appears to be in good condition.
2. OUTLET PIPE: One (1) 24" steel pipe. The pipe appears to be in good condition.
3. SHELL MANWAYS: Four (4) 30" diameter manways. The manways appear to be in good condition. The davit arms have peeling paint with minor corrosion.
4. SUMP: One (1) 96" diameter x 24" deep sump. The sump appears to be in good condition with minor areas of peeling paint and minor corrosion.
5. OVERFLOW: One (1) 12" Overflow. The overflow appears to be in good condition.

3. Outlet Nozzle.

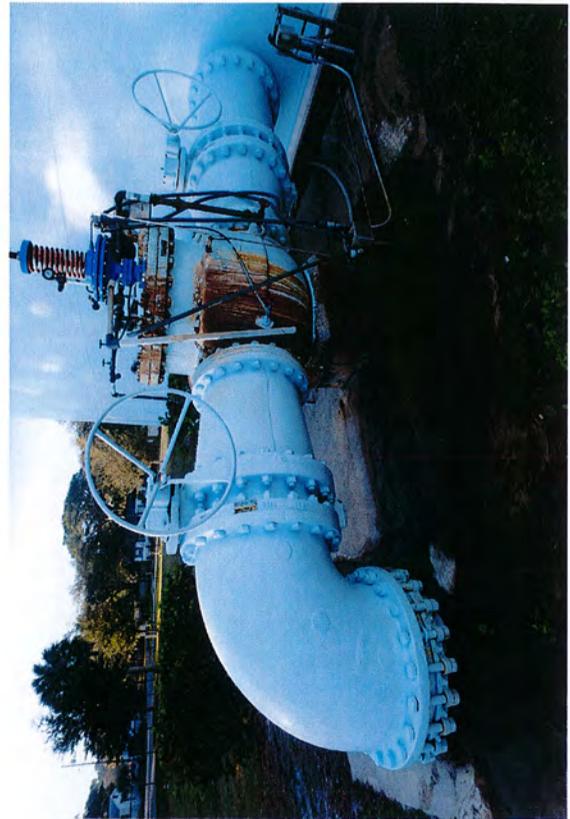
4. Inlet Nozzle.

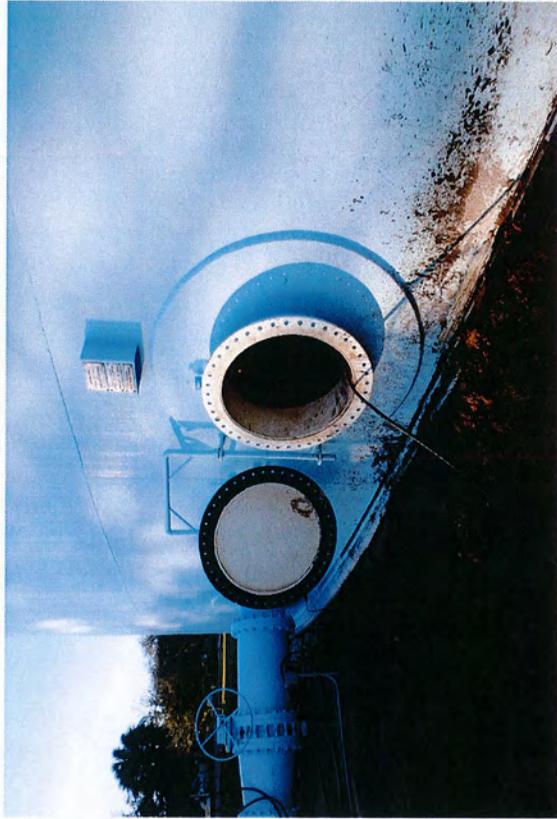
6. Manway,

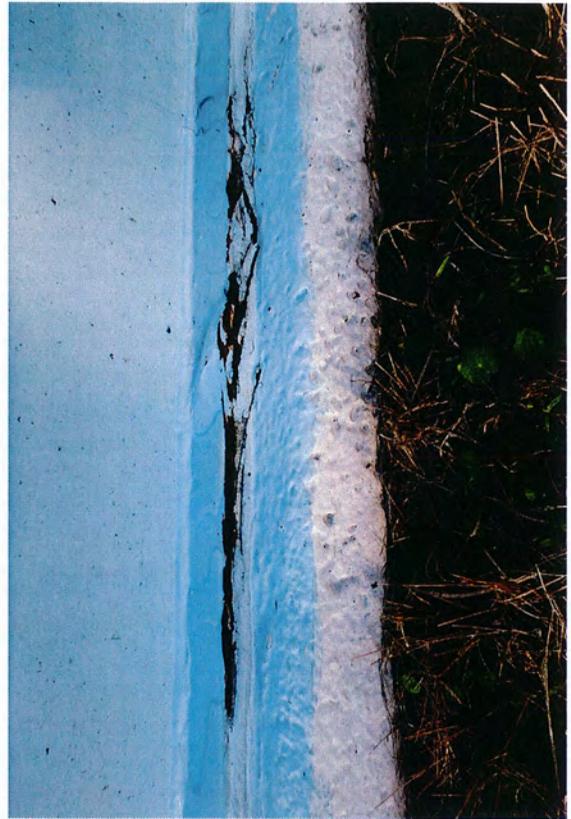
The exterior coating is in good overall condition with isolated areas of peeling paint with minor corrosion on the shell and chime.

8. Area Of Corrosion on Tank Chime.

1. EXTERIOR: The areas of the shell and chime that have peeling paint with minor corrosion should be thoroughly cleaned and re-coated.
2. INTERIOR: At the next convenient out-of-service period we recommend prepping and re-coating the interior roof rafters and corrosion spots on the floor.
3. LADDER SAFETY: Coat the rungs with a non-skid coating.

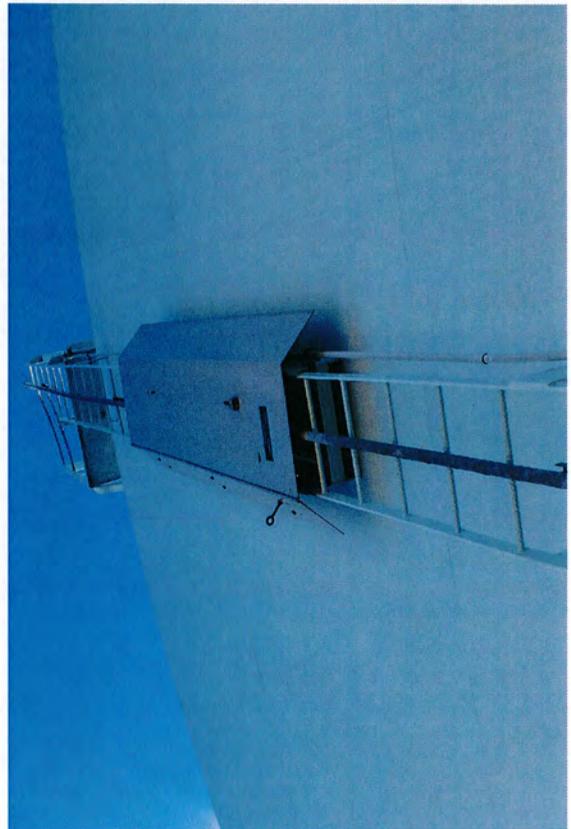
One (1) exterior tank ladder – Good condition. Constructed of steel, this ladder is not equipped with a fall protection device. The ladder rungs are not skid proof.

7. Exterior Ladder.

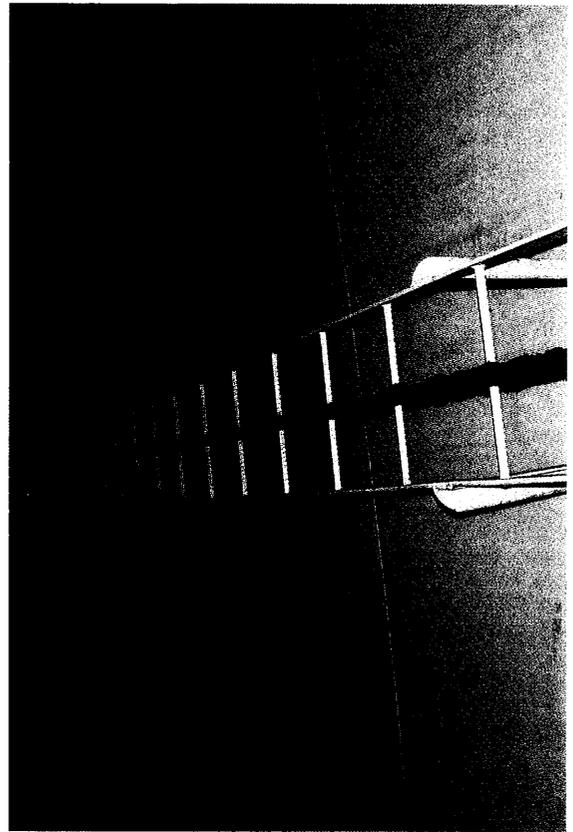
One (1) interior ladder – Good condition. Constructed of steel, this ladder is equipped with a rail-type fall protection device. The fall protection device has minor corrosion throughout. The ladder rungs are not skid proof.

12. Interior Ladder.

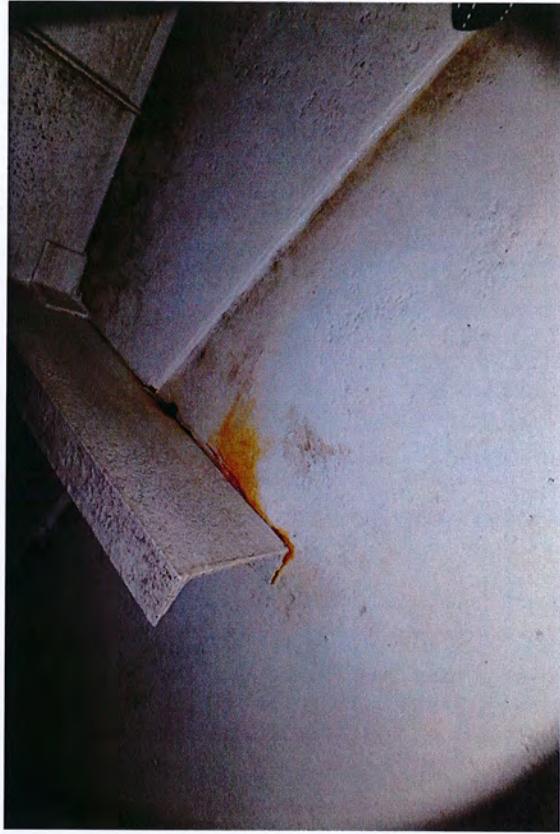
The interior coating of this tank is in good condition. However, there is some minor corrosion present on the roof rafters, floor plates and beneath some of the roof column base plates.

14. Corrosion Deposits Beneath Column Base.

Wear plates should be installed beneath the column bases to prevent further corrosion in this hard-to-paint area.

- A. The estimated cost to install wear plates beneath the column bases per the recommendation contained herein would be\$50,000
- B. The estimated cost to prepare and paint the internal steel rafters per the recommendation contained herein would be\$20,000

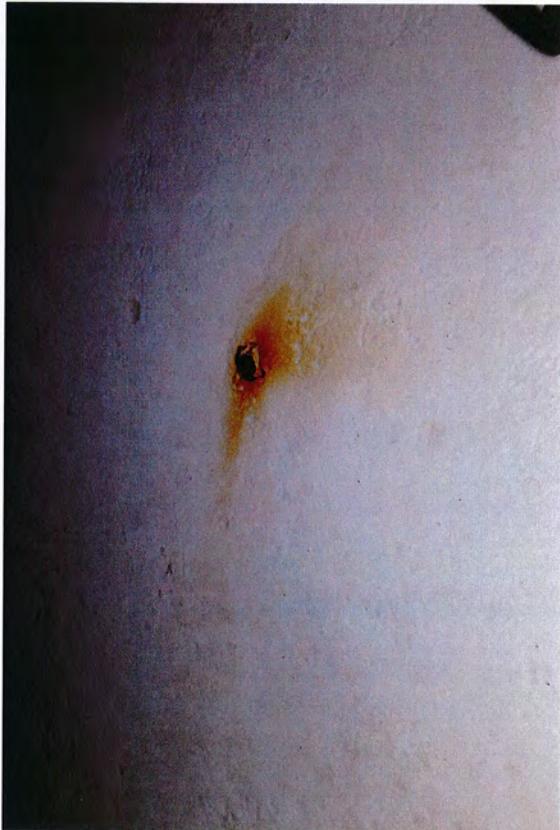
The interior of the tank was washed out by TEAM personnel. The tank bottom appears to be in good overall structural condition. However, there are areas of pitting up to 0.088" deep that were observed on the tank floor.

13. Area of Pitting on Tank Bottom.

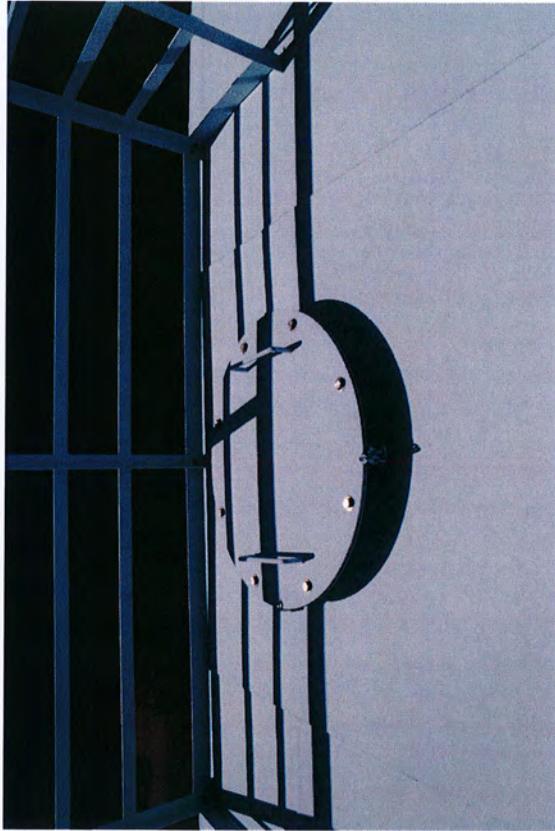
7. ROOF MANWAY: One 24" square manway on the roof of this tank. The manway is in good condition.

18. Roof Manway.

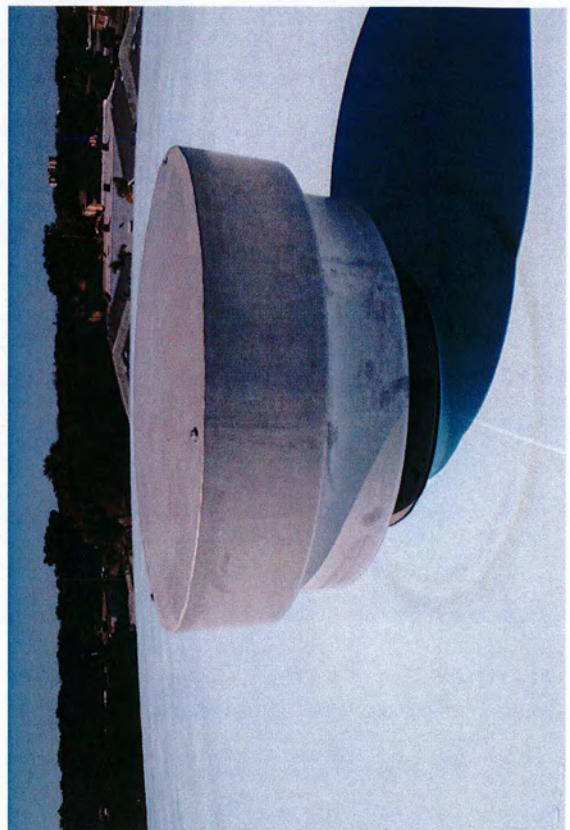
8. ROOF VENT: One 12" diameter roof vent. The roof vent is in good condition.

19. Roof Vent.
