**REPORT OF THE
SUPPLEMENTAL INVESTIGATION**

**SAN CARLOS FLUME
TAMPA, FLORIDA**

**RE: Report of the Supplemental Investigation
San Carlos Flume
Manhattan to Hesperides
Tampa, Florida
Work Order No. 9
Our File: DES 137123**

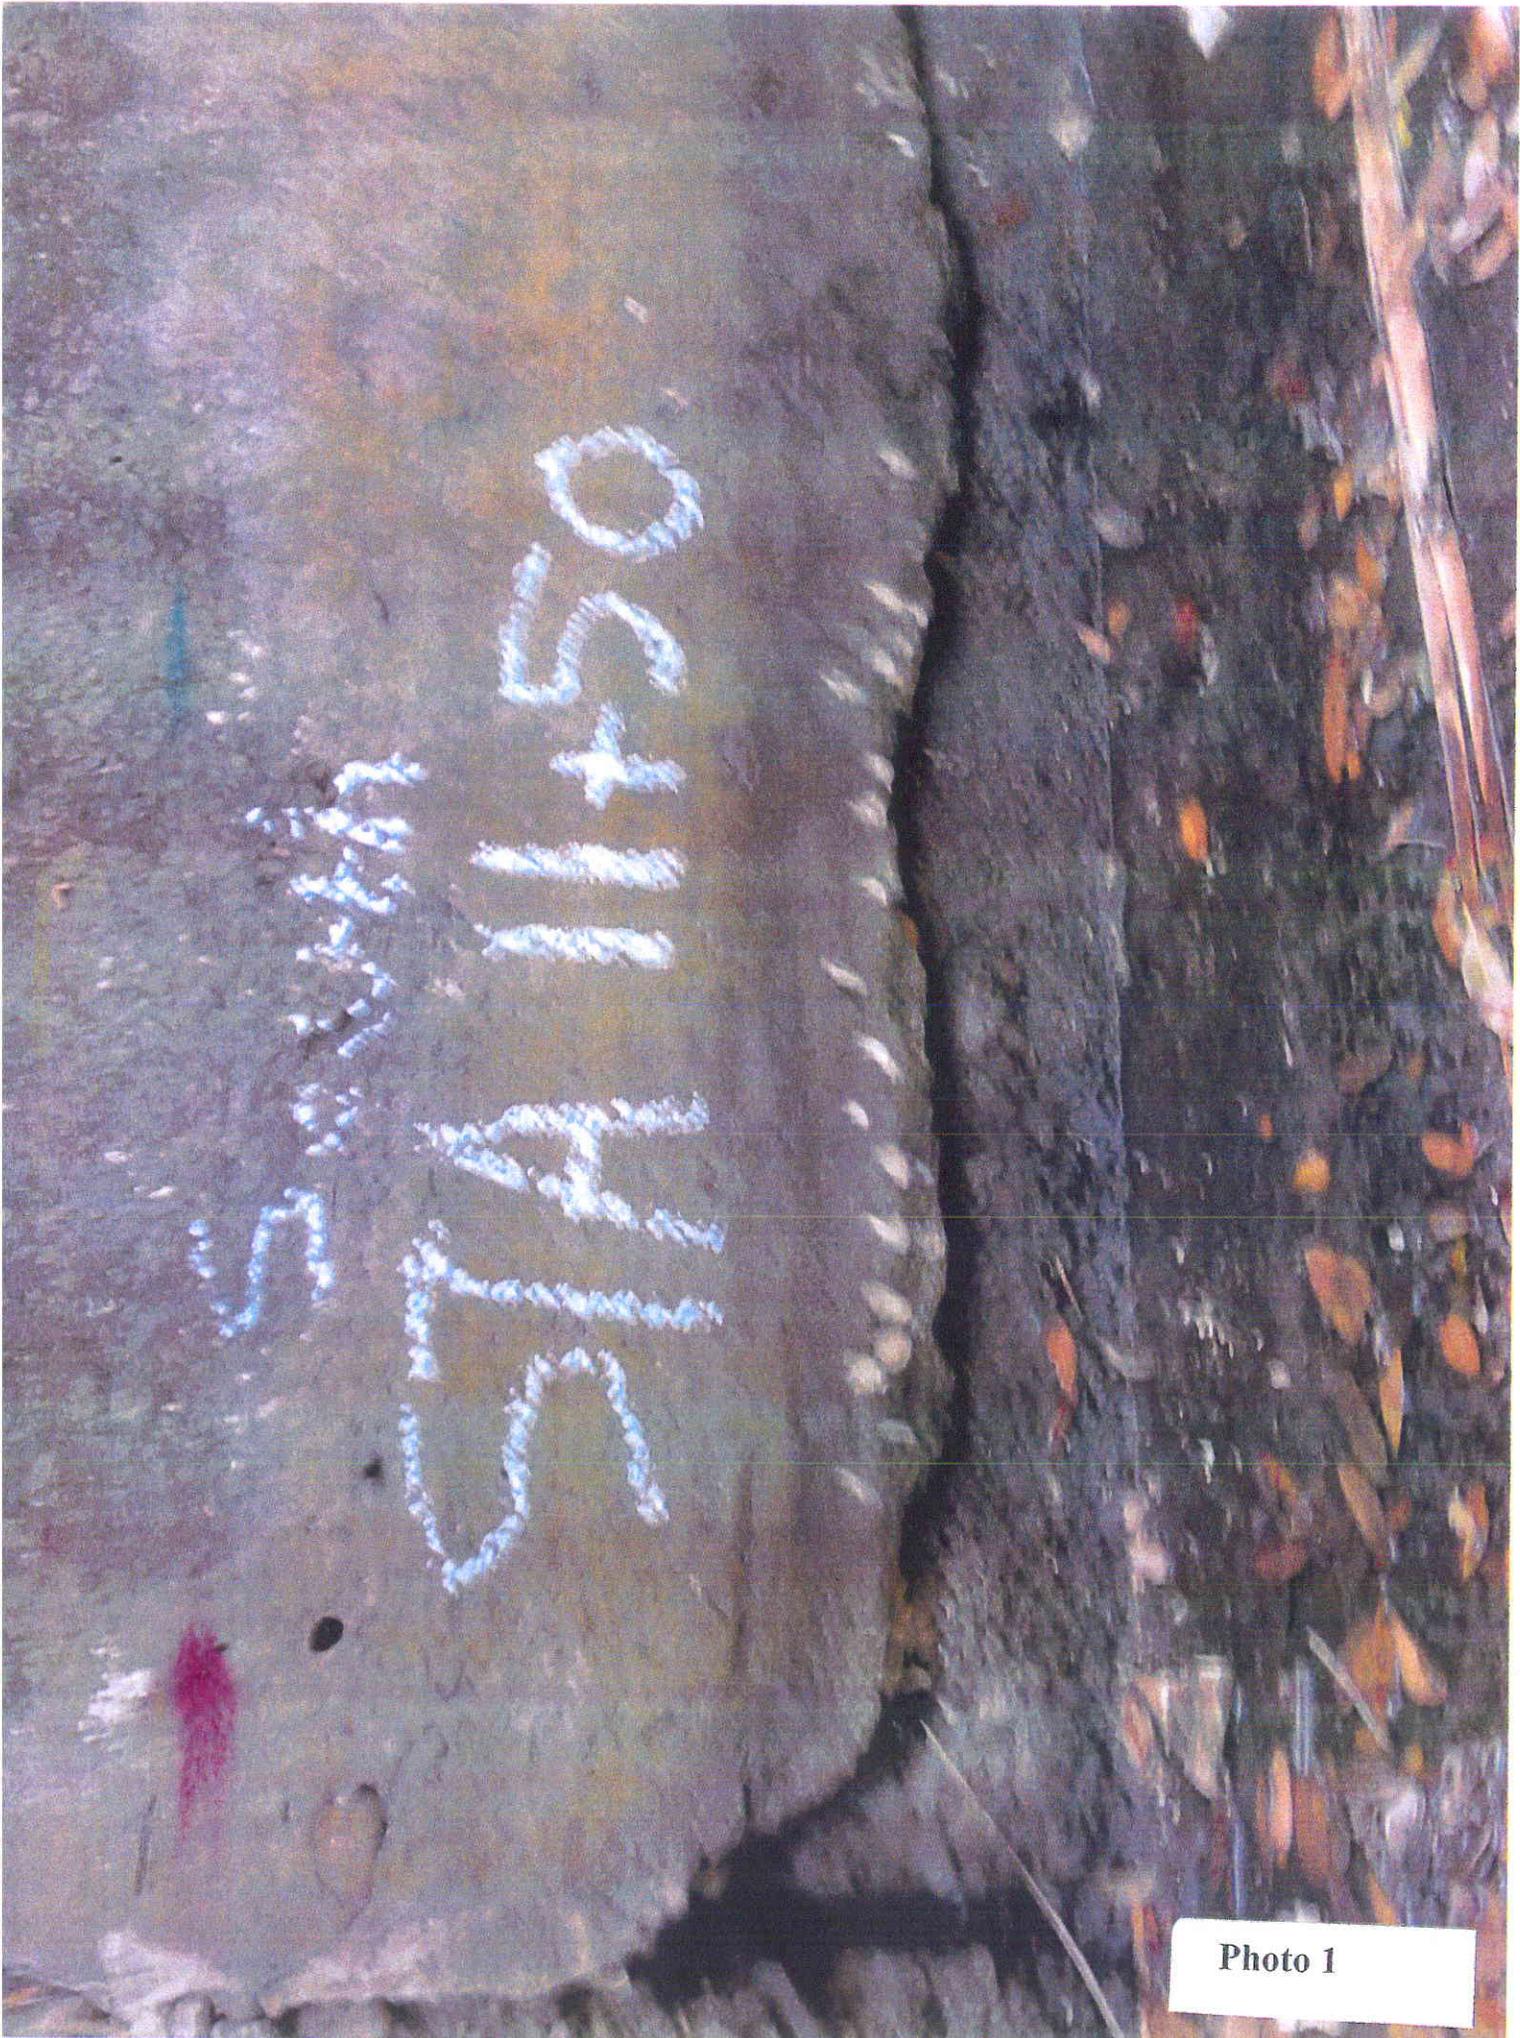
Photo 1

APPROXIMATE STATION	CONDITION	PHOTOGRAPH
10+50	Pachometer reading of slab inconclusive.	
11+00	Pachometer reading of slab inconclusive.	
11+50	Pachometer reading of slab inconclusive. Mortar patch over bottom slab between about Sta. 10+00 to Sta. 12+50	Photo # 1.
13+50	Weak pachometer readings at 6" on center, north-south	
14+00	Weak pachometer readings at 6" on center, north-south	
14+10	Rebar-dowels connecting side wall panels to bottom slab at 6-inch centers. Reinforcing bars colored blue for contrast.	Photo #2.
14+30 (North Side)	Wall panels displaced by tree root growth	Photo #3.
14+75 (North Side)	Wall panels displaced by tree root growth	Photos #4 & #5.
15+00	Rebar-dowels connecting side wall panels to bottom slab at 6-inch centers. Reinforcing bars colored blue for contrast.	Photo #6.
16+00	Rebar-dowels connecting side wall panels to bottom slab at 6-inch centers. Reinforcing bars colored blue for contrast.	Photos #7 & #8.

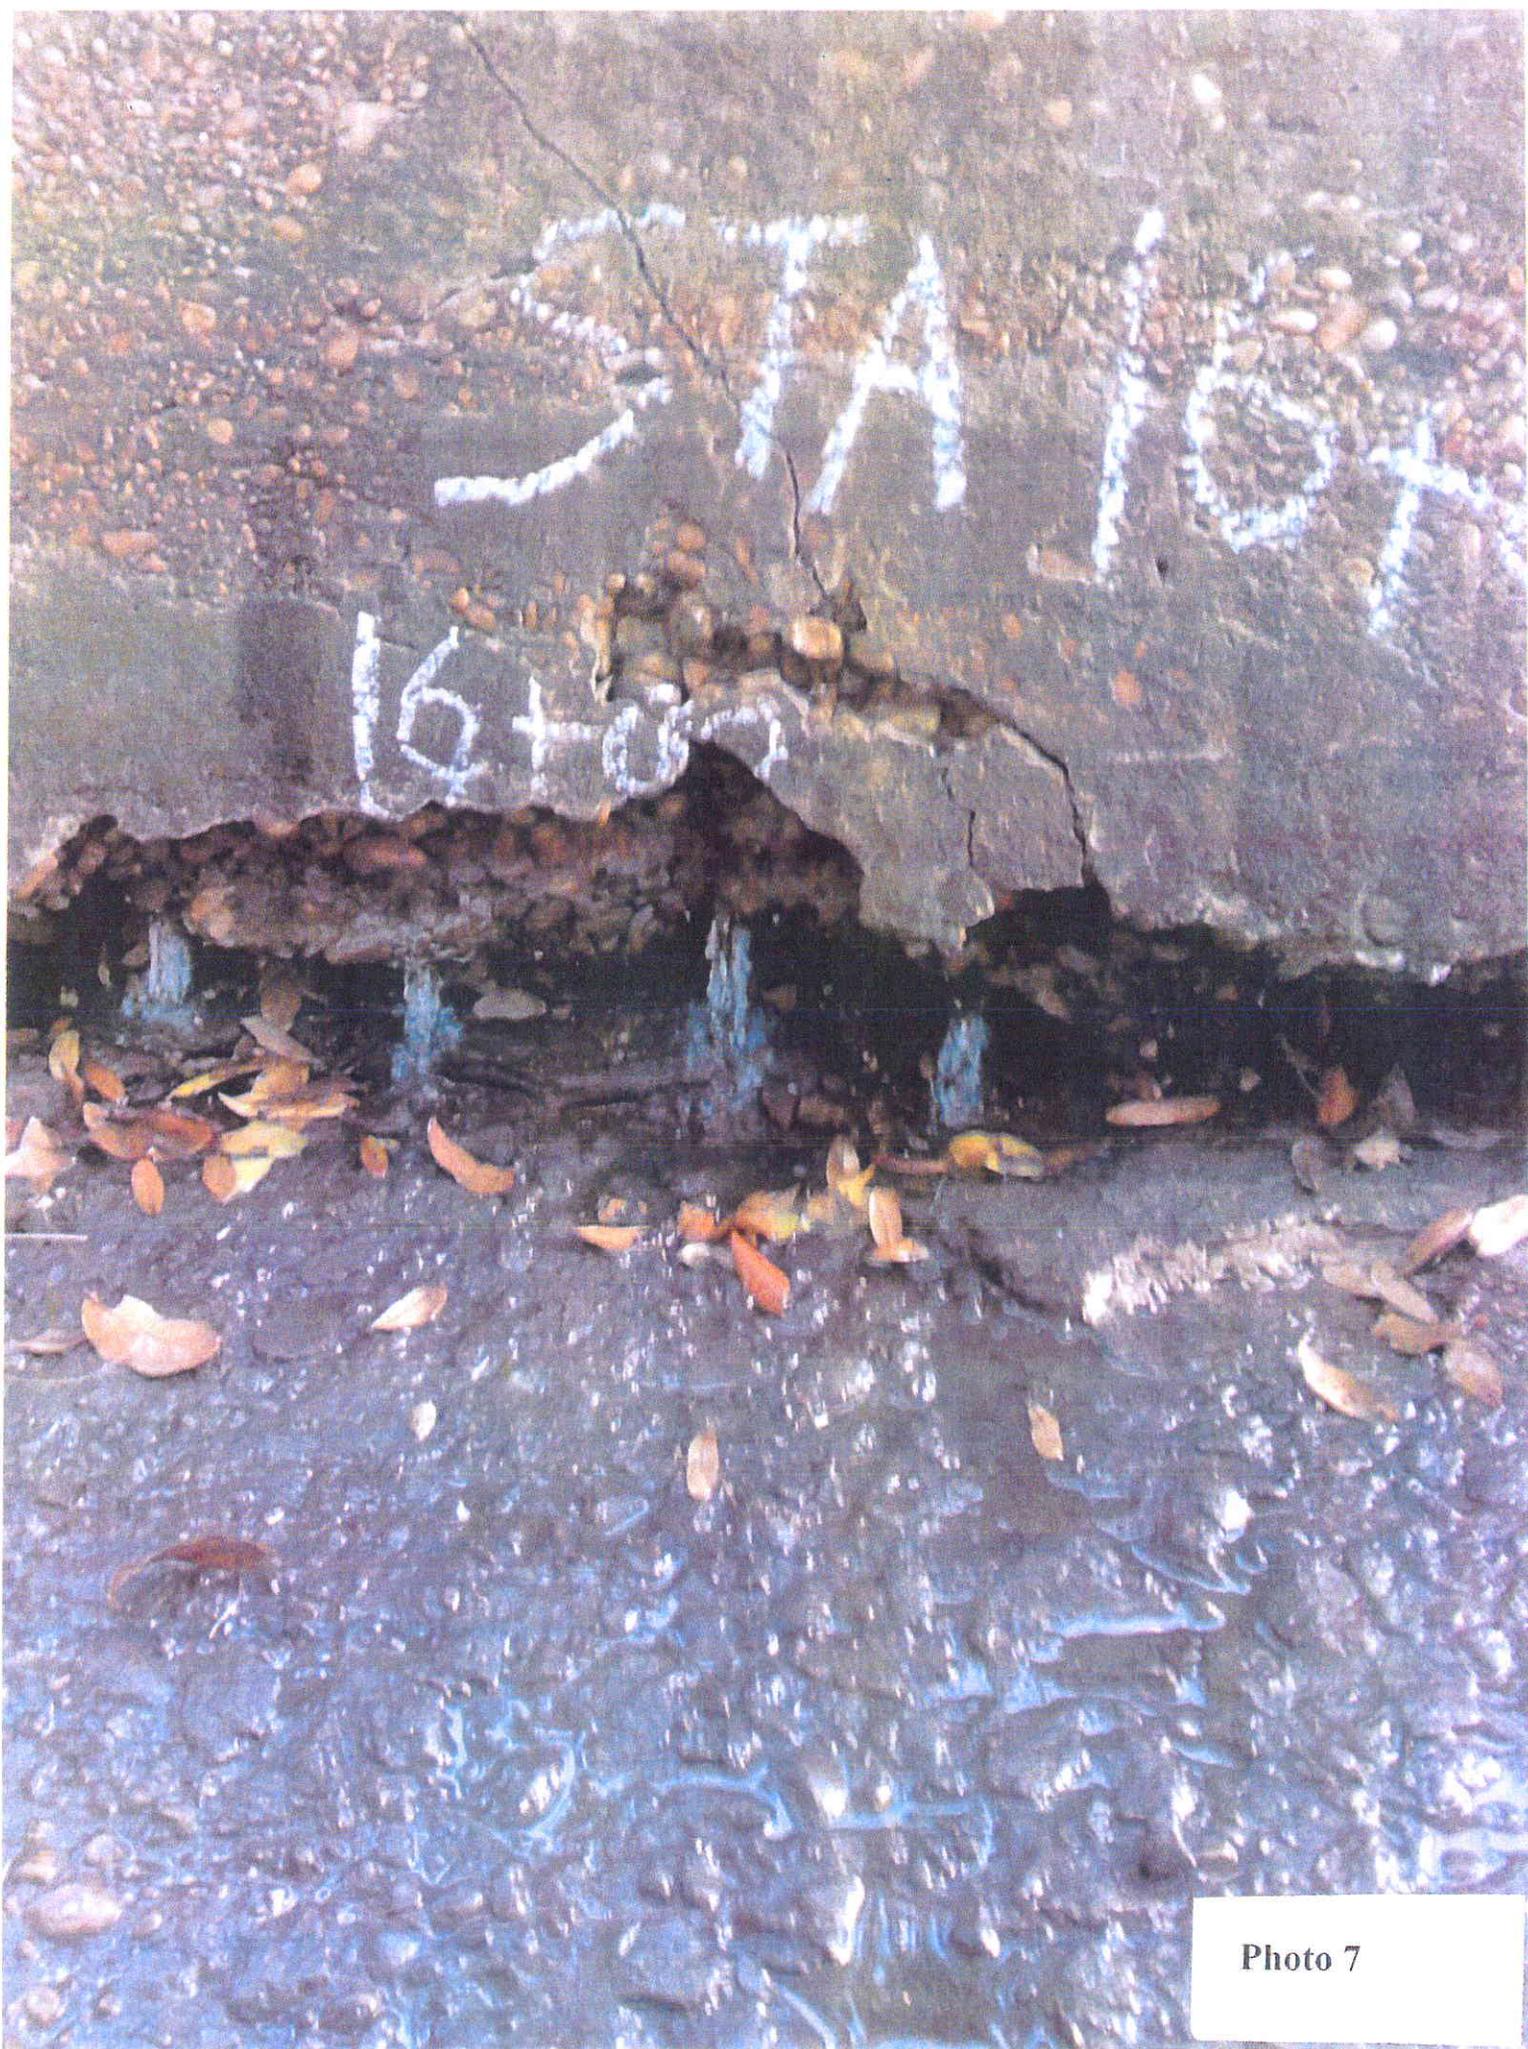
Photo 7

SLAB TO WALL PANEL CONNECTION - The bottom of the wall panels rest on top of the bottom slab. Scans indicate reinforcing steel connecting the slab to the bottom of the wall panels at approximate 6 inch intervals. At several locations, deterioration of the concrete has exposed the steel. While the exposed steel was very rusted, the reinforcement appears to be #4 bars. Photographs of selected locations are attached. Also included are photographs in the vicinity of Stations 14+30 to 14+75 where tree root growth behind the wall panels has displaced the wall panels.
