Krause Force Main Assessment and Replacement Alignment Study

**City of Tampa
Wastewater Department**

FINAL DRAFT – March 2013

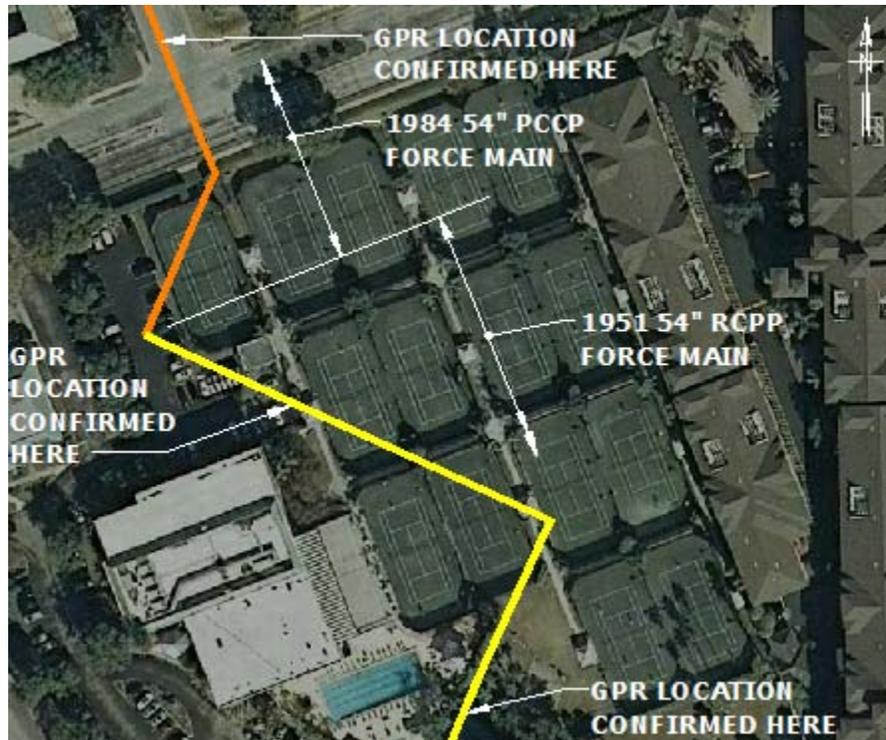
On Harbour Island residential and light commercial development has been dense. While the City retains an easement for the force main, some of the development, namely the Tennis Club, has disregarded the City's easement and constructed courts and fences on top of the pipeline as shown on Photo 1.

Photograph 1 – Pipe under Tennis Courts

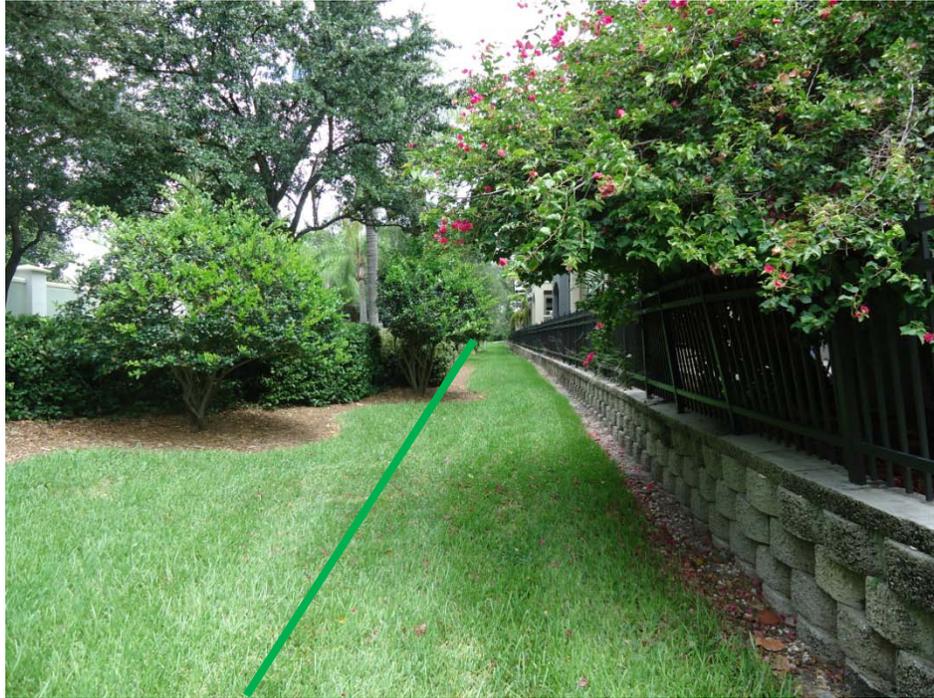
South of the courts, upscale, multifamily residential development crowds the relatively narrow 20-foot wide easement. The easement is made into a lushly landscaped trail with backyard patios lining both sides of the easement as shown in Photos 2 and 3.

Photograph 2 – Landscaped, Narrow Force Main Easement

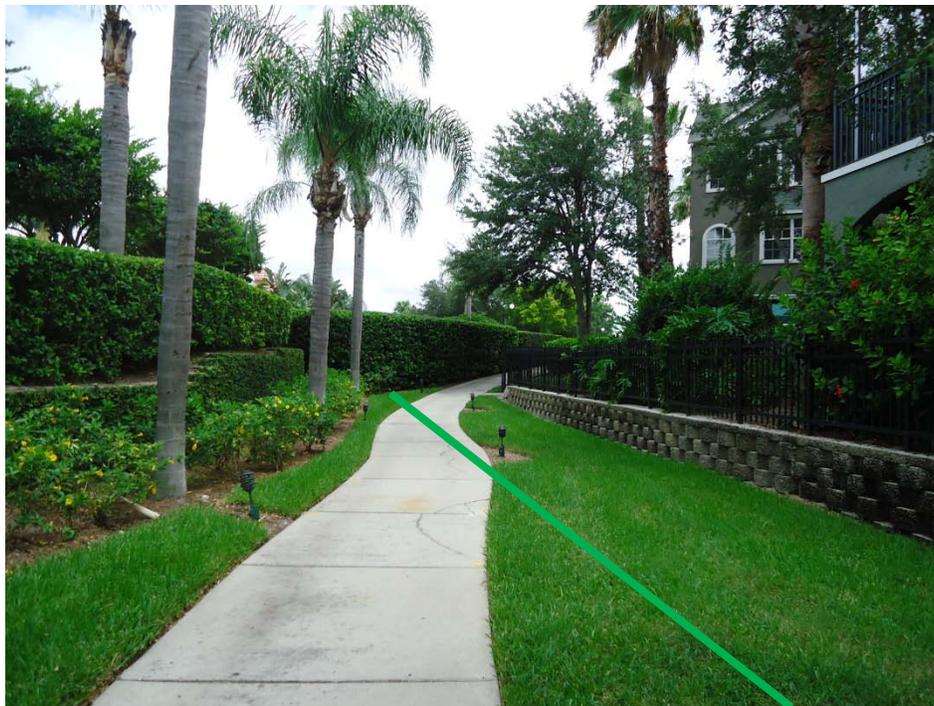
Photograph 3 – Force Main is Parallel and 7.5 offset from Short Block Wall

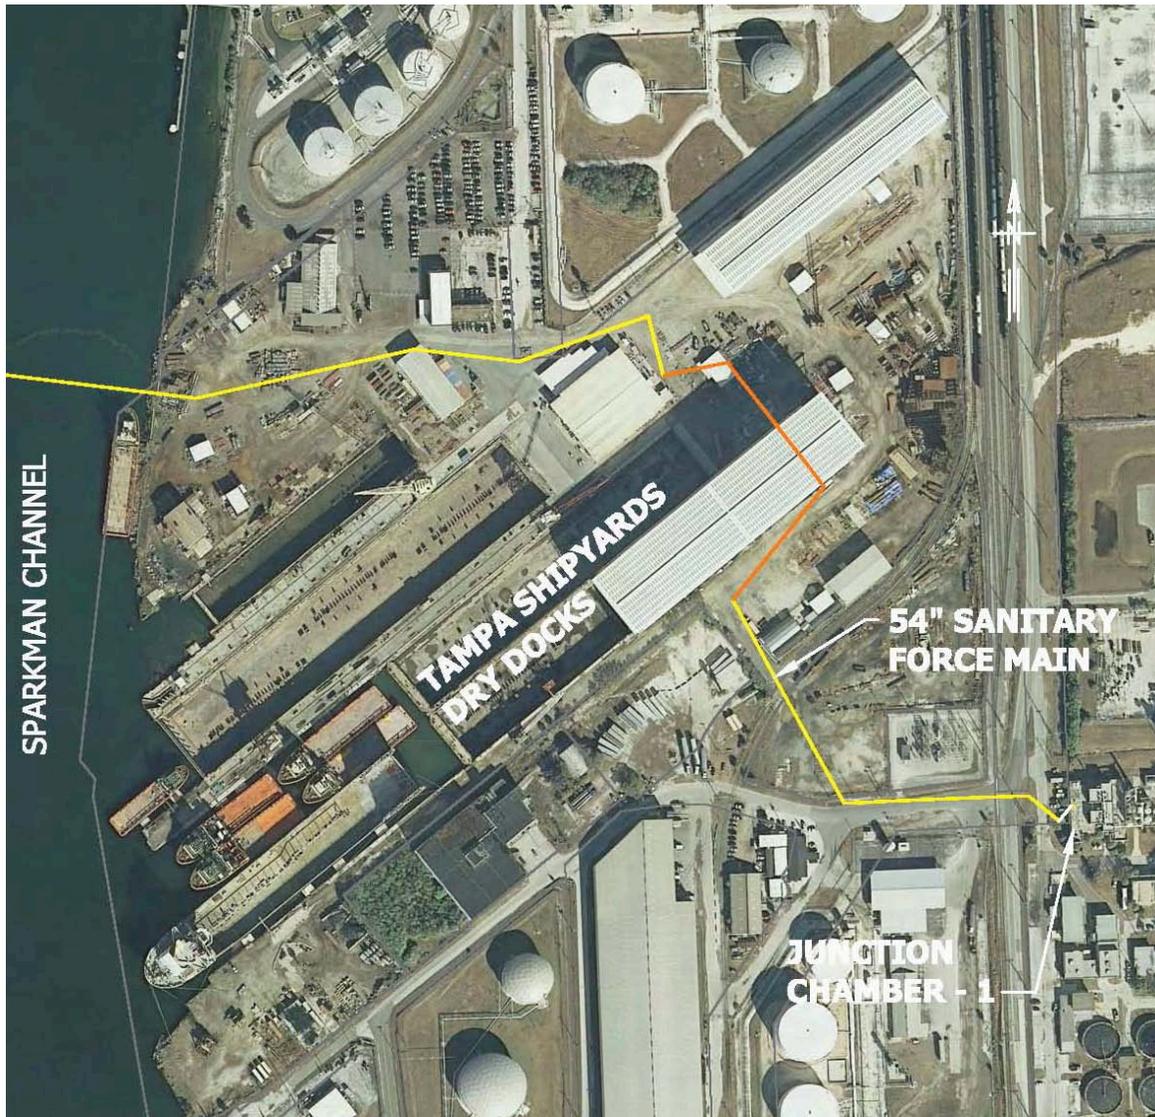
On Hookers Point heavy industrial development has coexisted with the pipeline since its construction. The roads are mostly owned by the Tampa Port Authority. Most of the easements here are paved and the force main appears to pass under a building in the Tampa Shipyards. The force main crosses two sets of railroad tracks on Hookers Point although one set of tracks appears to be inactive. See Photo 4.

Photograph 4 – Force Main on Hooker's Point

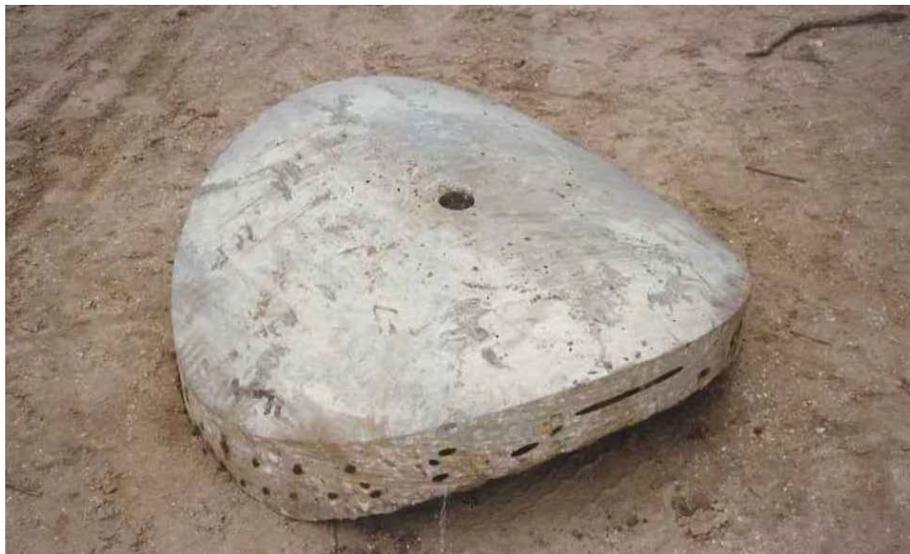
The best assessment of the overall condition of the now 62 year old pipeline has come from the three relocation projects where the pipe was tapped, usually four times for each relocation. At the end of each relocated segment, the pipe was tapped for flow diversion and tapped for insertion of a line stopper. The flow diversion taps are made into the side of the pipe and the line stop taps are made in the top of the pipe. The top of the pipe is where crown corrosion from collecting gases would be evident. All of the coupons retrieved from making the 30-inch to 48-inch diameter taps during the period 1984 to 1986 looked satisfactory. Several of the coupons and edges of cut pipe wall are shown in the following Photos 6 through 11.

Photograph 6 – 48-inch Coupon, May 14, 1987, Convention Center Pipeline Relocations

I discussed the condition of the coupons with our retired resident construction engineer who provided resident construction services for all three relocations and took the photos. He recalled observing the condition of the coupons as surprisingly good. The pipe at that time was approximately 35 years old. One of the tapping operations was performed just upstream of where the old force main dipped beneath Garrison Channel where collection of gases might be expected, but the coupon showed no sign of crown corrosion. This can also indicate that the City staff has been adequately using manual air release valves to vent accumulating gases.

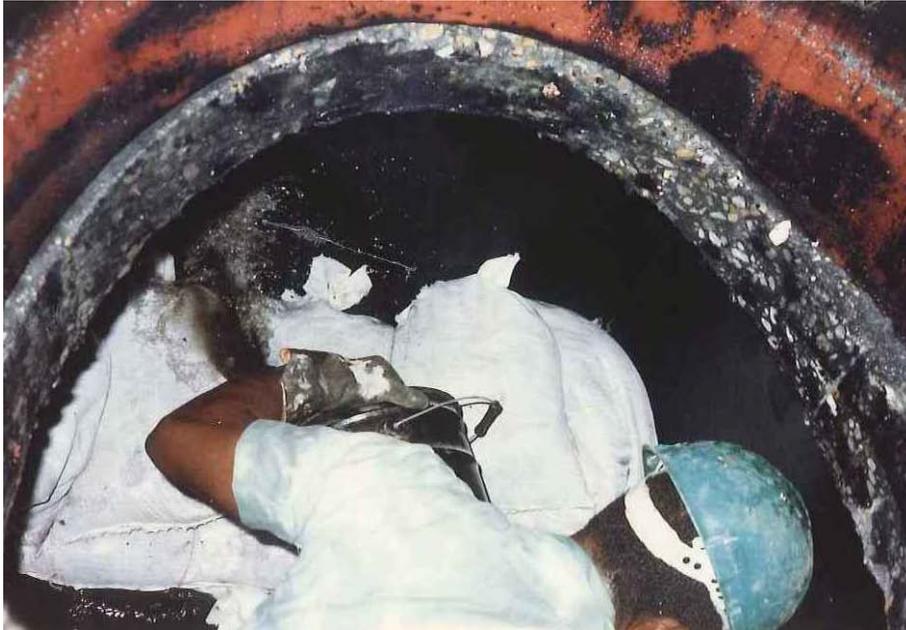
Photograph 7 – Cut Pipe Wall, June 26, 1987, Convention Center Pipeline Relocations

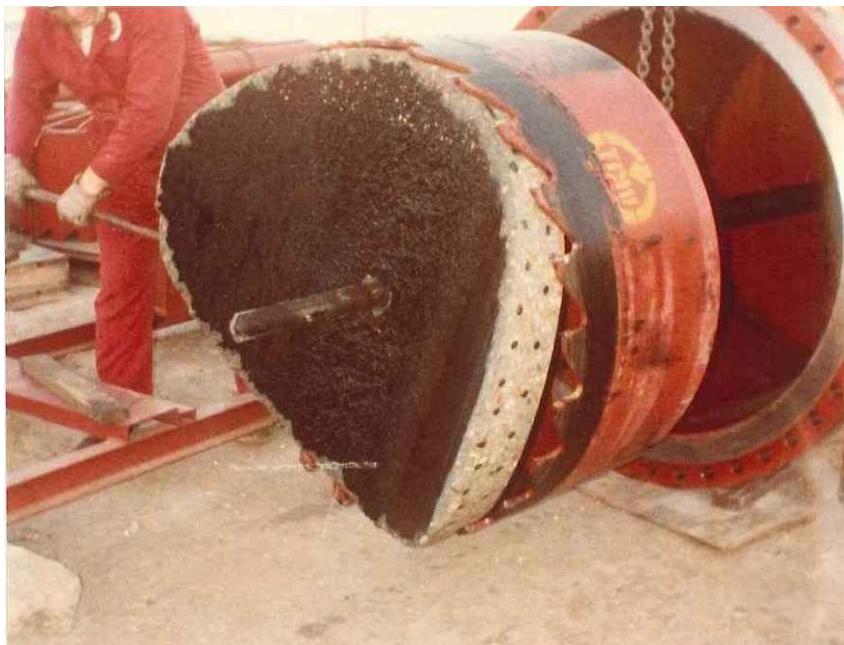
Photograph 8 – 48-inch Coupon, May 8, 1984, Tampa Shipyards Relocation

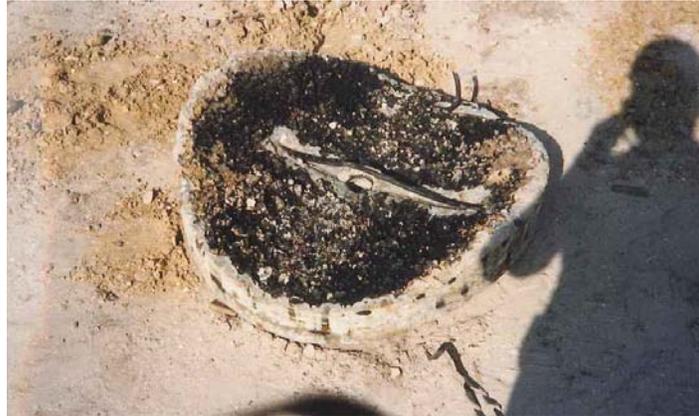
Photograph 9 – 36-inch Coupon, June 22, 1987, Convention Center Pipeline Relocations

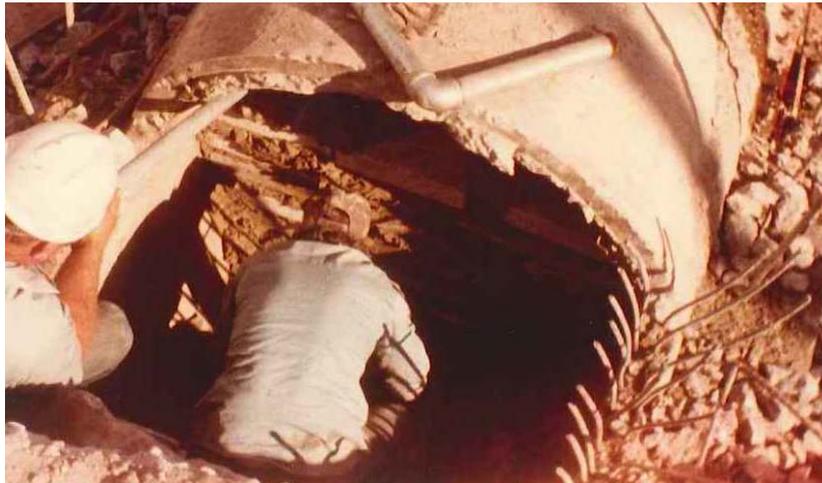
**Photograph 10 – Cut Pipe (note double row of steel reinforcing),
March 24, 1984, Harbour Island Relocation**

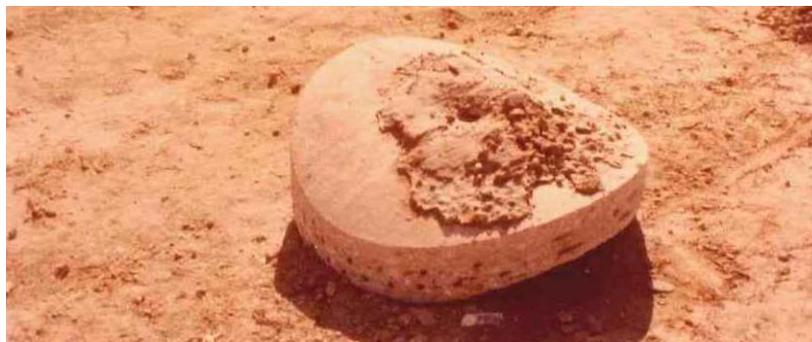
Photograph 11 – 36-inch Coupon, March 21, 1984, Tampa Shipyards

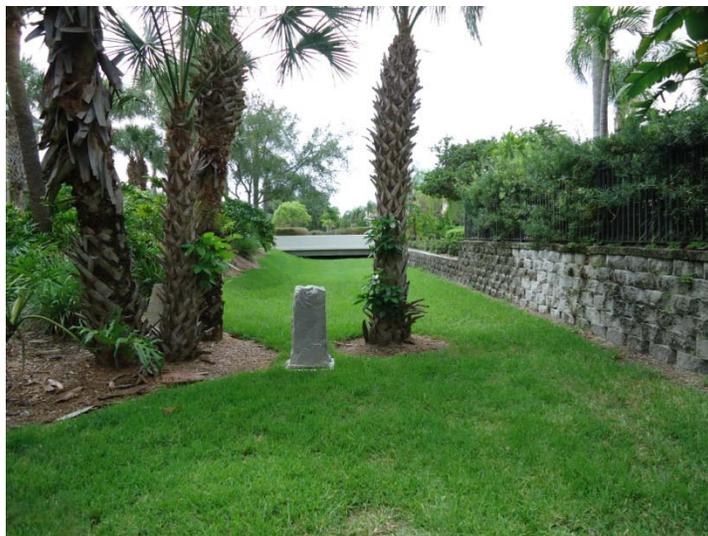
Just on the north side of the second road crossing progressing along the route from the southeast, the pipe was easily detected in a drainage swale with just less than 3 feet of cover. This point is adjacent to where the pipe crosses beneath a bridged roadway. Probing confirmed the curved profile of the top of the pipe. Impacting the pipe with the probe returned a sharp reply indicating the exterior of the pipe was sound. An air release valve is located approximately 100 feet northwest of this location. Moving the GPR to the air release valve returned a detection of 4.5 feet of cover.

Photograph 11 – Air Release Valve with Fake Rock Enclosure, note Low Bridge Beyond

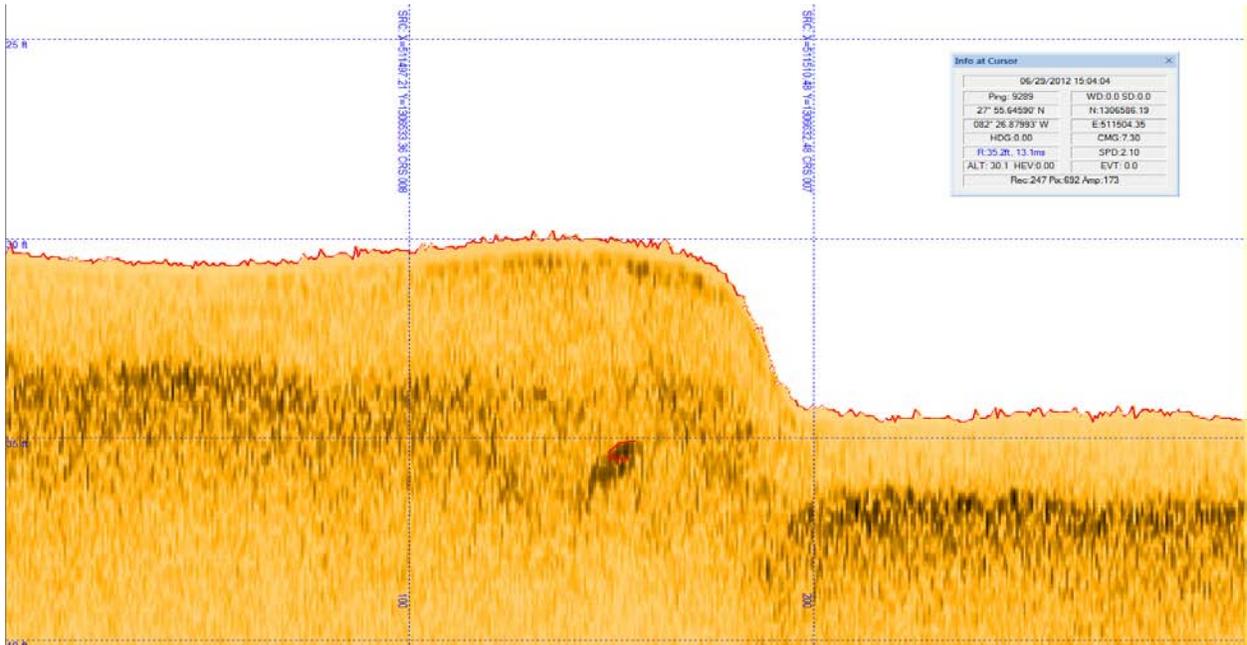
with confidence with between 2 and 5 feet of cover. See Figure 6. Where the record drawings indicate the pipe was installed in rock, the pipe was detected with covers ranging from 2 to 3 feet; however, the cover material returns a dense signal implying it consists of rocky material above the pipe/bedding envelope. Rock removed during excavation of the trench may have been placed back on top of the bedded pipeline which may provide excellent protection from erosion or mechanical impacts such as boat anchors. See Figure 7. Along the east side of the channel, the pipe was detected with as little as 1 foot of cover, but generally more. Frequent ship docking and traffic here, as well as shallower water depths, may explain an apparent loss of cover material.

Figure 6 – Track 1plus50N Sub Bottom Sonar Image showing Pipe with 5’ of Cover in Granular Soils near West Bank of Channel

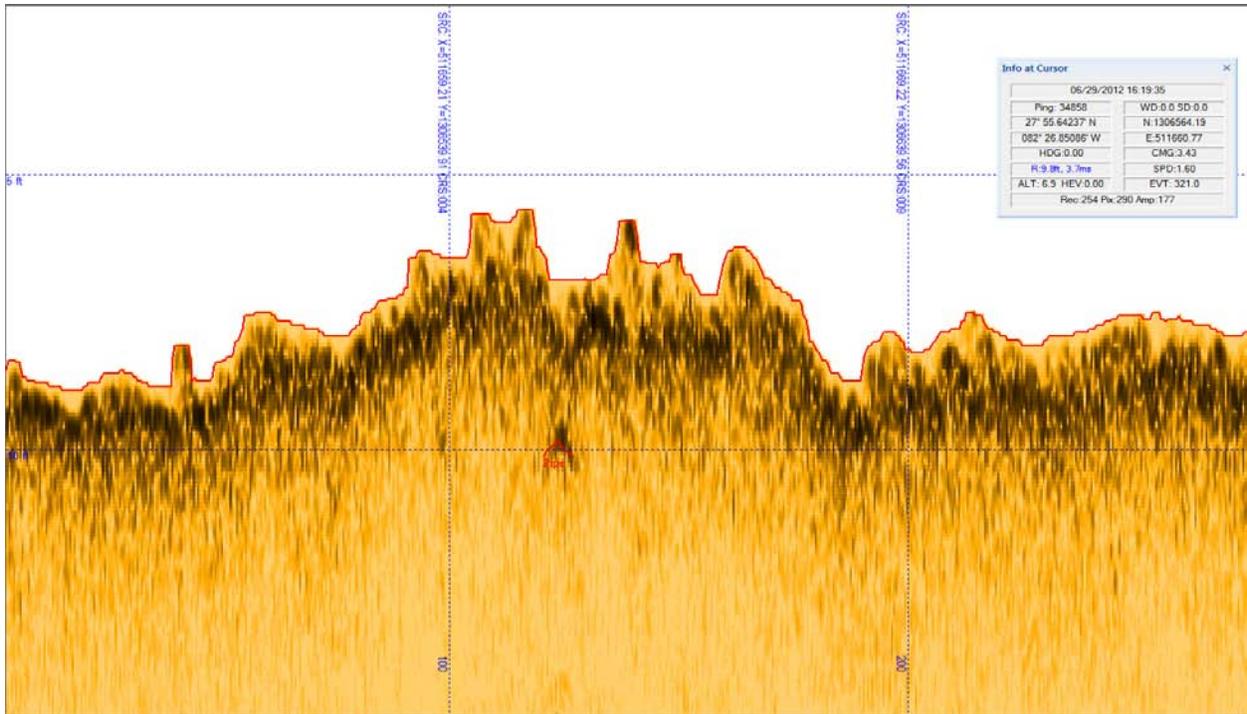
Figure 7 – Survey Track 3plus00N Sub Bottom Sonar Image showing Pipe with 2.8’ of Cover in Rocky Soils near Center of Channel

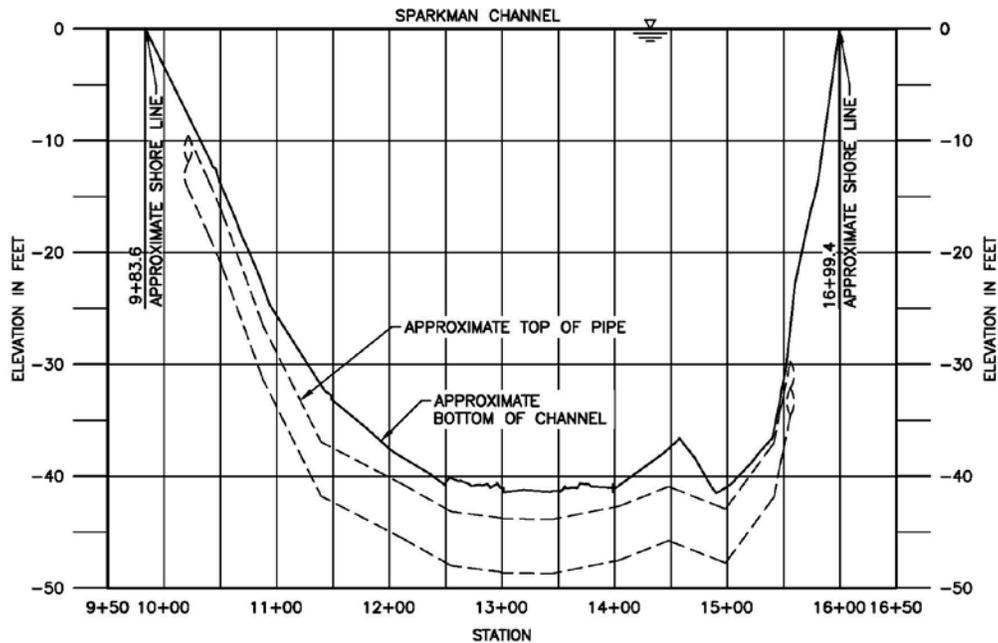
Figure 8 – Profile of Sparkman Channel Showing Pipe According to Sub-bottom Sonar Detection

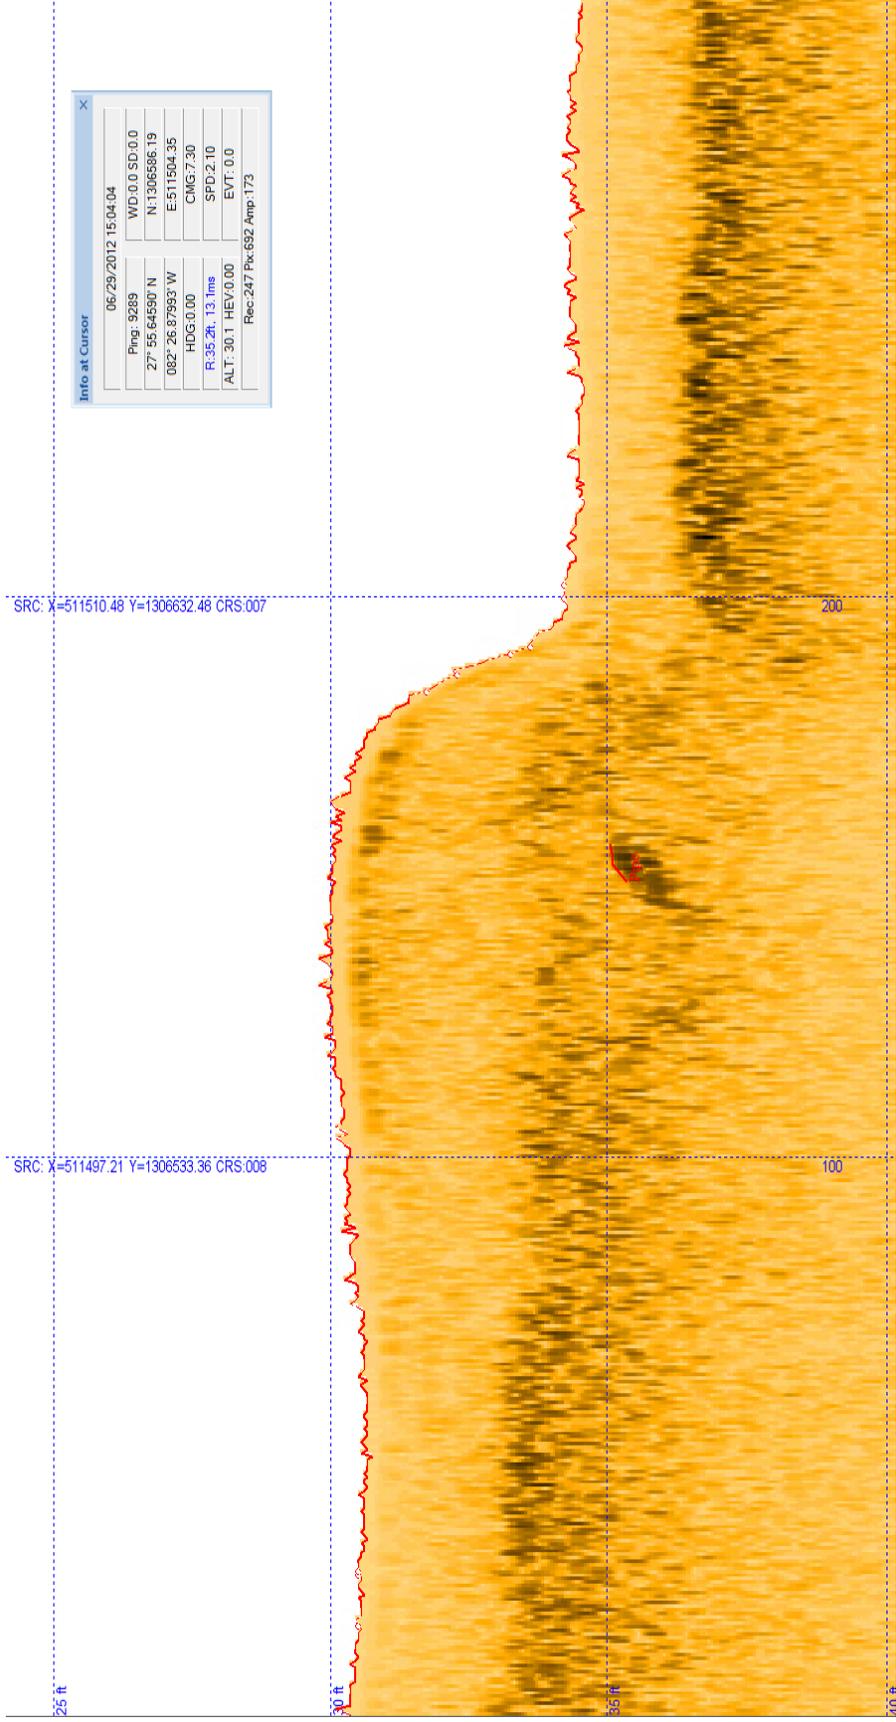
Figure 1. Line 1Plus50N:

Dark mass in the center of the image is the pipeline. It is marked with red as "Pipe" (difficult to see without zooming). The annotation is purposely small to avoid masking the target. This is in the silt near the west side. Vertical annotation includes FL State Plane Coordinates, course made good and depth in feet from the transducer based on assumed sediment velocity of 1640 meters / second. Depth of burial at this detection is 5.1 ft.

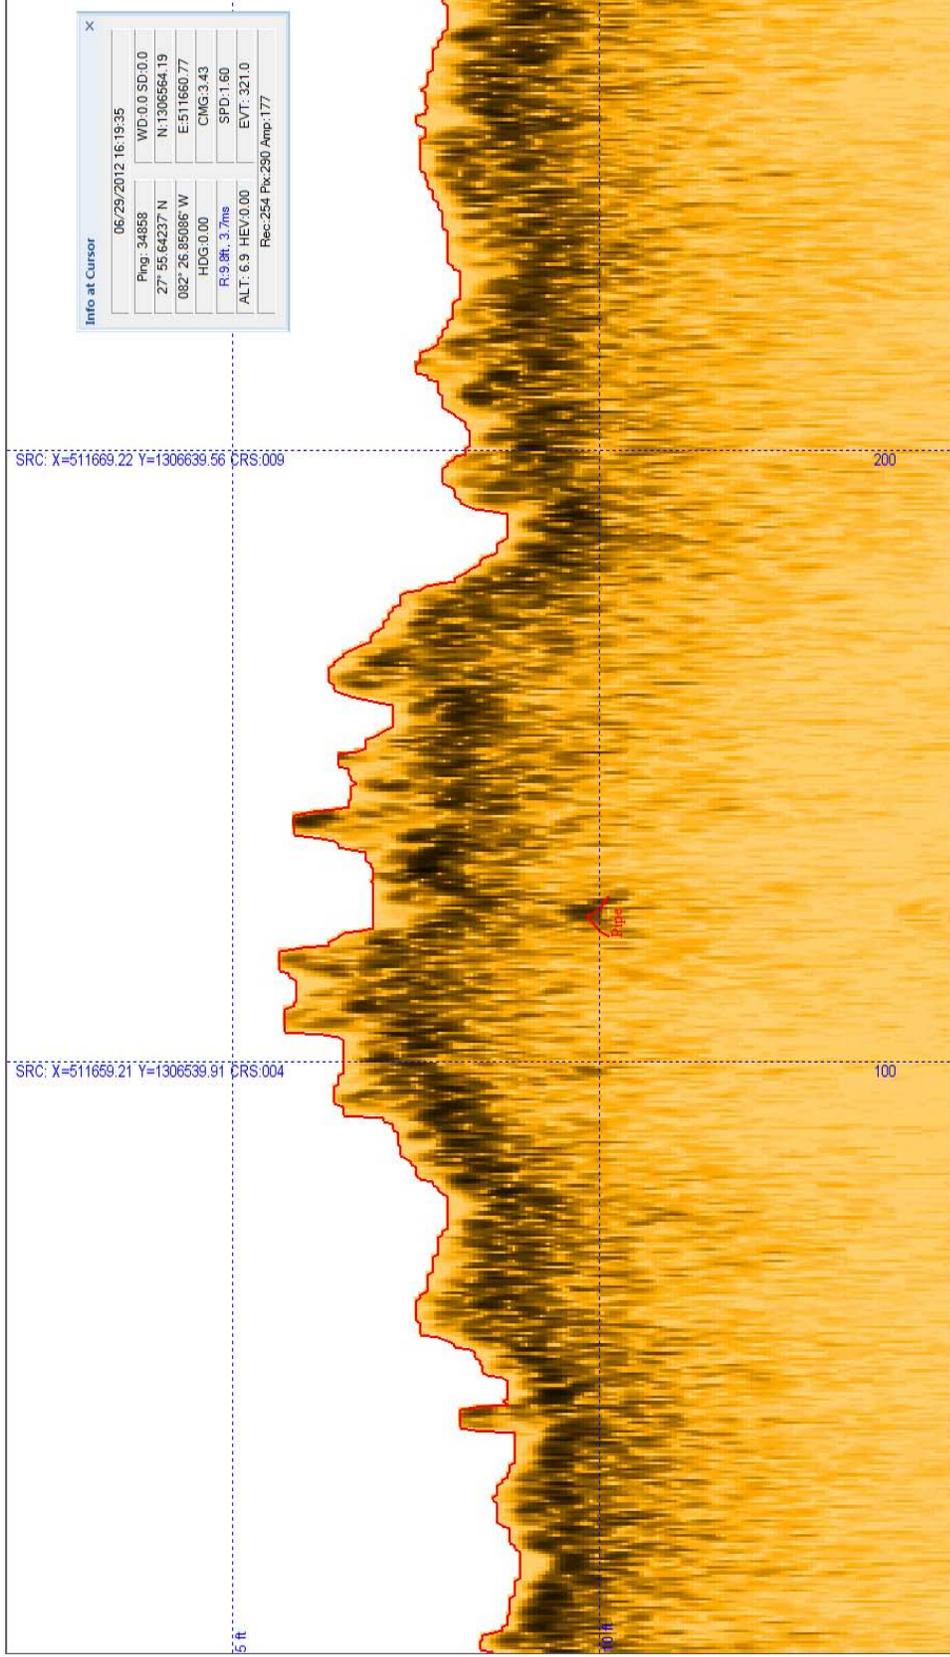
Figure 2. Line 3Plus00N:

Dark mass in the center of the image is the pipeline. It is marked with red as "Pipe" (difficult to see without zooming). The annotation is purposely small to avoid masking the target. This is in rocky bottom near the middle of the crossing. Note the rugged bottom profile. Vertical annotation includes FL State Plane Coordinates, course made good and depth in feet from the transducer based on assumed sediment velocity of 1640 meters / second. Depth of burial at this detection is 2.8 ft.
