Krause Force Main Assessment and Replacement Alignment Study

**City of Tampa
Wastewater Department**

FINAL DRAFT – March 2013

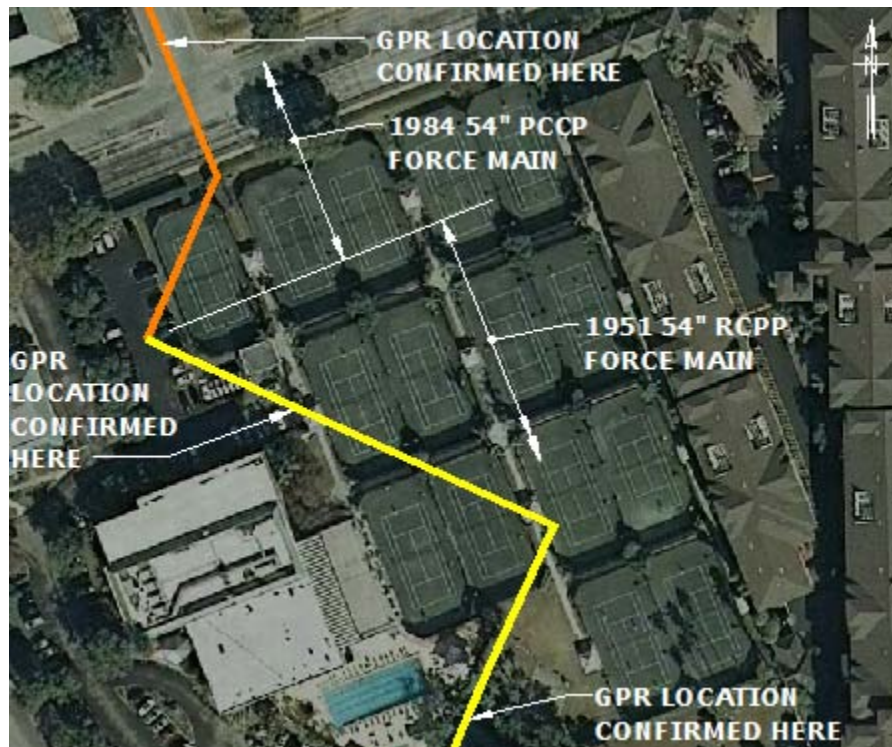
On Harbour Island residential and light commercial development has been dense. While the City retains an easement for the force main, some of the development, namely the Tennis Club, has disregarded the City's easement and constructed courts and fences on top of the pipeline as shown on Photo 1.

Photograph 1 – Pipe under Tennis Courts

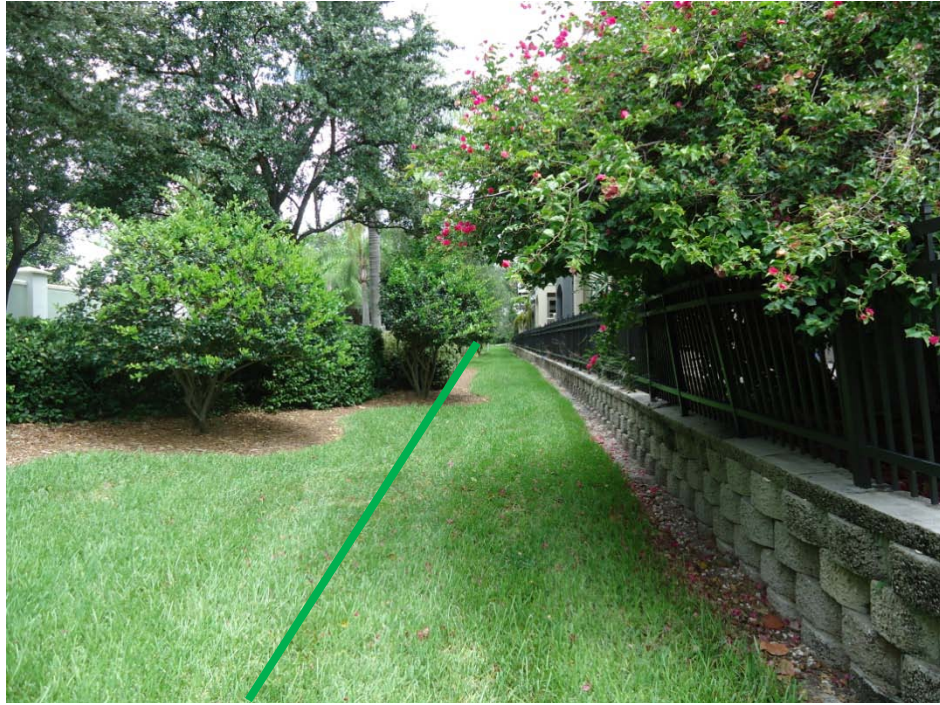
South of the courts, upscale, multifamily residential development crowds the relatively narrow 20-foot wide easement. The easement is made into a lushly landscaped trail with backyard patios lining both sides of the easement as shown in Photos 2 and 3.

Photograph 2 – Landscaped, Narrow Force Main Easement

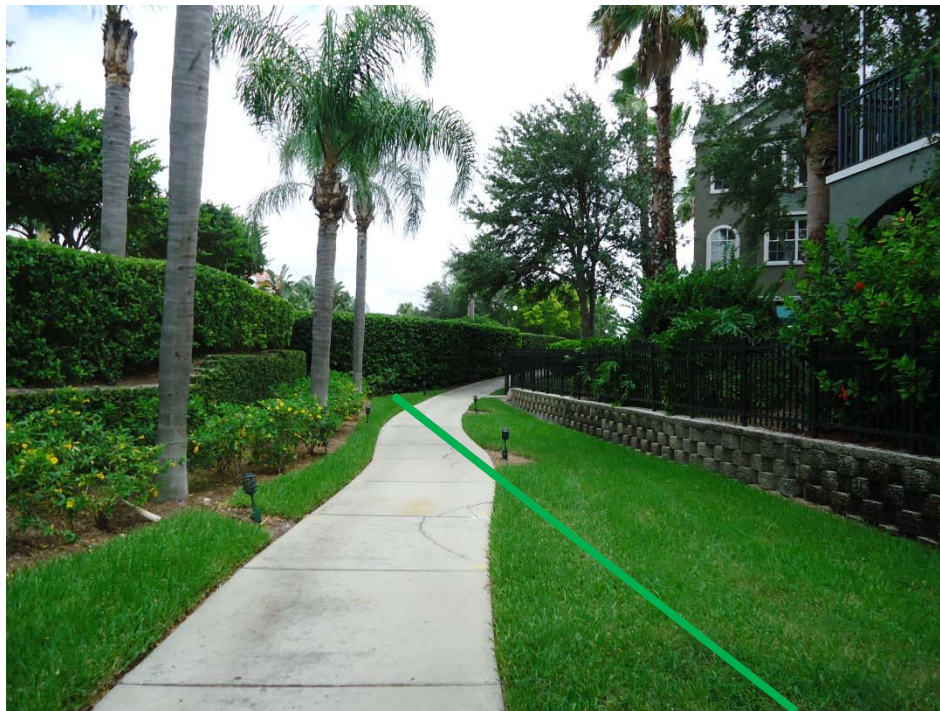
Photograph 3 – Force Main is Parallel and 7.5 offset from Short Block Wall

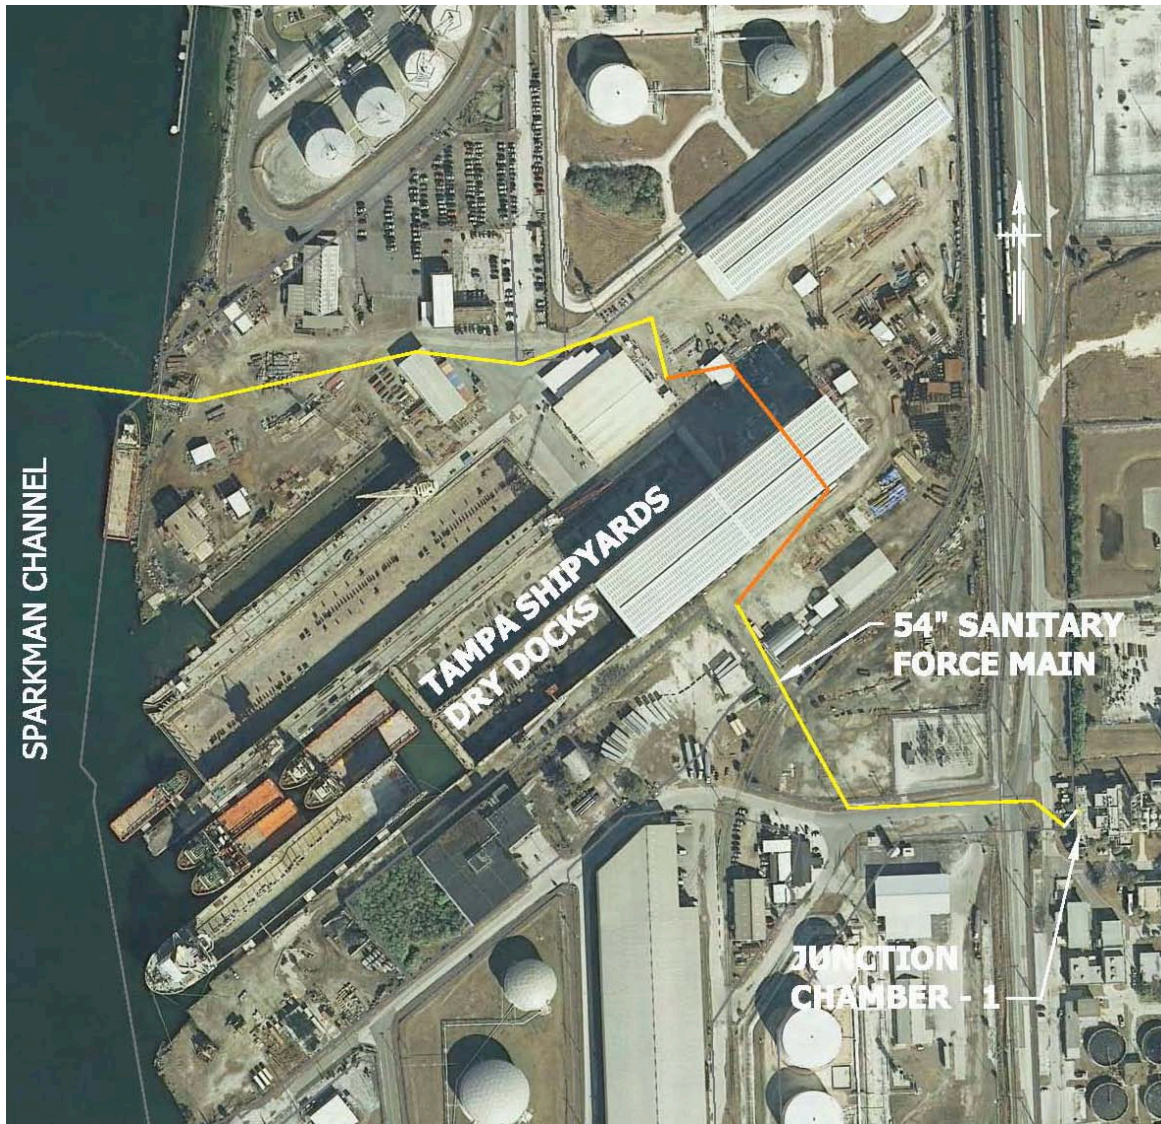
On Hookers Point heavy industrial development has coexisted with the pipeline since its construction. The roads are mostly owned by the Tampa Port Authority. Most of the easements here are paved and the force main appears to pass under a building in the Tampa Shipyards. The force main crosses two sets of railroad tracks on Hookers Point although one set of tracks appears to be inactive. See Photo 4.

Photograph 4 – Force Main on Hooker's Point

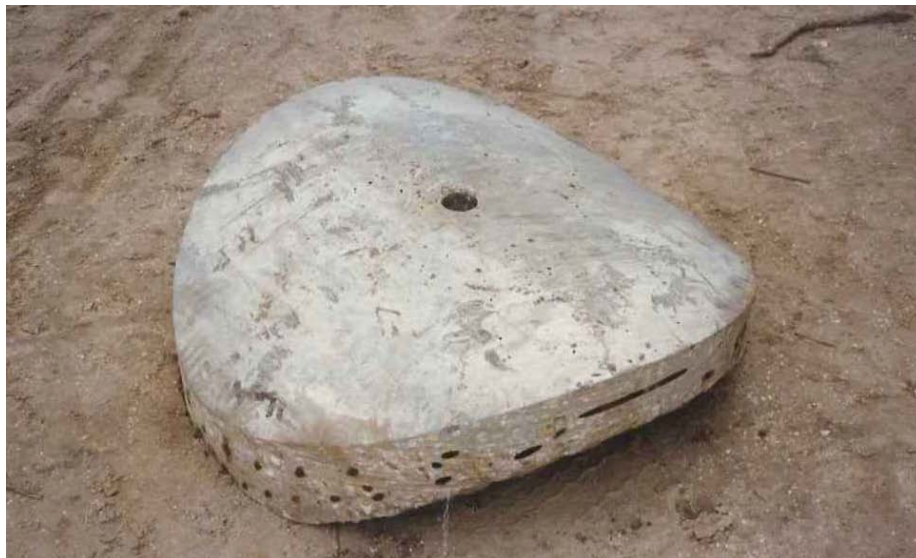
The best assessment of the overall condition of the now 62 year old pipeline has come from the three relocation projects where the pipe was tapped, usually four times for each relocation. At the end of each relocated segment, the pipe was tapped for flow diversion and tapped for insertion of a line stopper. The flow diversion taps are made into the side of the pipe and the line stop taps are made in the top of the pipe. The top of the pipe is where crown corrosion from collecting gases would be evident. All of the coupons retrieved from making the 30-inch to 48-inch diameter taps during the period 1984 to 1986 looked satisfactory. Several of the coupons and edges of cut pipe wall are shown in the following Photos 6 through 11.

Photograph 6 – 48-inch Coupon, May 14, 1987, Convention Center Pipeline Relocations

I discussed the condition of the coupons with our retired resident construction engineer who provided resident construction services for all three relocations and took the photos. He recalled observing the condition of the coupons as surprisingly good. The pipe at that time was approximately 35 years old. One of the tapping operations was performed just upstream of where the old force main dipped beneath Garrison Channel where collection of gases might be expected, but the coupon showed no sign of crown corrosion. This can also indicate that the City staff has been adequately using manual air release valves to vent accumulating gases.

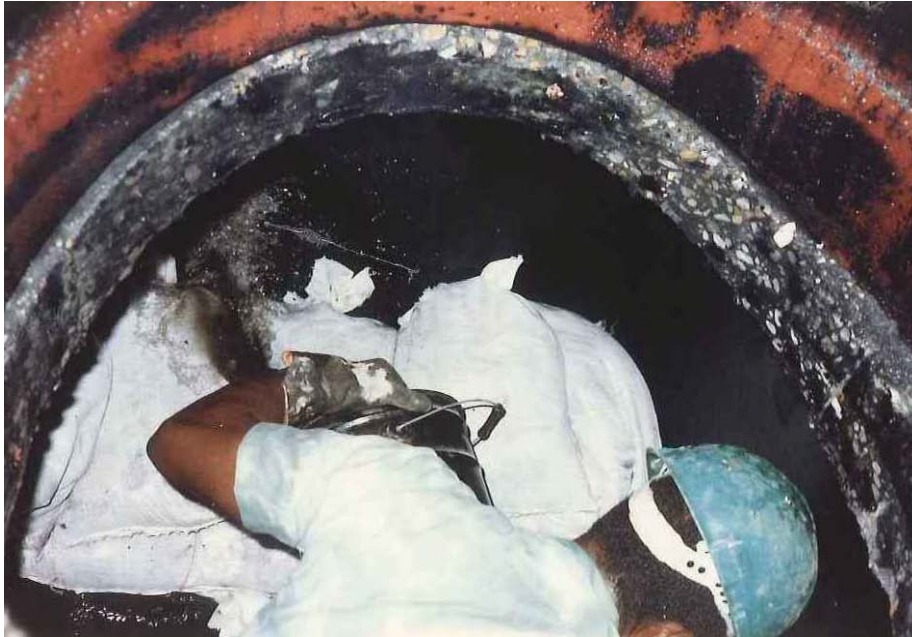
Photograph 7 – Cut Pipe Wall, June 26, 1987, Convention Center Pipeline Relocations

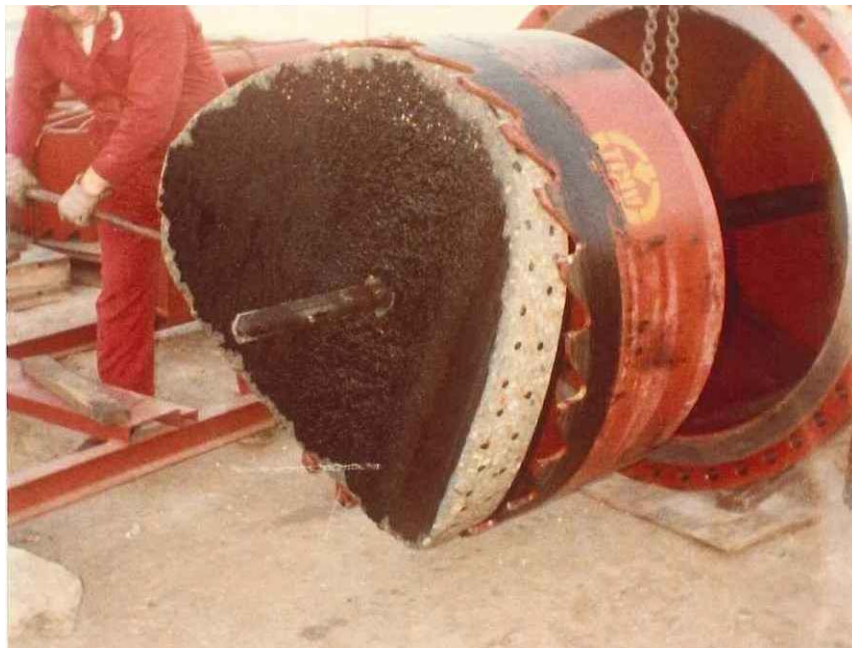
Photograph 8 – 48-inch Coupon, May 8, 1984, Tampa Shipyards Relocation

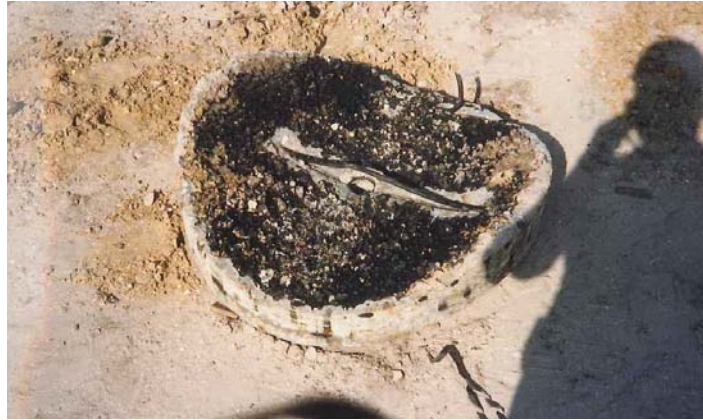
Photograph 9 – 36-inch Coupon, June 22, 1987, Convention Center Pipeline Relocations

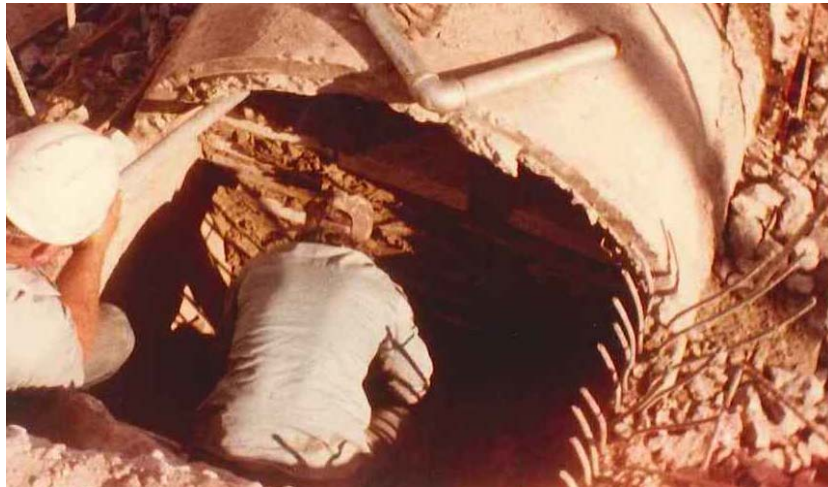
**Photograph 10 – Cut Pipe (note double row of steel reinforcing),
March 24, 1984, Harbour Island Relocation**

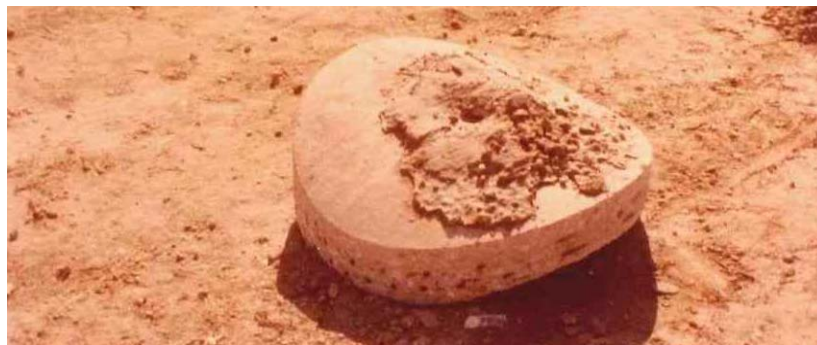
Photograph 11 – 36-inch Coupon, March 21, 1984, Tampa Shipyards

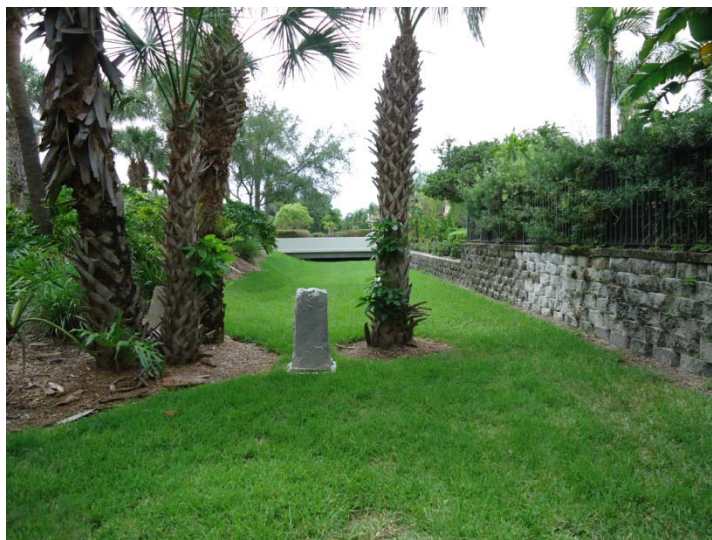
Just on the north side of the second road crossing progressing along the route from the southeast, the pipe was easily detected in a drainage swale with just less than 3 feet of cover. This point is adjacent to where the pipe crosses beneath a bridged roadway. Probing confirmed the curved profile of the top of the pipe. Impacting the pipe with the probe returned a sharp reply indicating the exterior of the pipe was sound. An air release valve is located approximately 100 feet northwest of this location. Moving the GPR to the air release valve returned a detection of 4.5 feet of cover.

Photograph 11 – Air Release Valve with Fake Rock Enclosure, note Low Bridge Beyond

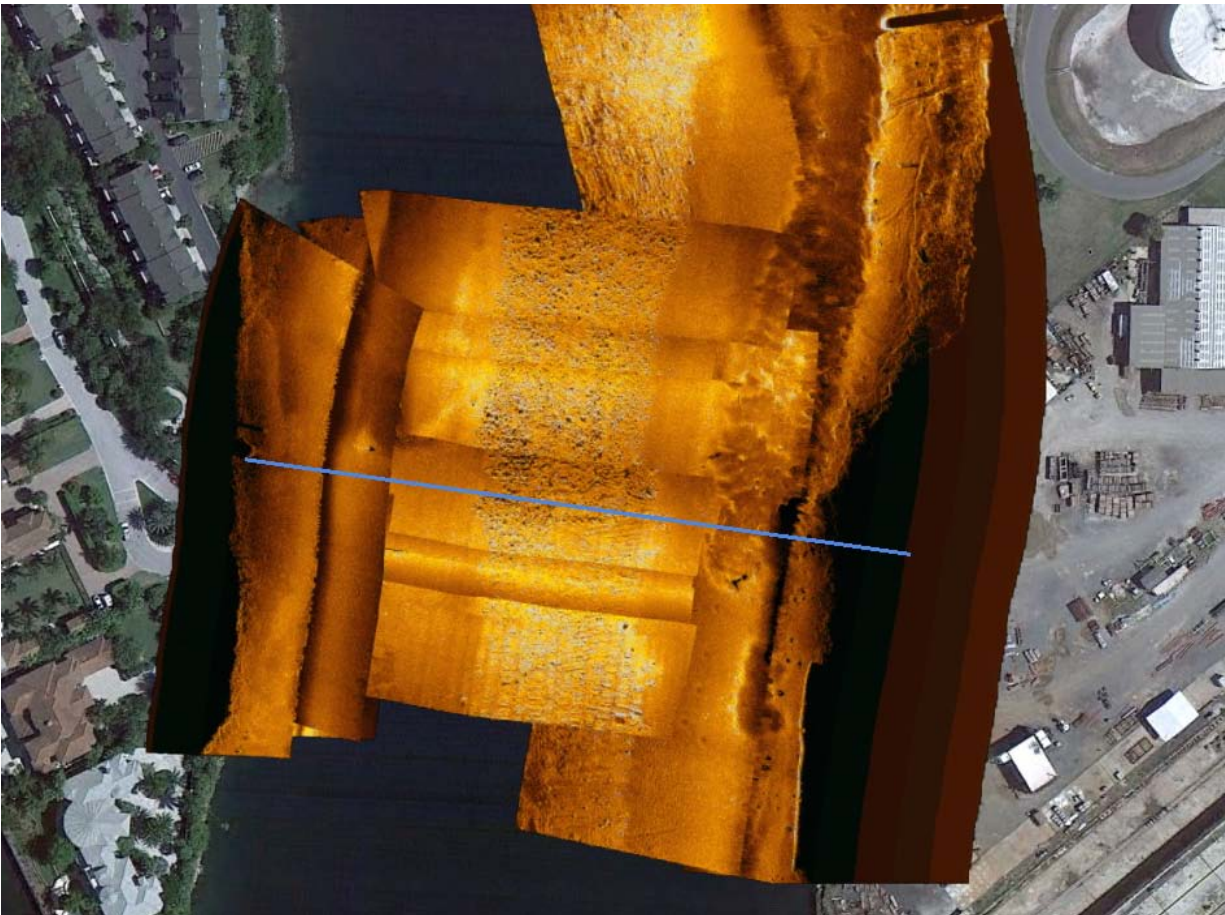
Figure 4 – Sidescan Sonar Image Mosaic of Bottom of Sparkman Channel. The blue line is location of buried force main. Force main is not exposed and therefore not visible.

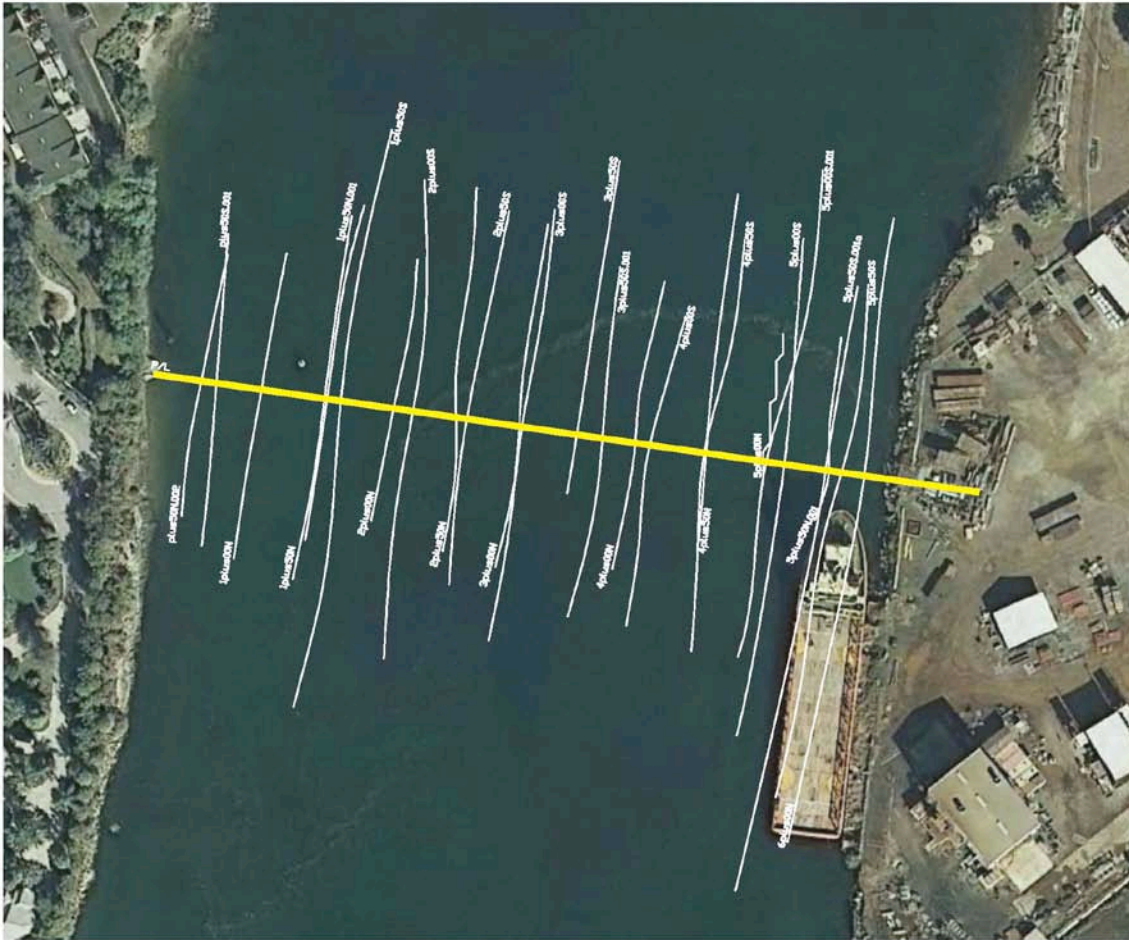
Figure 5 shows approximately 25 survey vessel tracks crossing the pipeline alignment. Not all of the tracks detected the target pipeline with confidence. On the east side of the channel, the soils are granular, as indicated by the record drawings and the plotted top of rock probing results. Here the pipe was detected

Figure 5 – Survey Vessel Tracks Crossing Pipeline

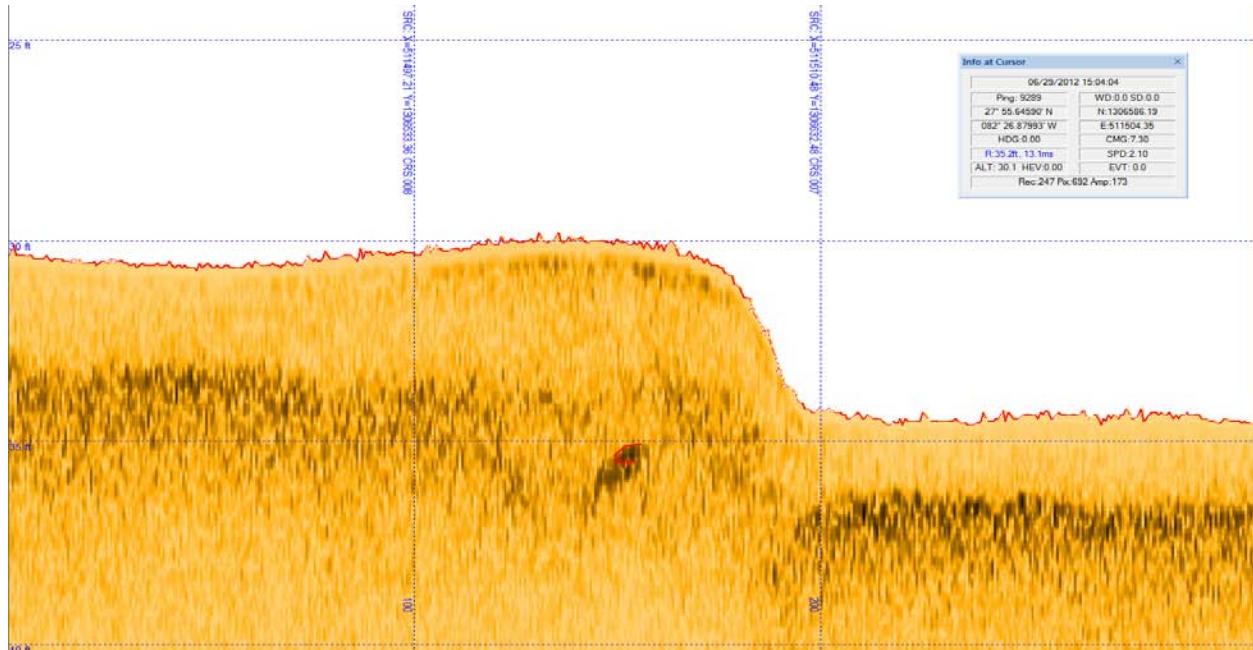
with confidence with between 2 and 5 feet of cover. See Figure 6. Where the record drawings indicate the pipe was installed in rock, the pipe was detected with covers ranging from 2 to 3 feet; however, the cover material returns a dense signal implying it consists of rocky material above the pipe/bedding envelope. Rock removed during excavation of the trench may have been placed back on top of the bedded pipeline which may provide excellent protection from erosion or mechanical impacts such as boat anchors. See Figure 7. Along the east side of the channel, the pipe was detected with as little as 1 foot of cover, but generally more. Frequent ship docking and traffic here, as well as shallower water depths, may explain an apparent loss of cover material.

Figure 6 – Track 1plus50N Sub Bottom Sonar Image showing Pipe with 5’ of Cover in Granular Soils near West Bank of Channel

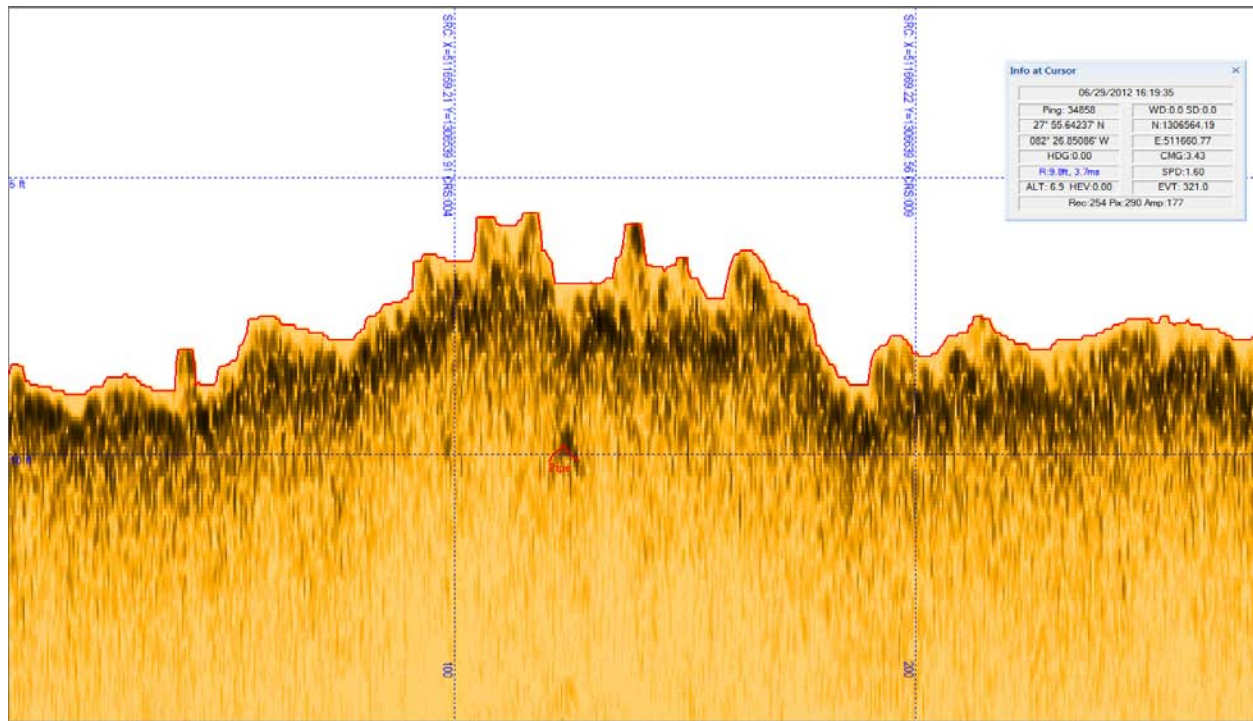
Figure 7 – Survey Track 3plus00N Sub Bottom Sonar Image showing Pipe with 2.8’ of Cover in Rocky Soils near Center of Channel

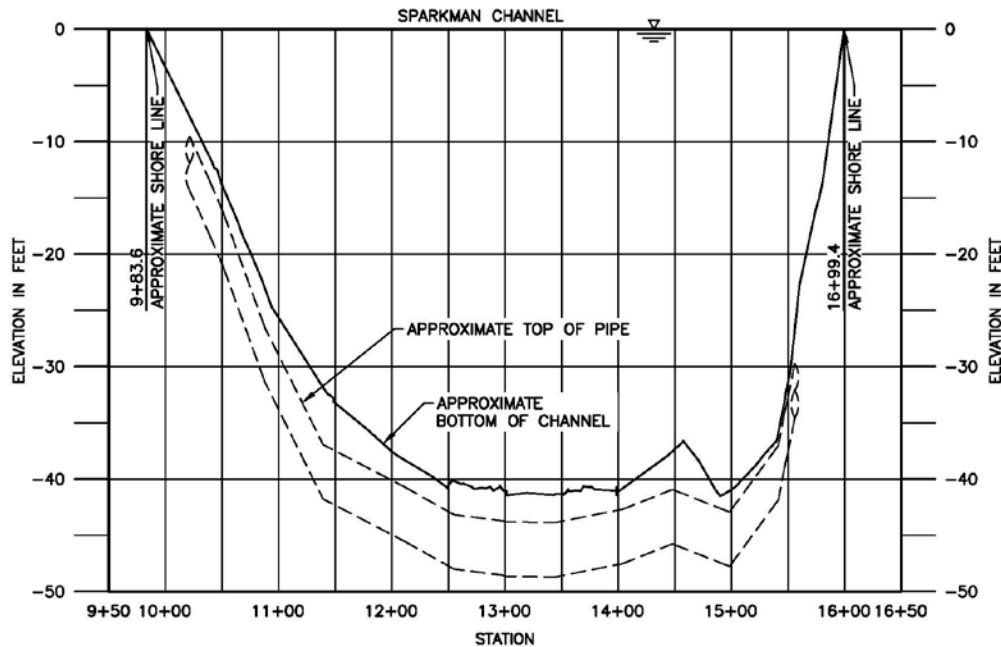
Figure 8 – Profile of Sparkman Channel Showing Pipe According to Sub-bottom Sonar Detection

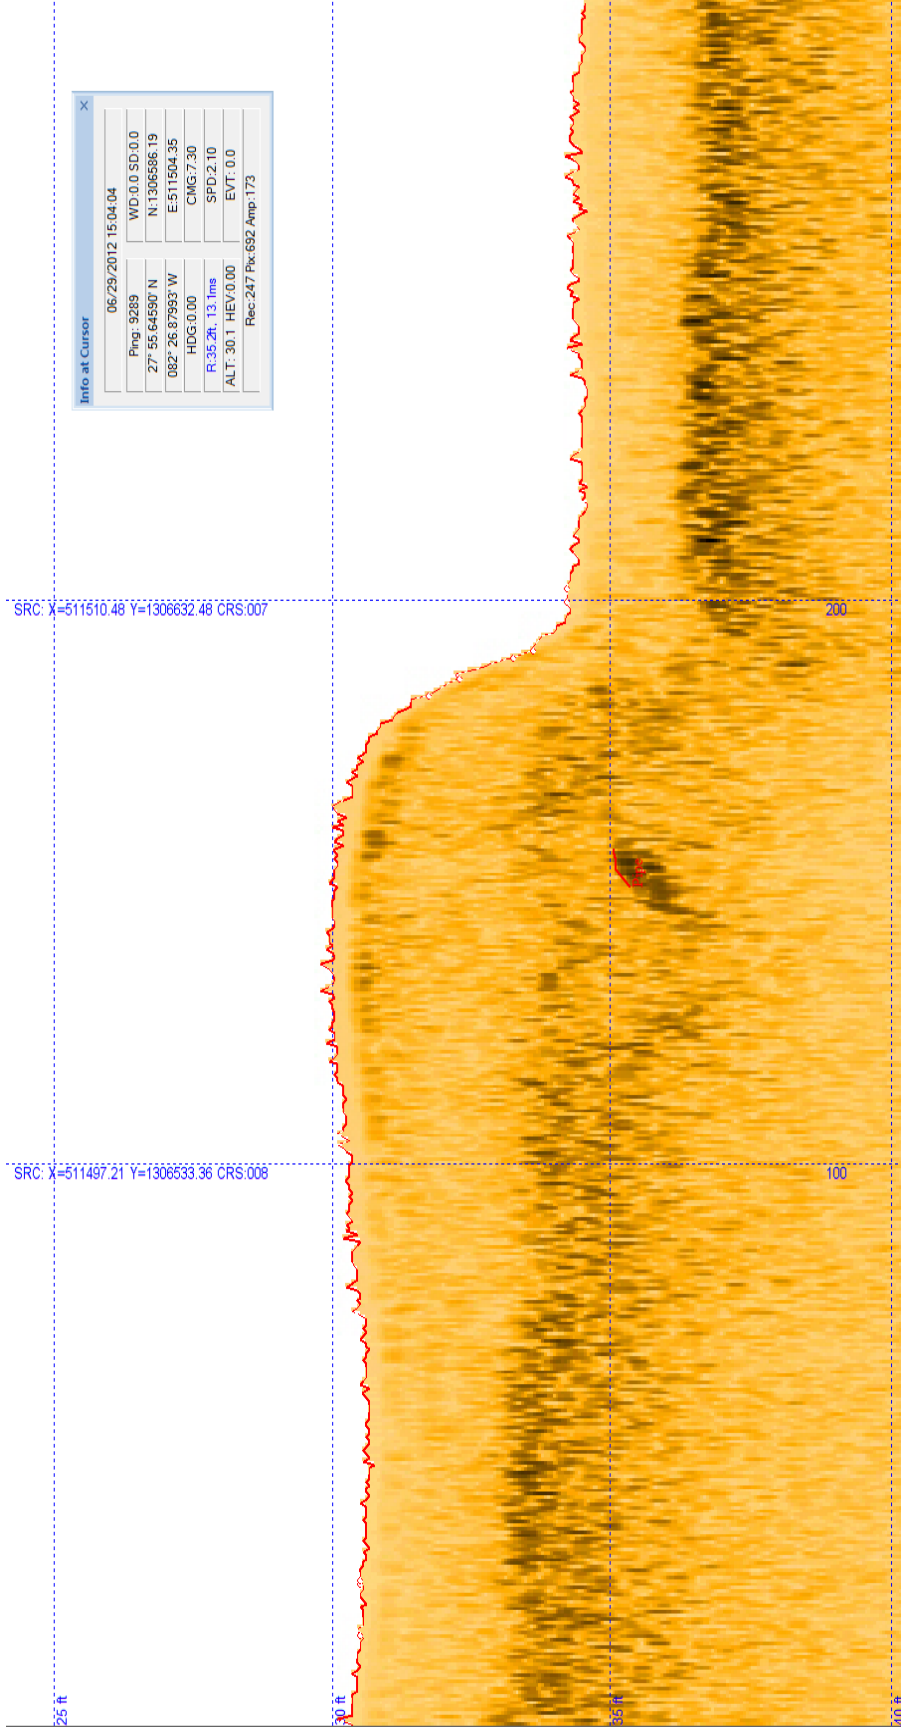
Figure 1. Line 1Plus50N:

Dark mass in the center of the image is the pipeline. It is marked with red as “Pipe” (difficult to see without zooming). The annotation is purposely small to avoid masking the target. This is in the silt near the west side. Vertical annotation includes FL State Plane Coordinates, course made good and depth in feet from the transducer based on assumed sediment velocity of 1640 meters / second. Depth of burial at this detection is 5.1 ft.

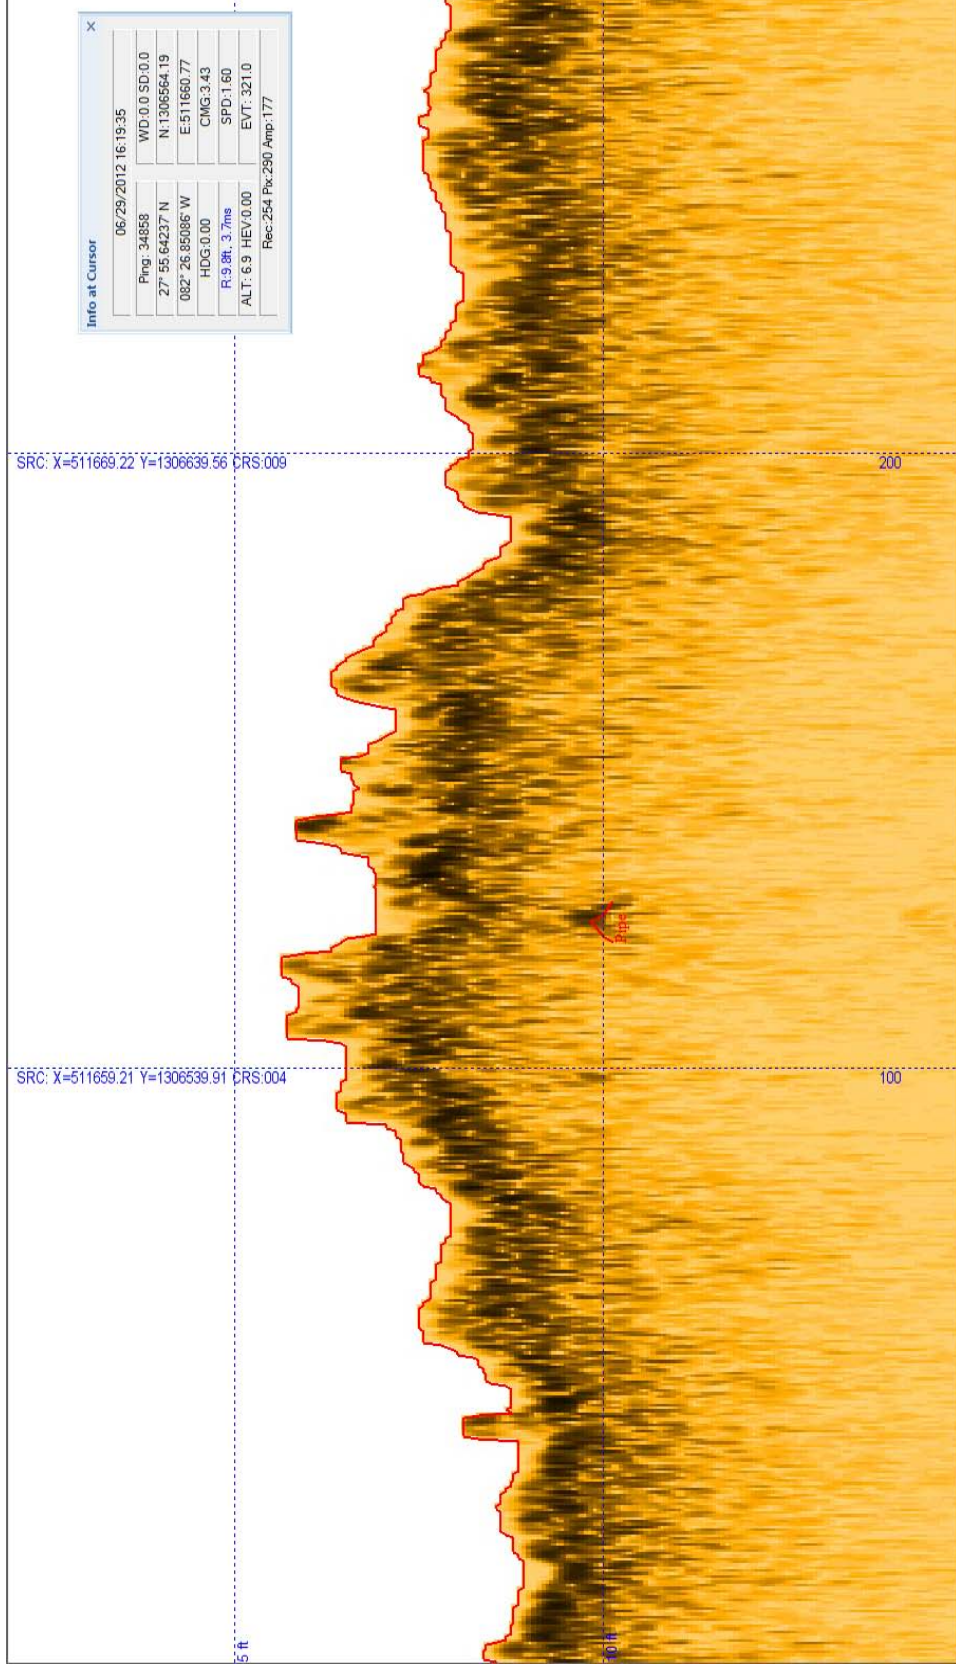
Figure 2. Line 3Plus00N:

Dark mass in the center of the image is the pipeline. It is marked with red as "Pipe" (difficult to see without zooming). The annotation is purposely small to avoid masking the target. This is in rocky bottom near the middle of the crossing. Note the rugged bottom profile. Vertical annotation includes FL State Plane Coordinates, course made good and depth in feet from the transducer based on assumed sediment velocity of 1640 meters / second. Depth of burial at this detection is 2.8 ft.
