HILLSBOROUGH RIVER DAM

HILLSBOROUGH RIVER DAM
DIAGNOSTIC ASSESSMENT WORKSHOP PROCEEDINGS
24 and 25 September 2013

Prepared for: City of Tampa Water Department

Prepared by: Francisco Silva - Tulla, Sc.D., P.E.
Consulting Civil Engineer
GeoEngineering & Environment

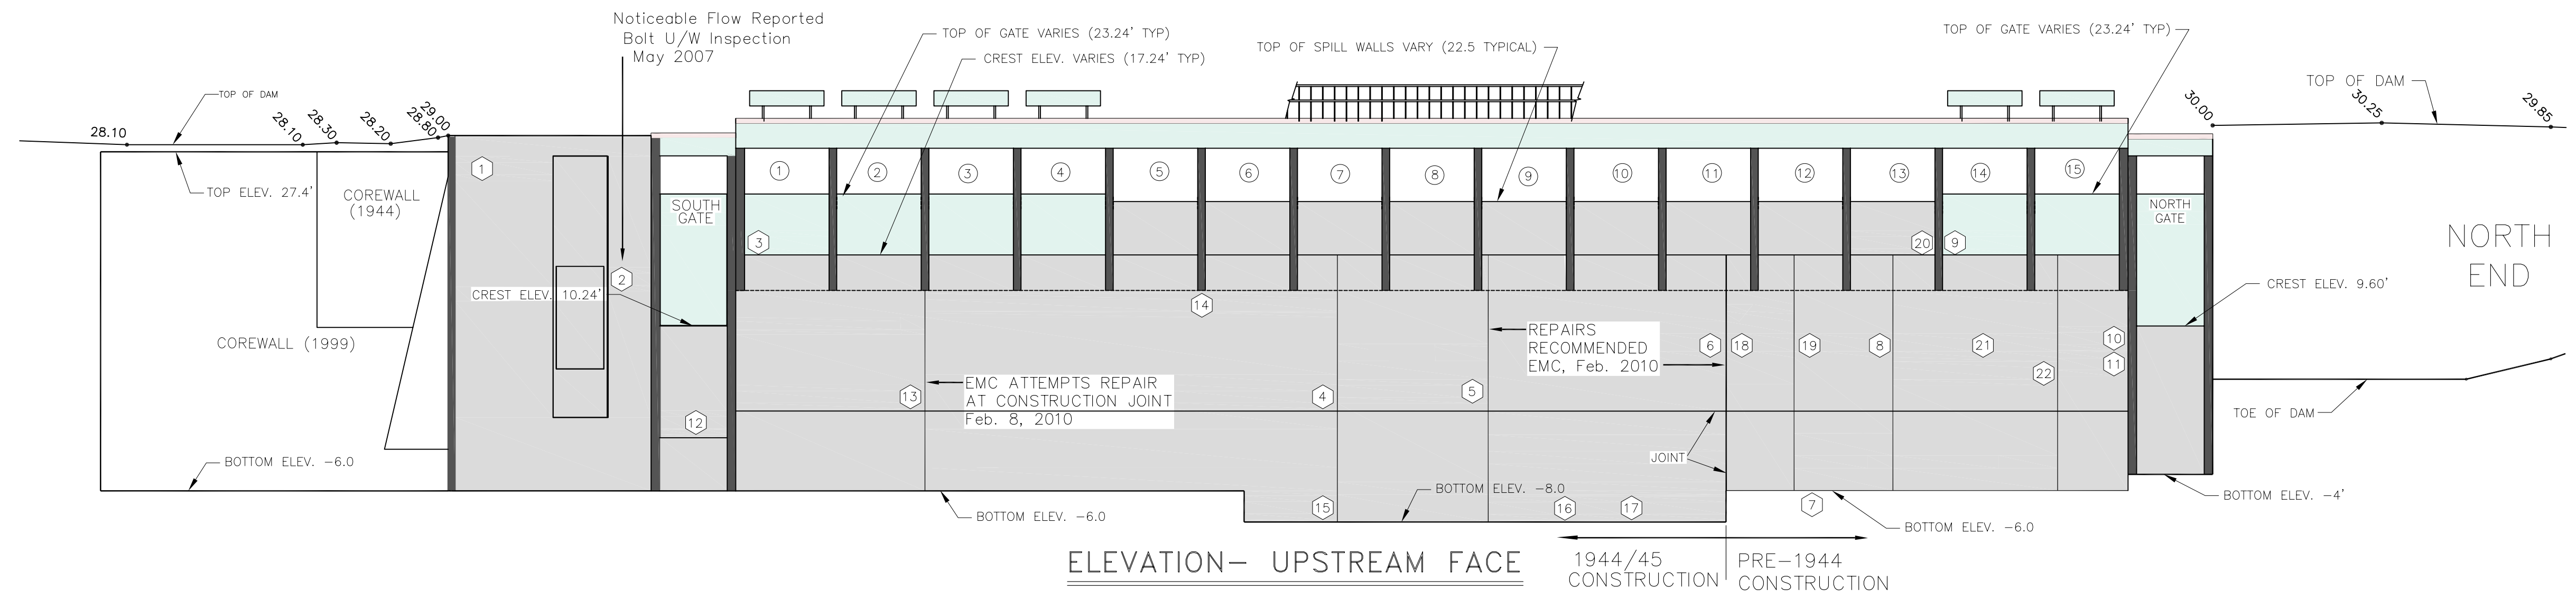
ELEVATION- UPSTREAM FACE
1944/45 CONSTRUCTION PRE-1944 CONSTRUCTION

Area of Dam	May 14, 2007 Inspection - Bolt Underwater Services				December 13, 2010 - EMC Divers, Inc.			
	I.D.	Deficiency Type	Description	Flow or Suction Observed	I.D.	Deficiency Type	Description	Flow or Suction Observed
Gravity Dam Sluice Gate	1	Void	4"H x 10"L x 6" Deep w/exposed rebar	No				
	2	Void	7"H x 6" W x 6" Deep	Yes				
	3	Hole	11/2" H x 3/4" W	No				
South Tainter Gate	4	Joint @ Bay 7	Hairline crack	No	12	Cracks	Epoxy repaired, 6' of bottom & 2' below W.L.	No
	5	Joint @ Bay 9	Joint opens to 11/2" W x 3" Deep	No	14	Joint @ Bay 5	Vertical repair at North pier	No
	6	Joint @ Bay 11	Joint between Old and New Dam sections	No	15	Joint @ Bay 7	Vertical joint 1"W x 2" Deep	No
	7	Pipe @ Bay 12	3" dia pipe extending 1' out at ground line	No	16	Crack @ Bay 9	At apron approximately 4" Deep	No
	8	Repair @ Bay 12	Bags filled with cement	No	17	Crack @ Bay 10	Vertical repair in apron	No
	9	Gap @ Bay 12	At river bottom, probed to 25"	No	18	Joint @ Bay 11	Large crack/void inside transition joint	No

10	Joint @ Bay 13	Hairline at top to 1/4" at river bottom	No	19	Joint @ Bay 12	Joint repair	No
	11	South void - 9"H x 6"W x 3" Deep		No	20	Pipe @ Bay 12	Pipe, 4" dia, penetrates 6' into concrete	No
	12	North void - 12"H x 7"W x 3" Deep		No	21	Hole @ Bay 14	Hole is 6" Deep x 5" Dia	No
	13	22"W x 12"H x 32" Deep - partial patch		No	22	Joint @ Bay 15	Vertical repair on apron	No
	14	Exposed Steel	1st Piece - 9" L	No				
		2nd Piece - 2" L	No

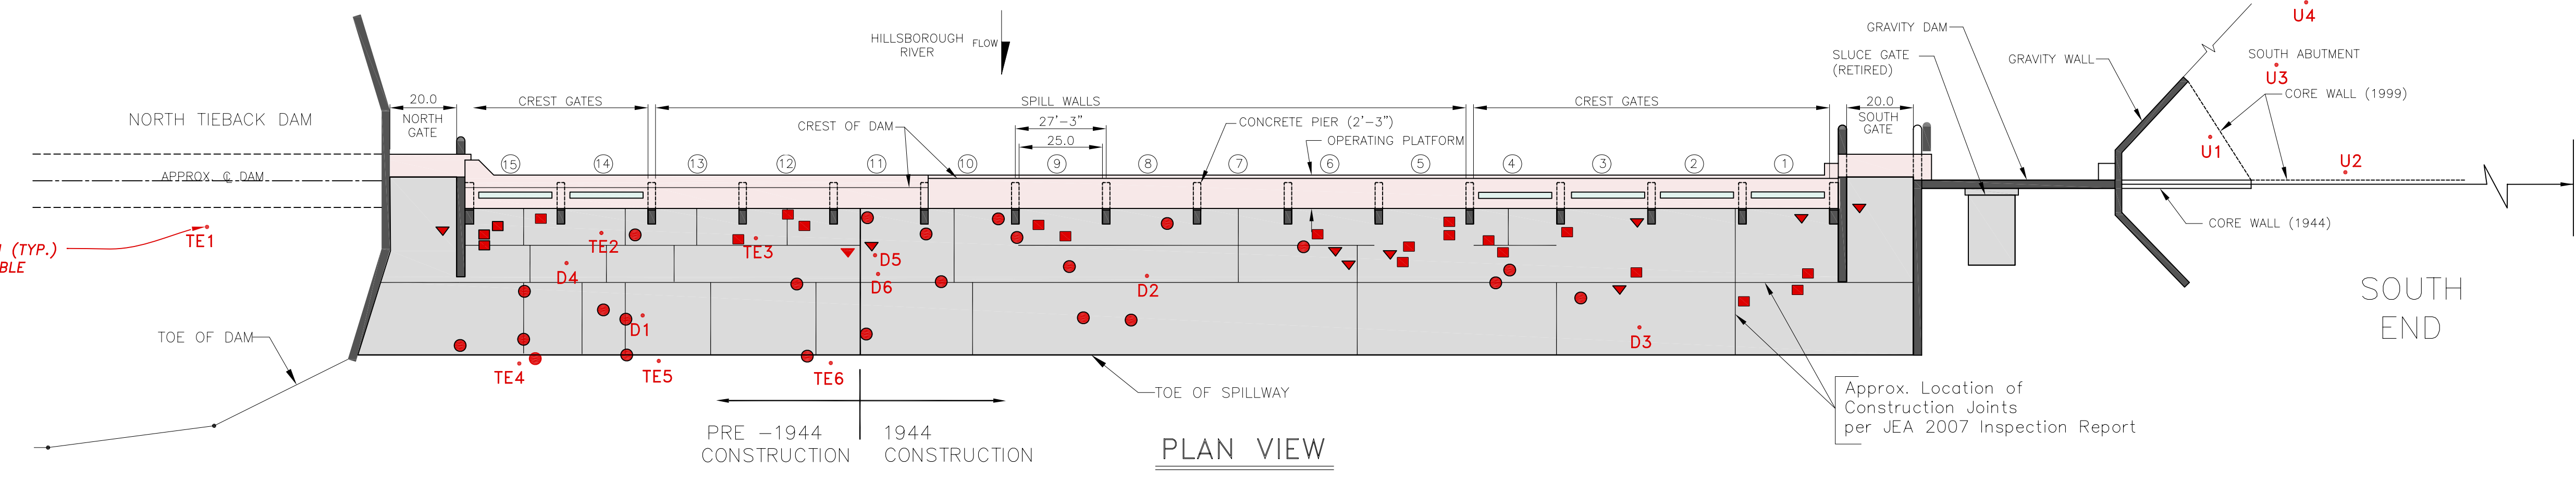
KEY TO SYMBOLS - PLAN VIEW
▼ LEAK
■ EXPOSED METAL
● SPALL OR HOLE
LOCATION PER JEA INSPECTION, 2007
