MAJOR ROADWAY PROJECT

PRELIMINARY ENGINEERING REPORT

**W COLUMBUS DR. / E COLUMBUS DR.
FROM DALE MABRY HWY TO N 13TH ST**

CIP No. 69631.105

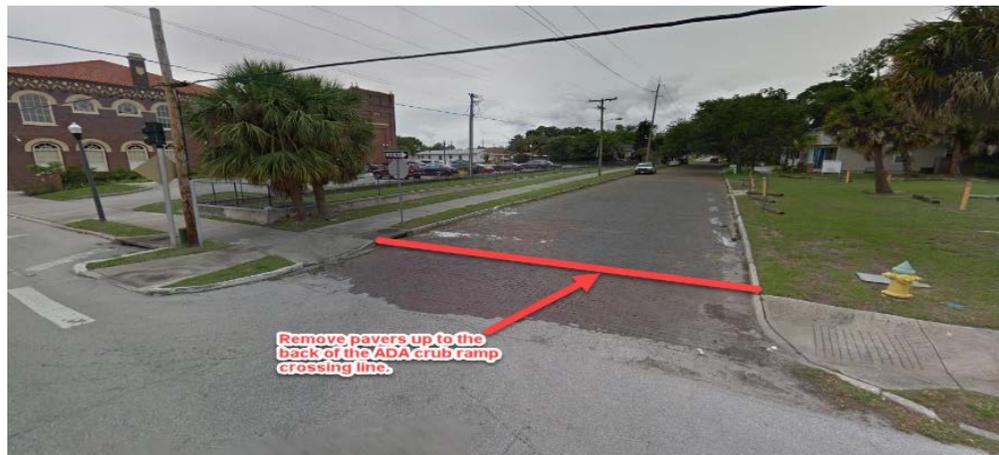
Side Street with decorative brick pavers

- **Asphalt:**
Milling and resurfacing from PC to PT of the return.
- **Patterned pavement:**
Milling and resurfacing from PC to PT, patterned pavement will not be replaced.
- **Brick pavers:** Remove brick pavers within the right-of-way up to the back of the pedestrian crossing to provide smooth safe passage (as shown below). Fill with asphalt base and match upper layers as per pavement design provided in Appendix D.

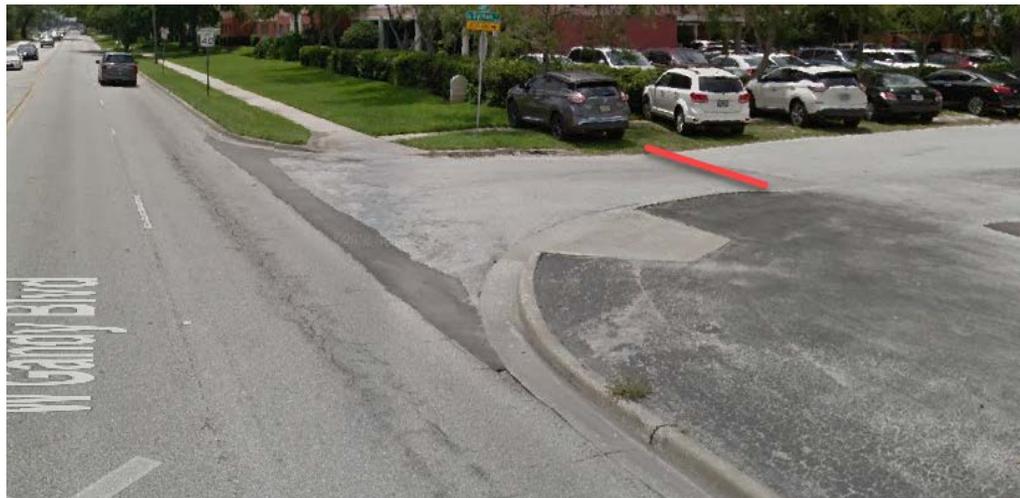
Side Street with asphalt pavement or patterned pavement

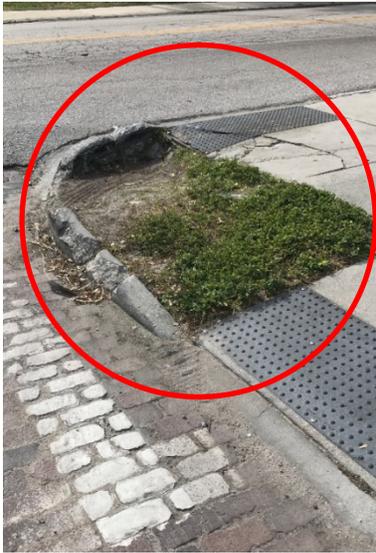
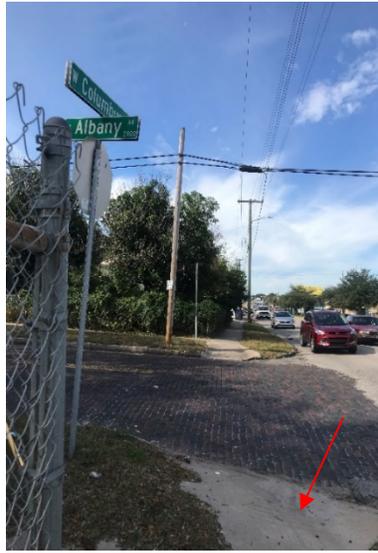
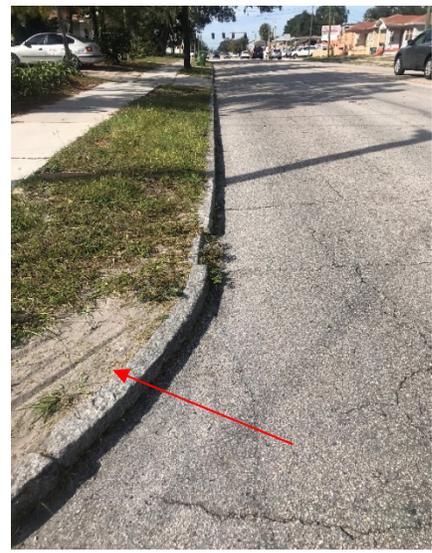
Side streets radius

- 3. Side Street Return Radii** at the following intersection: N. Matanzas Ave., N. Tampania Ave., N. St. Peter Ave., N. Albany Ave., N. Poplar Ave., N. Massachusetts Ave., N. Highland Ave., N. Tampa St., N. Central Ave. and N. Grove Ave. Reconstruct turning radius to accommodate predominant vehicles using the intersection and push back ADA ramps. If the side street return radii has the following type of treatment asphalt, pattern pavement or decorative brick pavers, use the treatment guideline as stated above. Clearly show and label the applicable information on the plans.

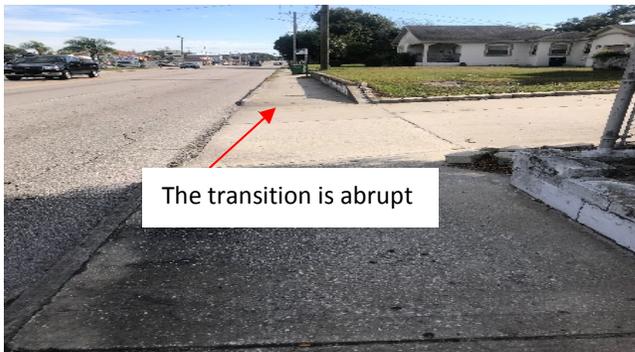
Driveway Apron Reconstruction

4. **Pavement Markings:** install all pavement markings per current FDOT standards.
5. **Reconstruct existing concrete driveways** (include apron per SI 515 for driveways) *with steep grades*, specifically sidewalks with cross slope steeper than 0.02, and/or rough surfaces making it difficult for the impaired or wheel chairs. Ensure the sidewalk transition at the driveway apron meets ADA criteria.

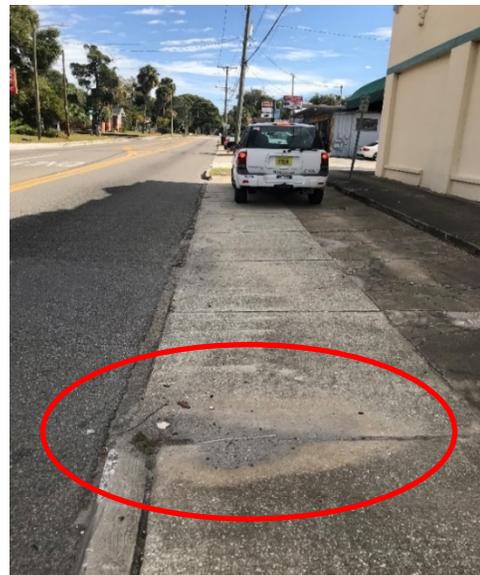
Southeast corner of N Boulevard and E Columbus Dr. Provide proper ADA transition from the sidewalk to the driveway.

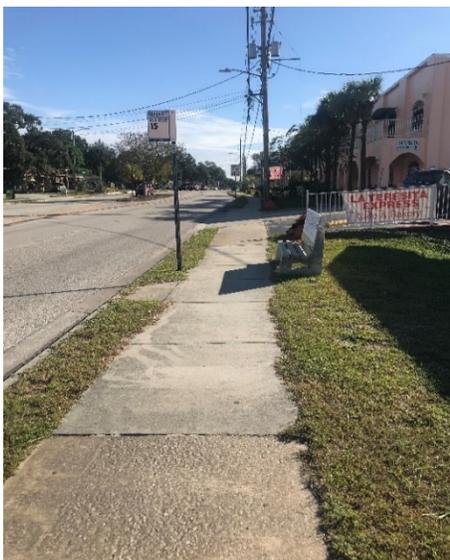
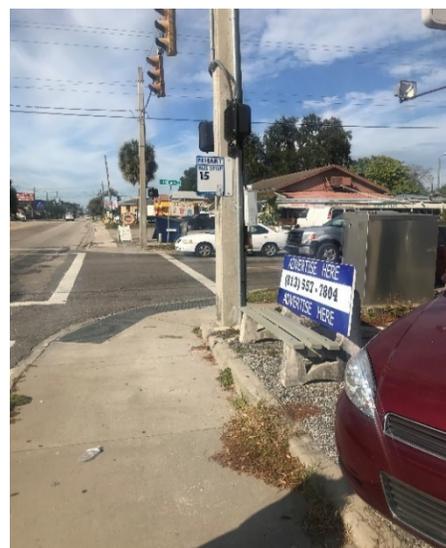
Coordinate with HART to provide ADA compliance

7. **Coordination with HART:** Coordinate with HART and all Bus Stops along project limits to provide for ADA compliance.

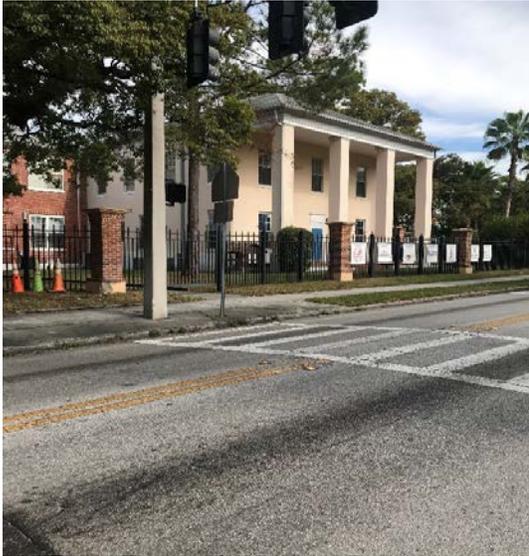
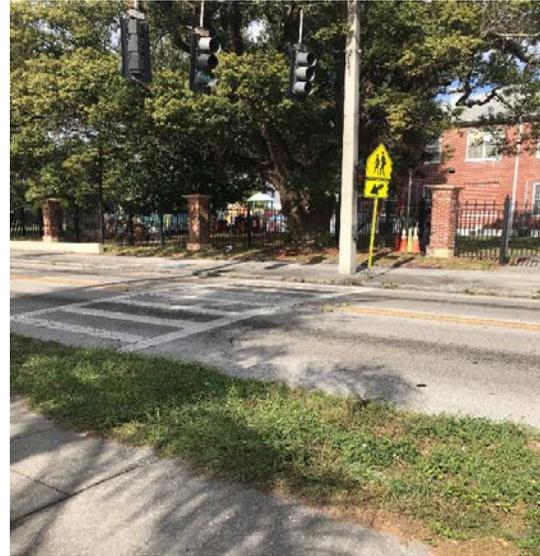
Midblock crossing between Massachousett Ave and Nevada Ave

Bring midblock crossings up to current standards (signs and markings), add ADA curb ramps and connectivity to sidewalks.

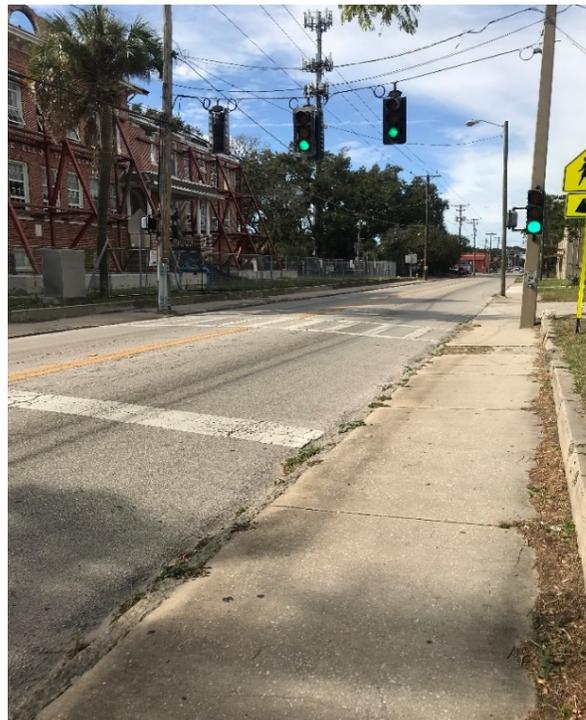
Midblock crossing between N Morgan St and N Jefferson St

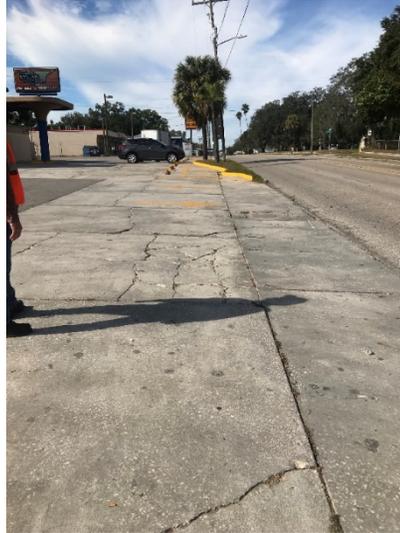
On the south side of W. Columbus Dr. from N Fremont Ave going east, there is approximately 300' of sidewalk gap. Construct sidewalk to provide pedestrian's connectivity,

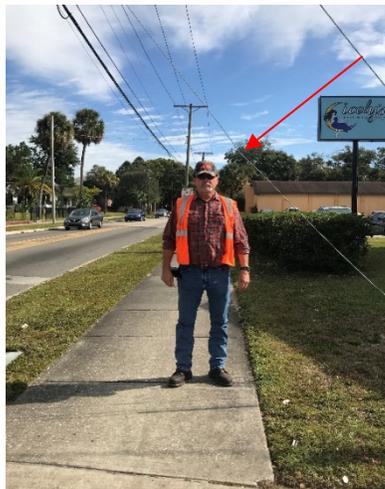
- a. Evaluate safety hazard for the items listed below and provide recommendations.
 - i. The location of guy wires within the sidewalk is creating a safety hazard for the pedestrians.

Guy wire

10. Utility poles along the corridor, consultant to coordinate with TECO to bring sidewalk width to ADA compliance and site distance per Standards. Provide propose solution to County PM and Project Development Team for discussion and approval.

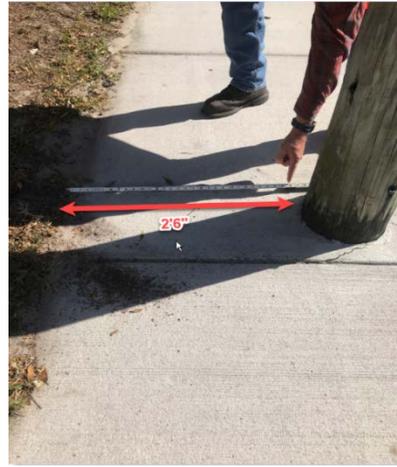
Minimum sidewalk width < 3'

Sidewalk width 2'6"

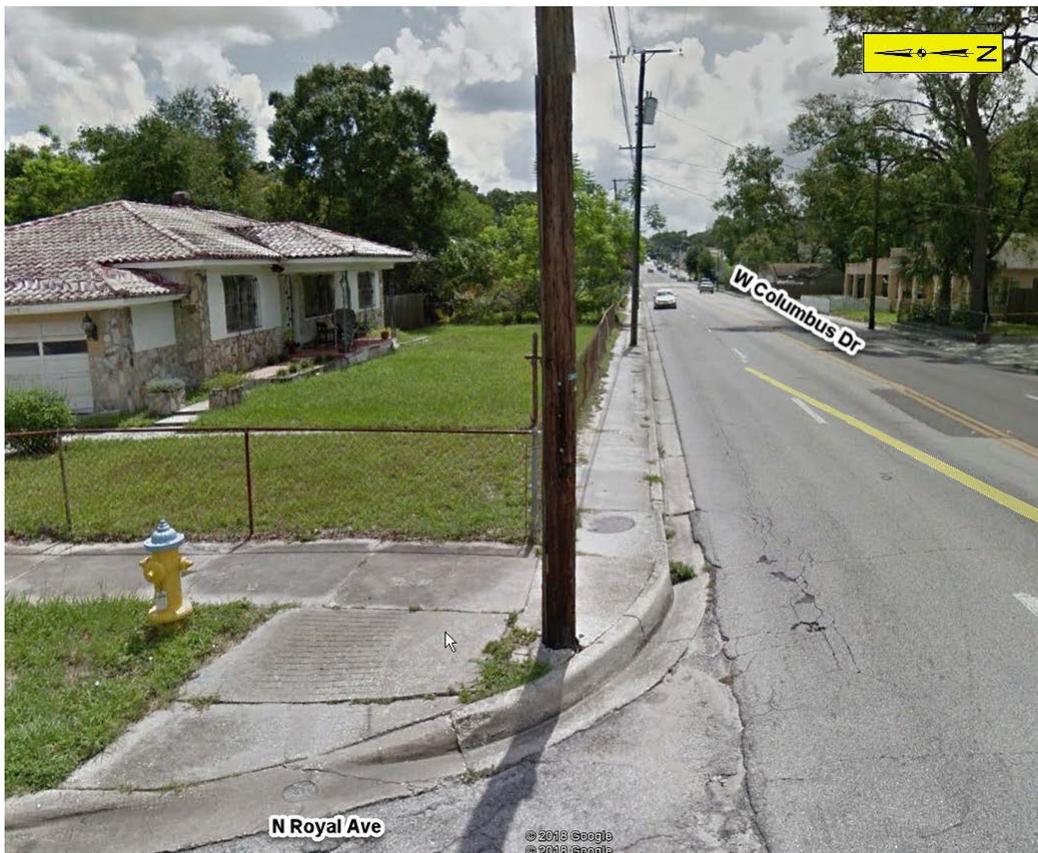
- iii. Sight Distance: Evaluate the sight distance at the intersection of N. Royal Ave. and W. Columbus Dr. provide recommendations.

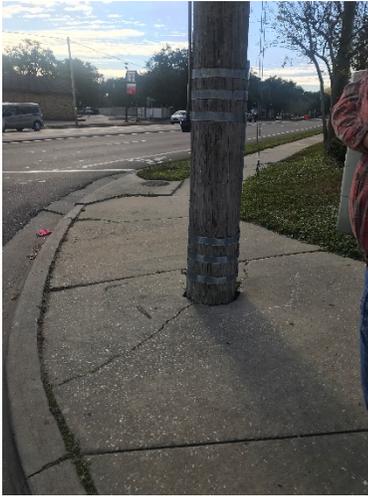
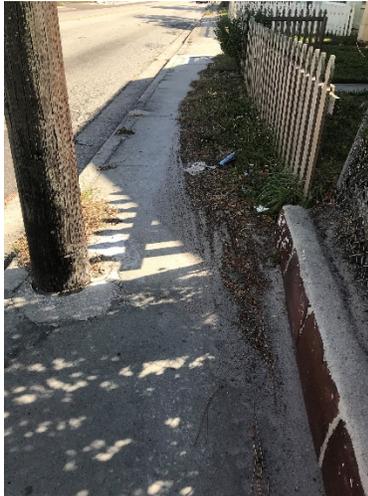
- **Sidewalk width along the entire corridor:** existing sidewalk width varies from 22" to 6'. The *minimum width* for sidewalk per ADA criteria is 4'; with allowance of 3' min. at a given point for passage. Coordinate with the COT and the utility company to remove obstructions within the sidewalk where the ADA minimum criteria is not met, or propose an acceptable solution, to provide proper sidewalk widths for ADA and pedestrian safety.

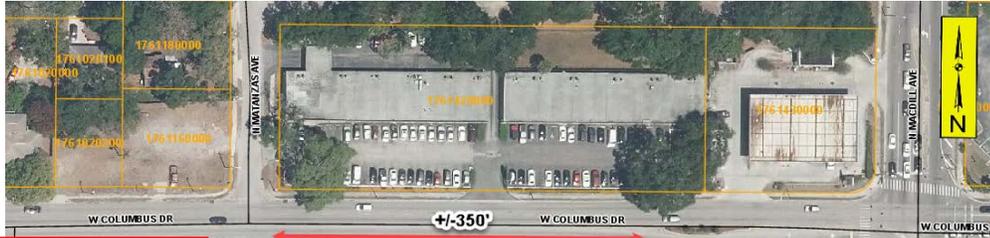
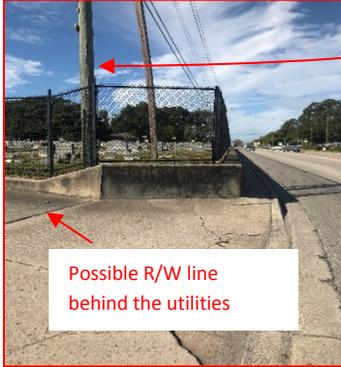
- **Along the Cemetery frontage property:** the sidewalk in front of Marti Colon Cemetery is narrow and unsafe. The cemetery retaining wall (+/- 350') is located within the sidewalk path and have less than 30" in width, which does not meet the minimum 36". Based on the Hillsborough County GIS data, the headwall appears to be on County Right-of-way. Coordinate with the COT to provide option for a safer passage. Following are possible options to considered:
 - i. Allow pedestrian and bicycle to walk and ride along the cemetery pathway (coordination with the cemetery will be required)
 - ii. Reduce lane width to provide wider sidewalk; proper transition must be provided.
 - iii. Provide pedestrian crossing before and after the cemetery.

Sidewalk width less than 3'

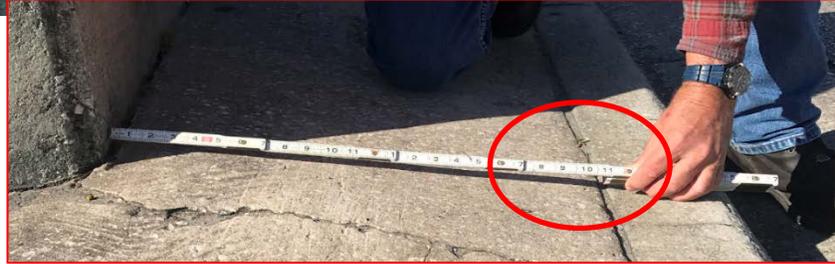
Sidewalk width along the cemetery wall - 1'10"

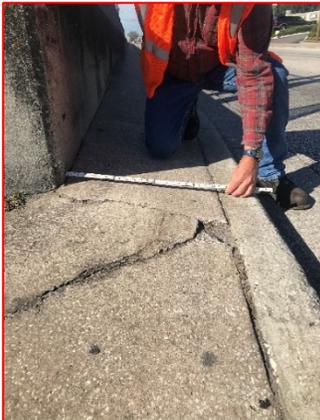
Sidewalk width less than 3'

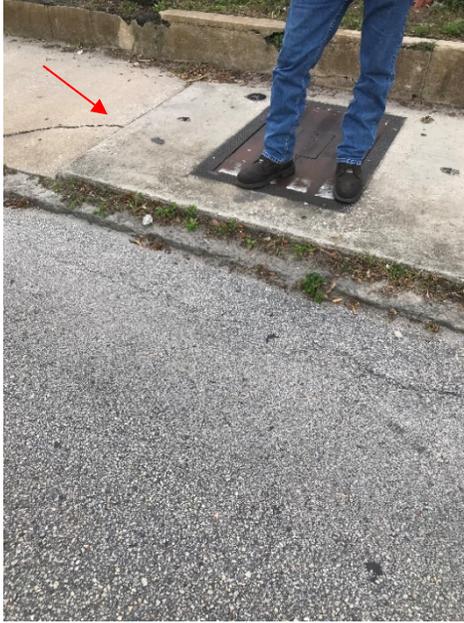
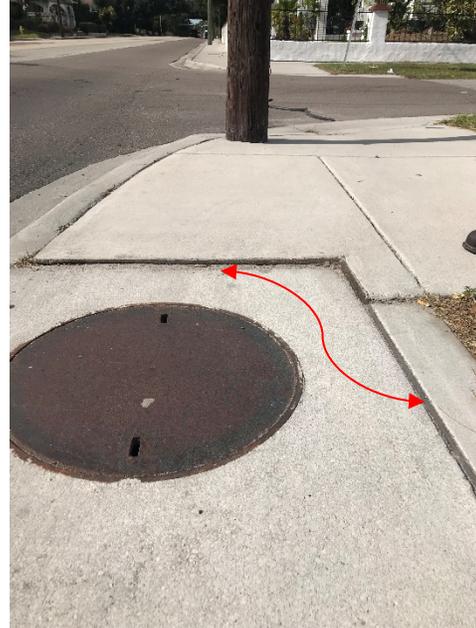
- 12. Tripping hazards & Utility tops:** throughout the project limits, several manholes and valves within the sidewalk are creating tripping hazard for the pedestrians. Adjust the utilities to eliminate the hazard.

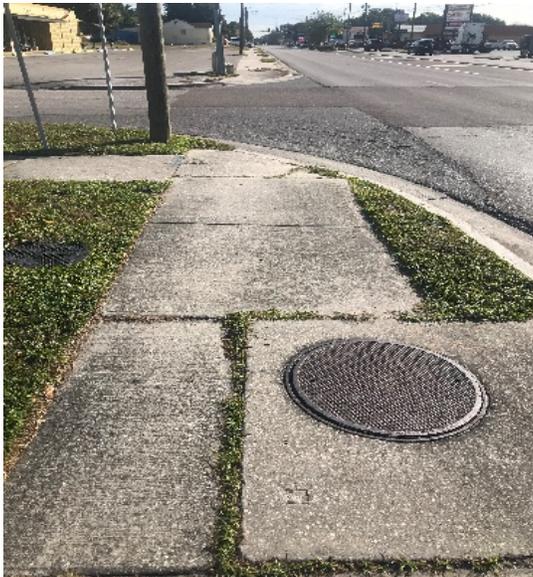
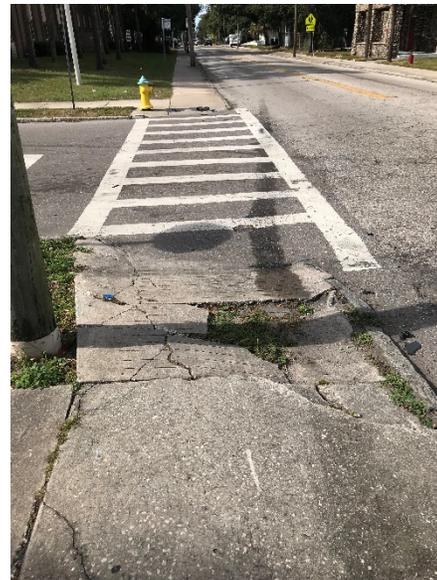
Provide appropriate curb ramp

- 13. Curb Ramps:** Reconstruct and/or add curb ramps as needed to bring to current standards. Refer to the 2013 DOJ/DOT Joint Technical Assistance on the Title II of the ADA and its subsequent Supplement Questions & Answers. Provide curb ramps as needed throughout the project limits.

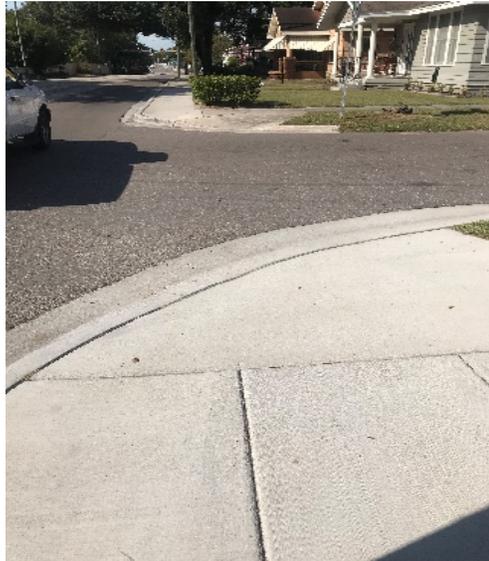
14. Detectable Warnings: Provide detectable warnings were missing and replace worn out ones throughout the project limits.

Detectable Warnings

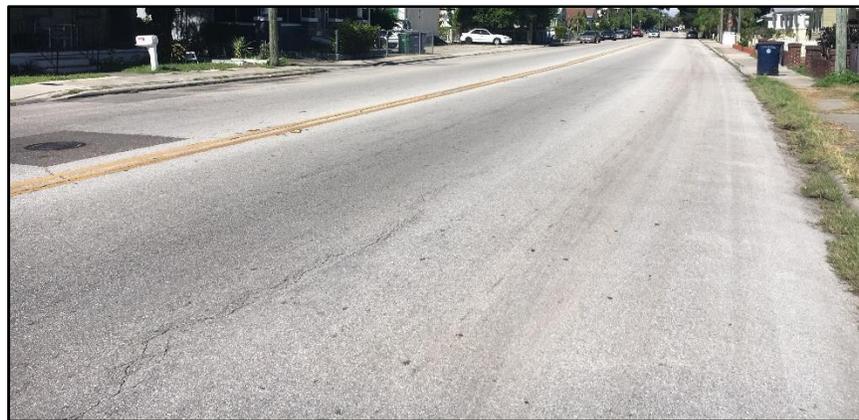
The pavement evaluated is generally in a fair (Figure 1) to poor condition (Figure 2). The pavement surface is exhibiting Alligator cracking, longitudinal and transverse cracking, and patched potholes.

Figure 1: Fair Pavement Condition.

- 3- **Milling Depth and Purpose:** Due to potential milling into the base, the following plans notes are recommended:
 - a. Anticipate that the base could be exposed during the milling operation and will require a prime cover prior to paving.

- b. Pavement depression or base failure: Place Leveling Course if Needed (SP-9.5).

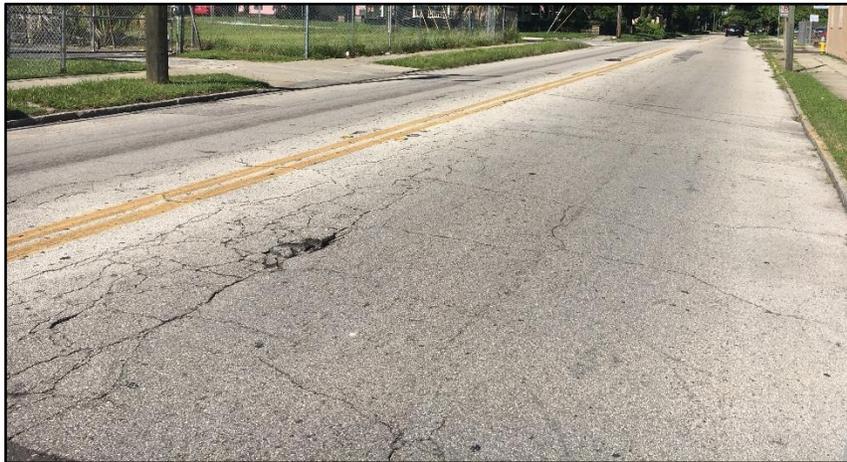
Figure 2: Poor Pavement Condition.
