TAMPA WATER WORKS

The David L. Tippin Water Treatment Facility Master Plan

July 2018
Volume 1 of 2

DAVID L. TIPPIN WATER TREATMENT FACILITY MASTER PLAN

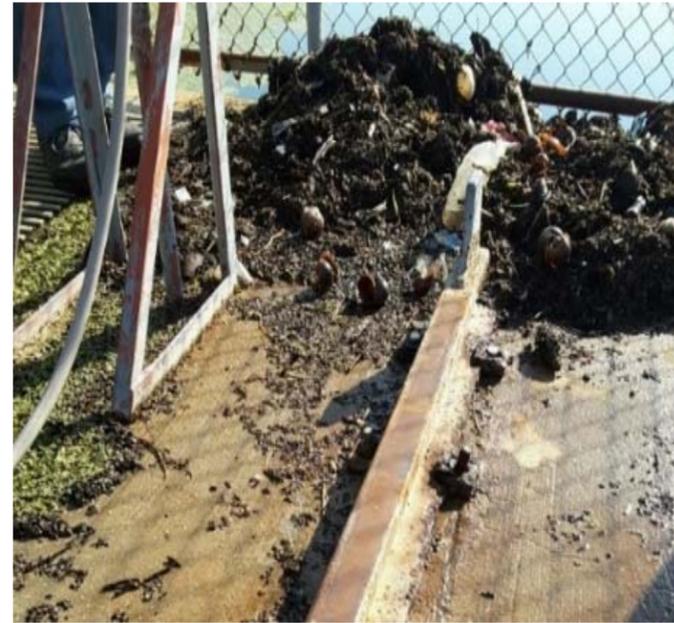
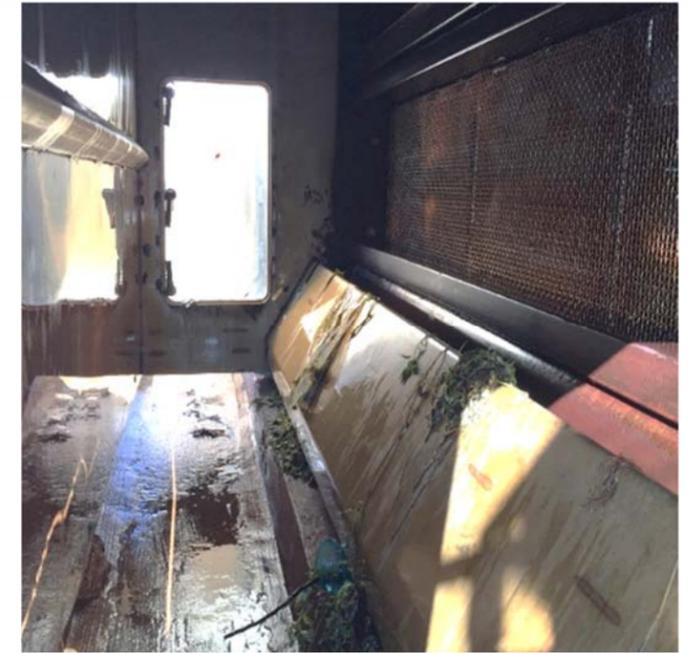
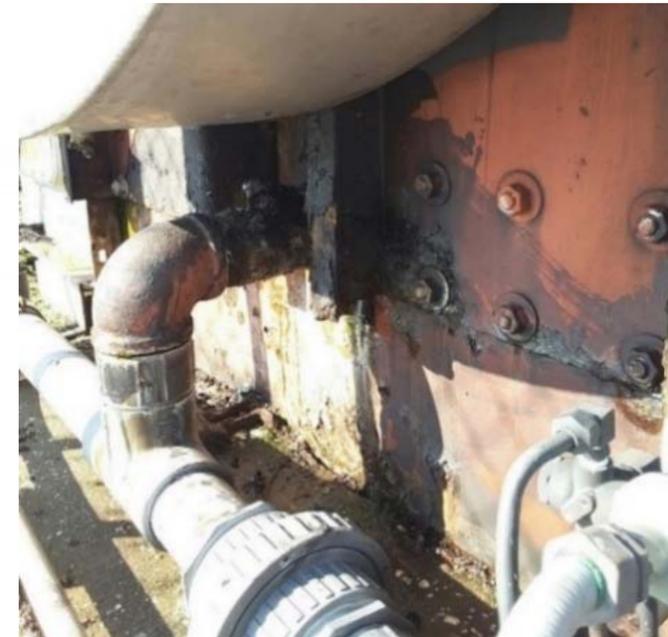
Photo
Left: Grass Rake Hooper and Motor with Corrosion.
Top Right: Intake Bar Rack.
Bottom Right: Grass Rake Guide Rail and Wheels with Corrosion.

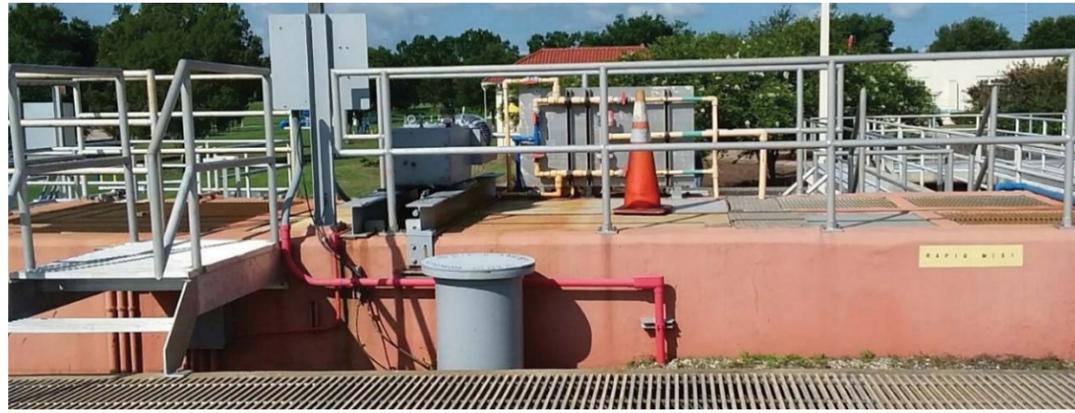
Photo
Top: Common influent box servicing Trains 5 & 6
Bottom: Coagulation basin with minor corrosion and concrete spalling

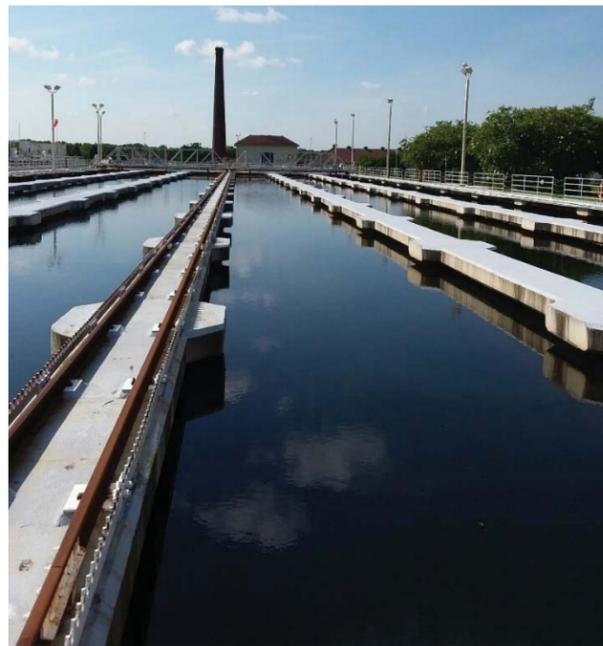
Photo
 Flocculators 5-4 and 6-4 in fair condition.

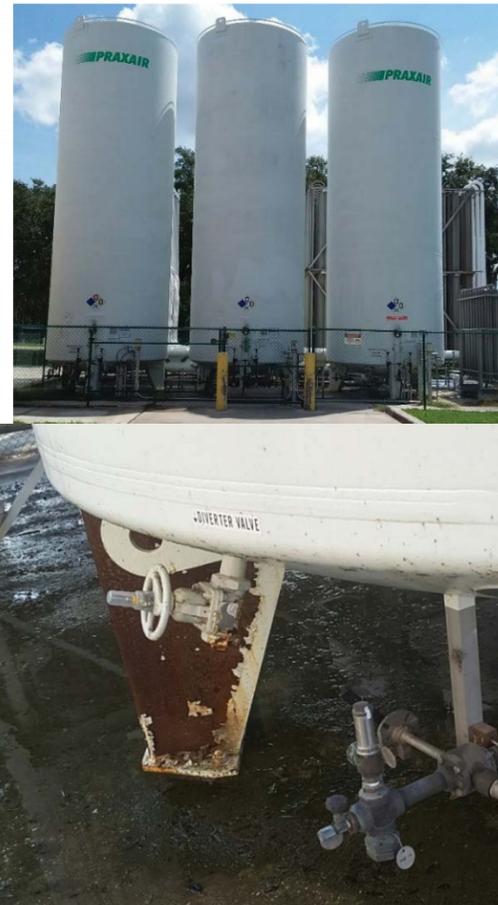
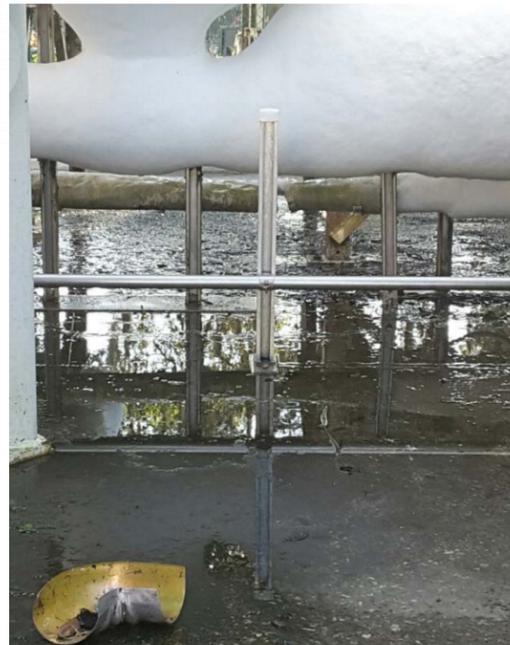
Photo
Left: LOX Vaporizers with corrosion.
Right: By pass vapor cooling system with corrosion and deterioration.

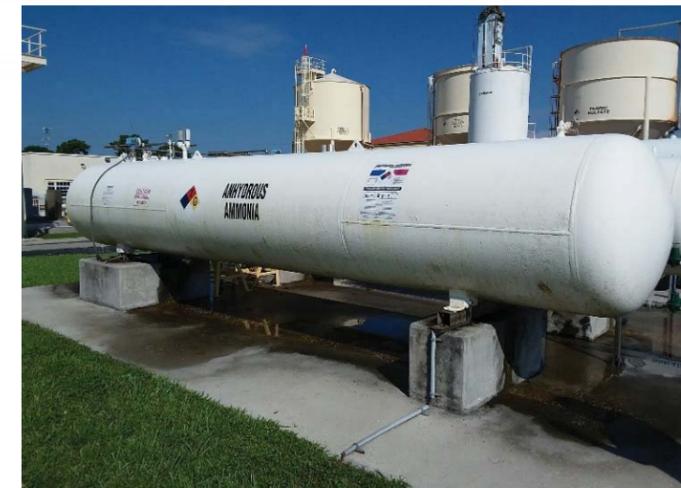
Photo
Left: Concrete spalling at base of storage tank.
Right: Ammonia storage tank (one of two).

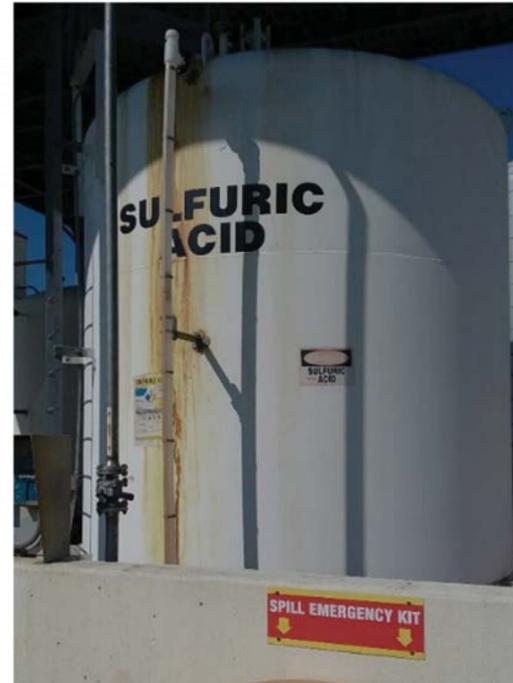
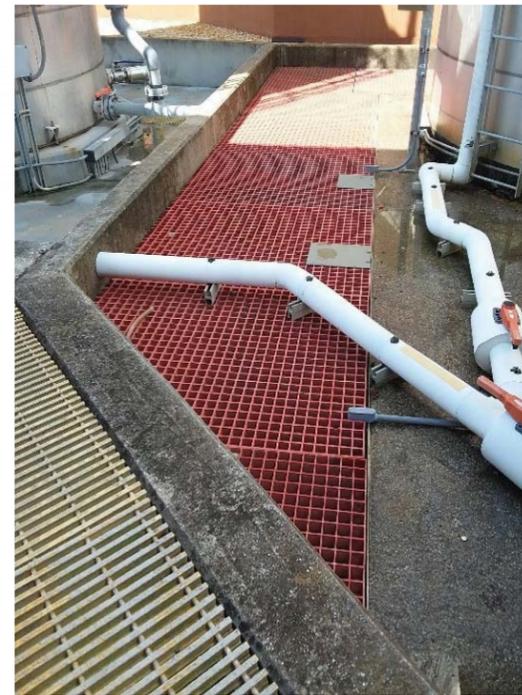
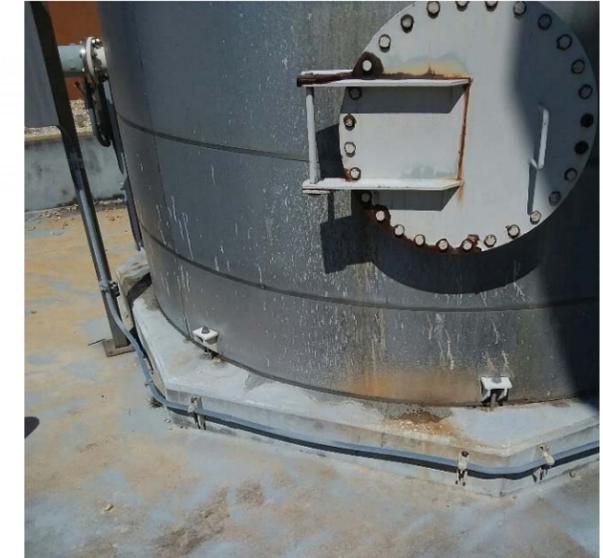
Photo
Left: Concrete spalling at fill station.
Right: Sulfuric acid tank with minor corrosion.

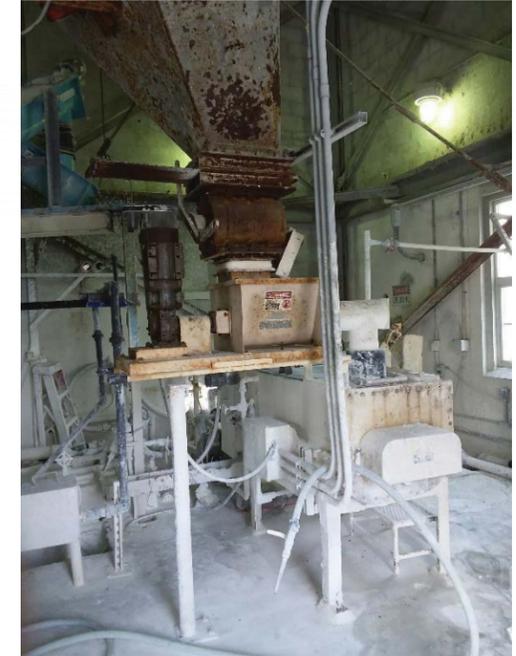
Photo
Left: Lime slurry discharge pump with corrosion and deposit buildup.
Middle: Grit Discharge from Slaker.
Right: Lime Hopper and Slaker.

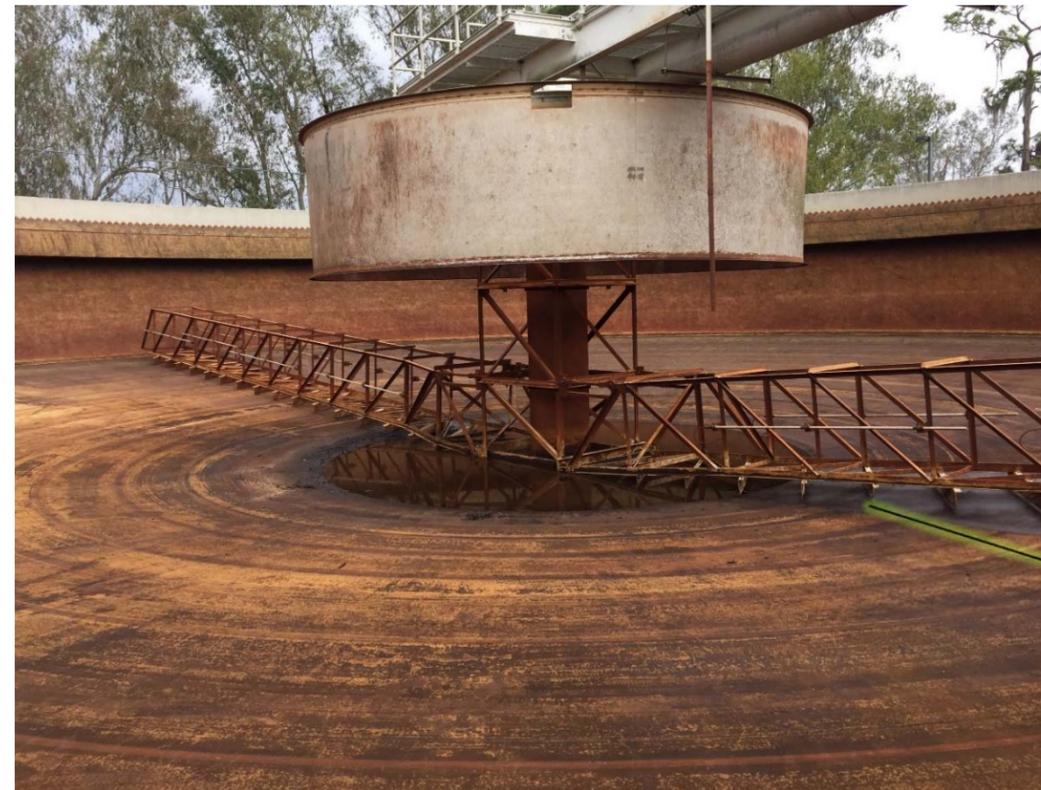
Photo
 Empty Gravity Thickener #4 showing deteriorated rake arm.

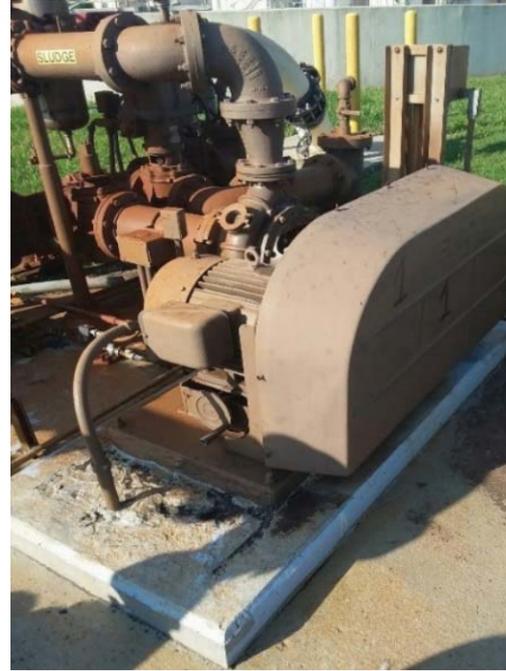
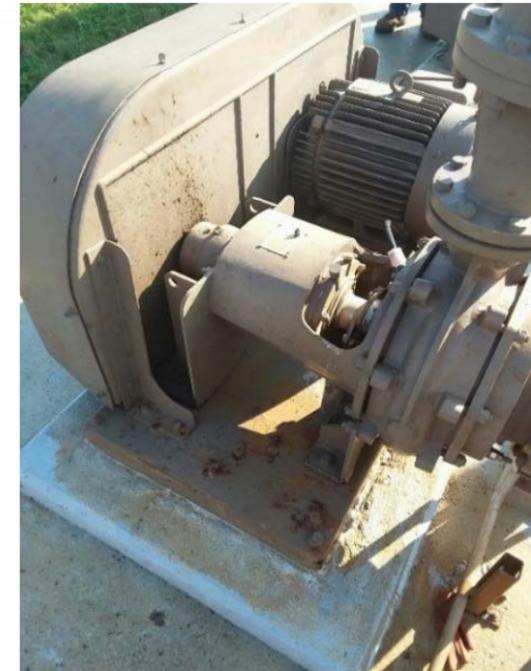
Photo
Left: Thickener Sludge Pump 1 with significant corrosion.
Right: Thickener Sludge Pump 2 in fair condition with corrosion.

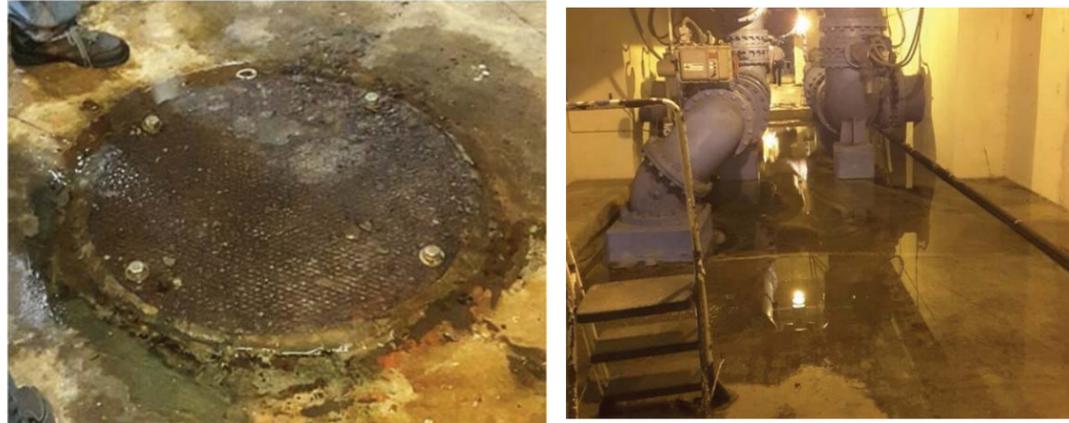
Overall, the structure is in poor condition. Because it has three separate flumes, the structure is of severe criticality. As stated previously, the filter gallery floor, which is also the flume ceiling, has cracks. These cracks are particularly concerning, since downstream head conditions pressurize the flume, causing leakage into the gallery and minor flooding.

Right: Filter galley flooding from finished water flume.

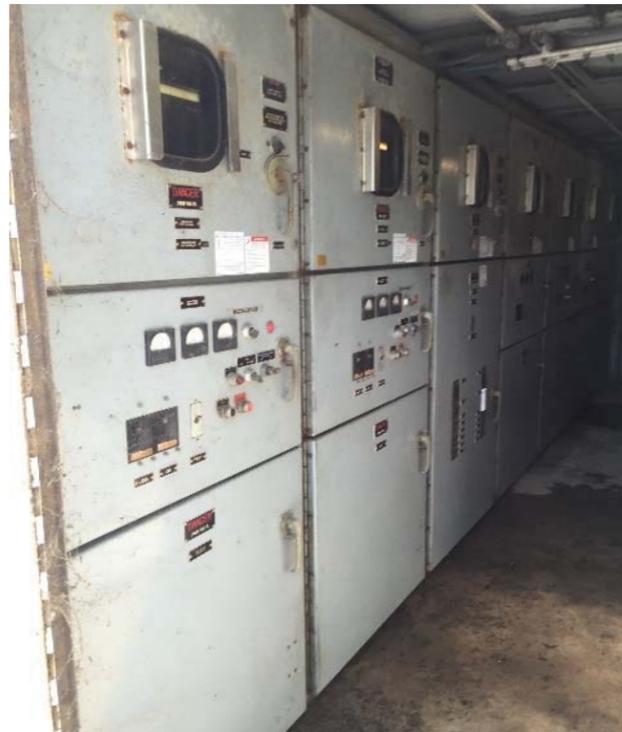
Photo
Water infiltration into
Raw Water Switchgear
enclosure.

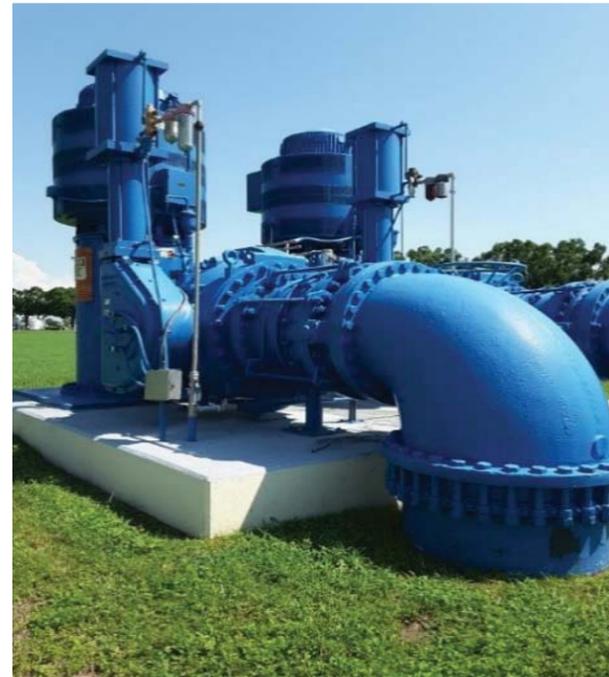
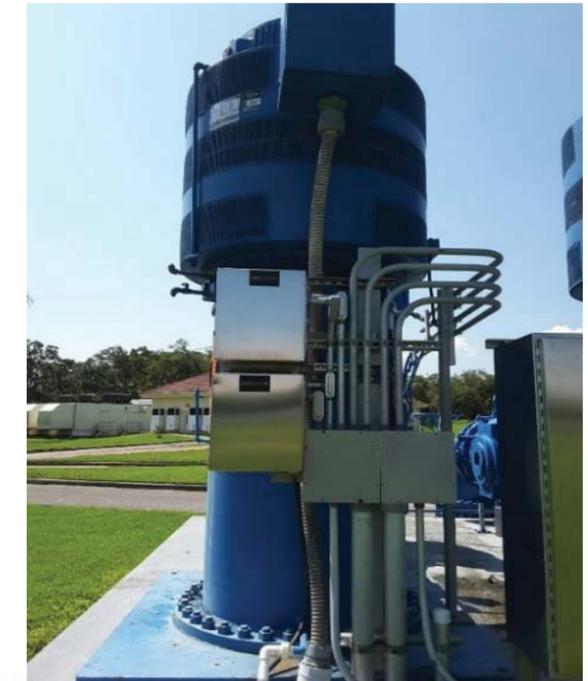
Right: High service discharge piping showing deterioration and corrosion.

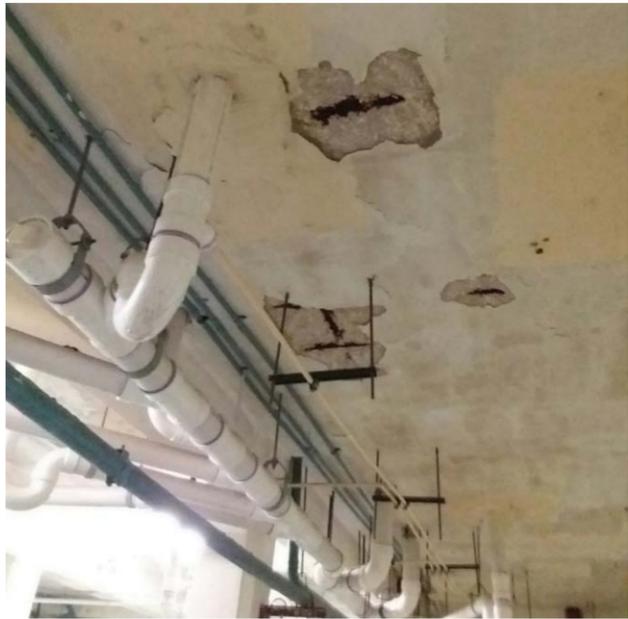
Photo
Filter Gallery Ceiling with paint peeling and concrete spalling.

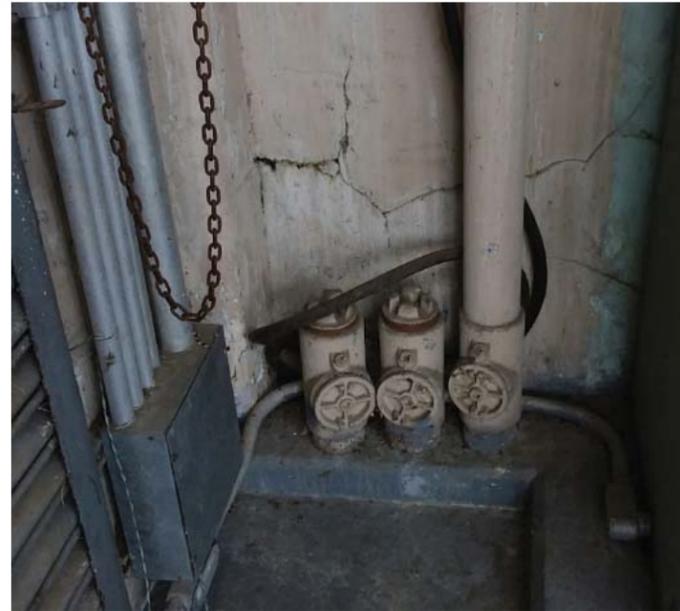
Photo
Remote High Service Building
Concrete and wall cracks in building

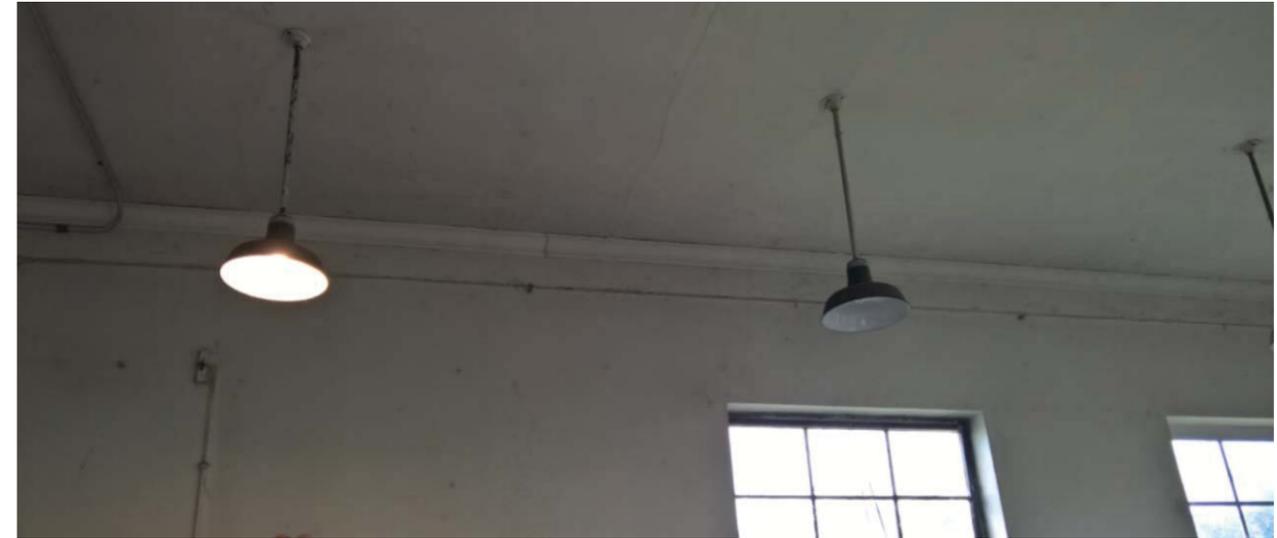
Photo
Accelerator Building lighting, switches, and electrical panels in poor condition.

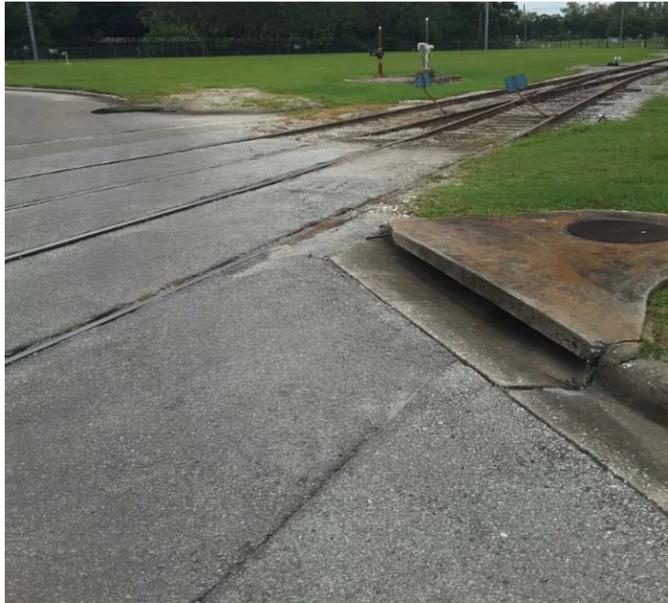
Photo
Site stormwater with minor sediment buildup.
