EXHIBIT "A"
SCOPE OF SERVICES

City of Tampa
Streetcar Extension and Modernization
Feasibility Study
FDOT FPID #437608 1 14 01
City of Tampa RFQ 16-D-00002

2. EXISTING CONDITIONS AND FIELD INSPECTION (TASK 2)

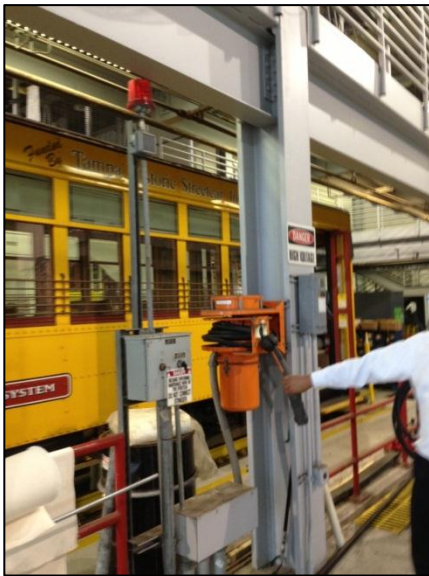
PHOTO 3
600V DC STINGER SYSTEM

The OCS inside the VMF is fed by a 100KVA Traction Power Substation with 480 volts alternating current (AC), 3 Phase, 60HZ delivered to the switchgear by the local utility company. The voltage is transformed and rectified to 600 volts DC to feed the six tracks with overhead contact wire (inside the VMF) and the 600 volt DC stinger system used to provide auxiliary power to the streetcar (see **Photos 3 and 4**).

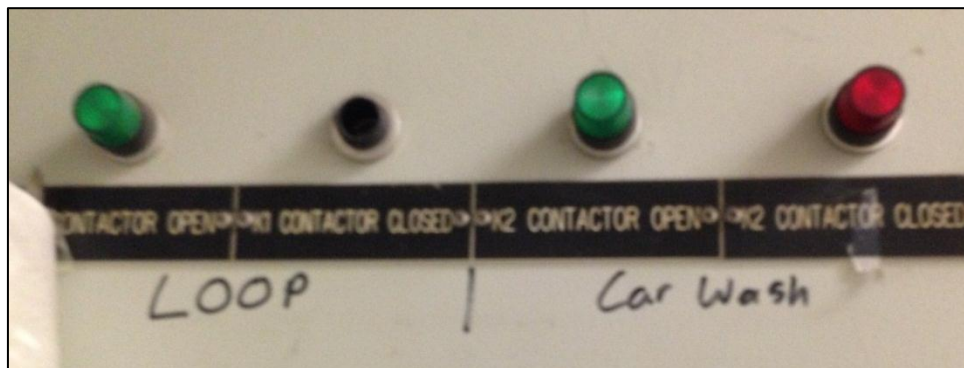
PHOTO 5
CONTACTOR BULBS BURNT OUT

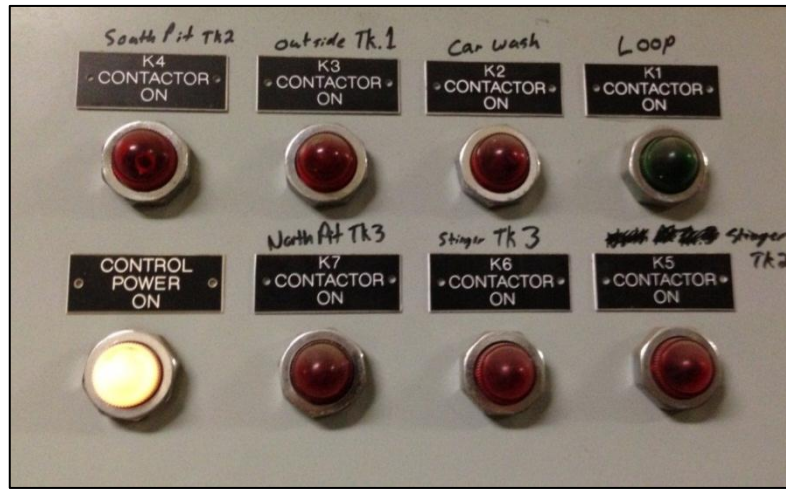
PHOTO 9
CONTACTOR PANEL

Two of the seven contactors were found open and out of service. The contactors were originally feeding track 1 and track 6 OCS outside in the yard which are now fed by the mainline North Substation. See **Photo 10** for view of yard tracks.

The relays on the control panel had no tags showing the last time they were tested and should be tested according to manufacturer recommendation on a regular basis.

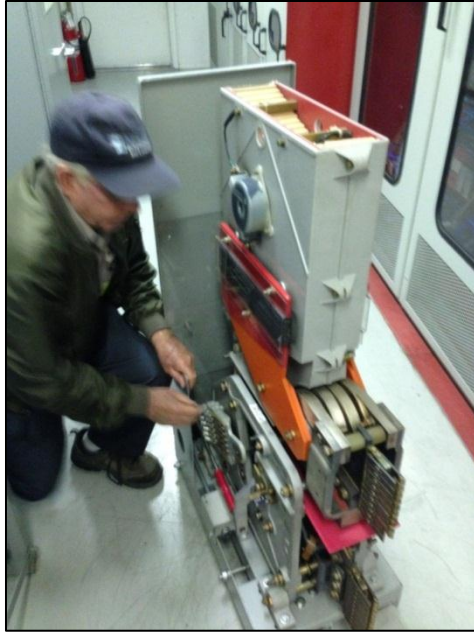
PHOTO 16
FEEDER #1 RACKED TO INSPECT CAUSE OF
FAILURE

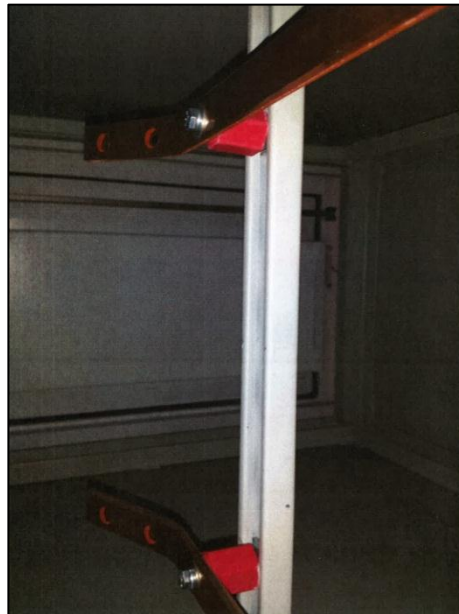
The electrical supervisor examined the negative drainage compartment at a later date when no streetcar was running and advised that the Floating Neutral Automatic Grounding Switch (FNAGS) had no cables connected at the bottom of the switch (see **Photo 18**). This immediate hazard was corrected by URS Traction Power Engineers working via telephone with the HART maintenance staff to ensure that the FNAGS was wired properly and placed back into service safely and efficiently.

PHOTO 18
FNAG SWITCH WITH NO CONNECTING CABLES

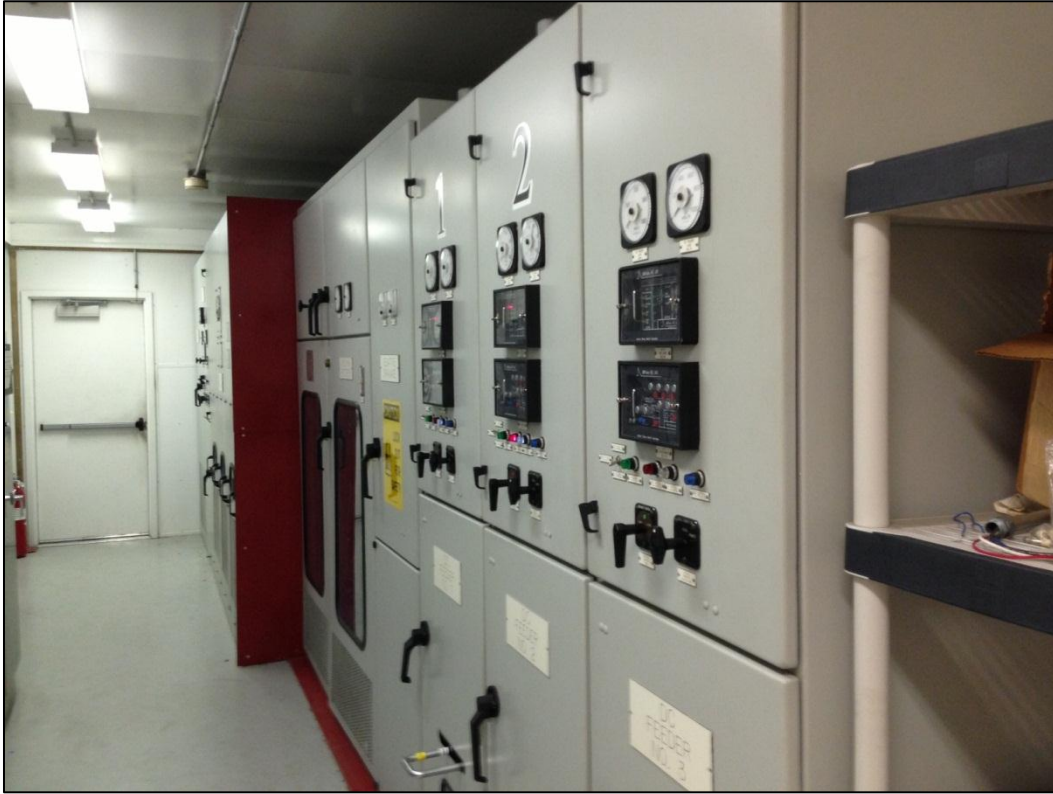
PHOTO 19
SOUTH TRACTION POWER SUBSTATION

The batteries were found to have been recently replaced. The South Substation was found to be clean and operating accordingly (see **Photo 19**), similarly to the North and VMF Substations. No alarms were noted on the annunciator panel. DC Feeder #2 was found to be in service feeding the OCS, while DC Feeder #1 is on standby. DC Feeder #3 is not connected or in service and slated for future use.

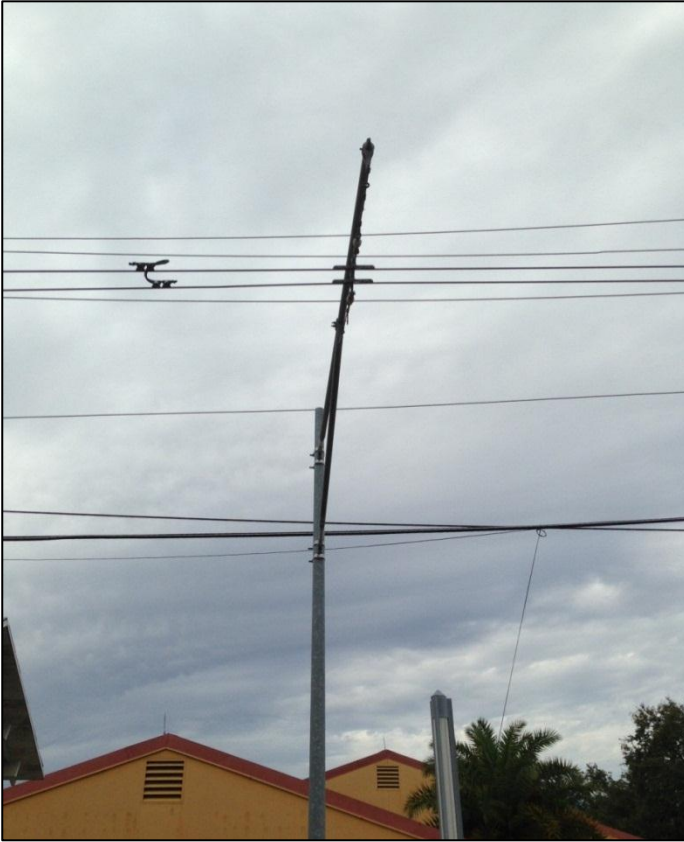
Several cantilever arms (see **Photo 20**) starting north of Cadrecha Plaza Station and along 8th Avenue are slightly pointing north and should be perpendicular to the track at the temperature encountered during the inspection (60 degrees Fahrenheit). This could be caused by cantilever arms that were not constructed entirely perpendicular to the track and should be adjusted. The plans of the existing system indicate that pole number 101+84 is at a location where the cantilever is not properly aligned. However, during the inspection, this pole was found to be labeled 101+85 (see **Photo 21**).

PHOTO 20
CANTILEVER ARM SHOWN NOT PERPENDICULAR TO
THE TRACK NORTH OF CADRECHA PLAZA STATION

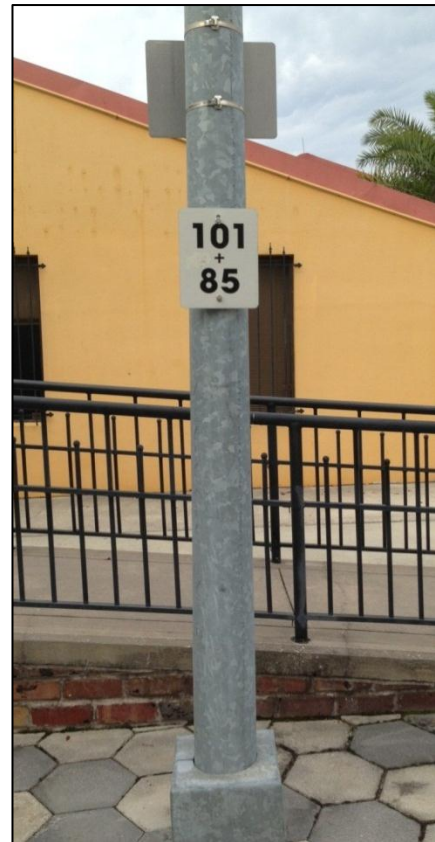
PHOTO 21
MISLABELED OCS POLE

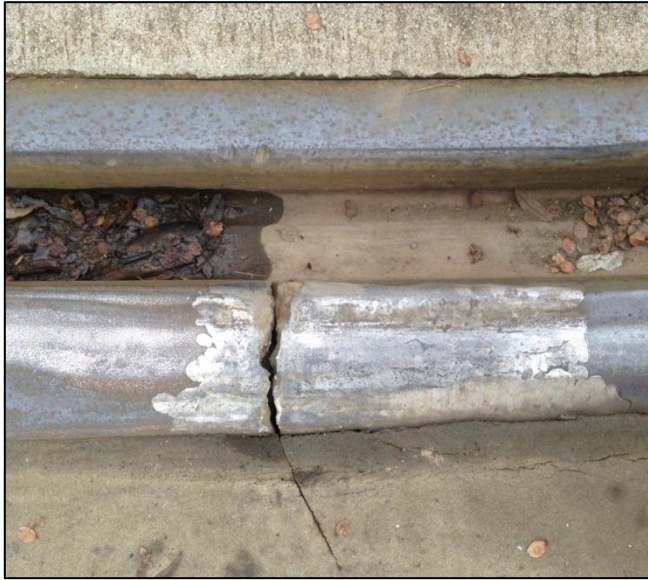
PHOTO 22
BROKEN RAIL WELD AT 17TH STREET AND
8TH AVENUE

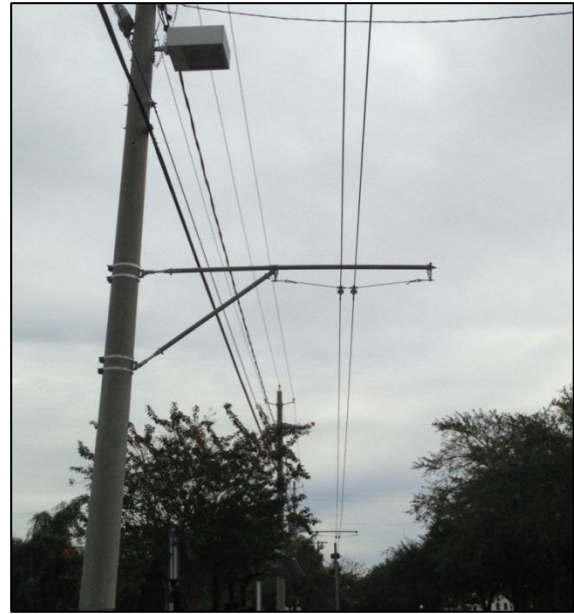
PHOTO 23
CANTILEVER ARM BOWING

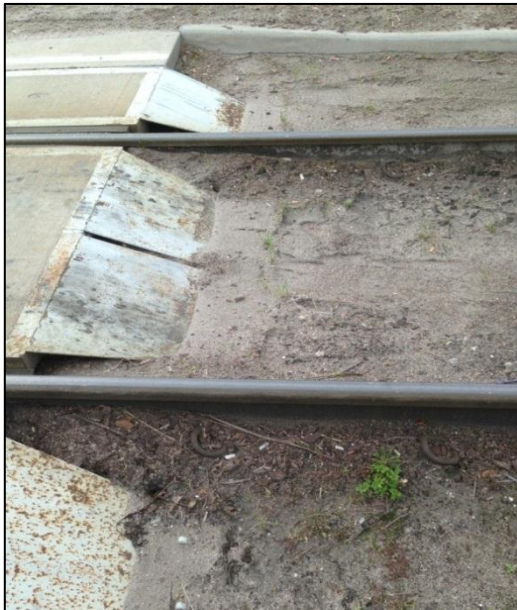
Continuing south from the VMF there are a number of locations where the rail is not properly insulated from earth and there is evidence of flooding creating a public hazard and greater potential for stray current corrosion subsurface utilities and rail fasteners (see **Photos 25 and 26**).

PHOTO 25
RAIL WITHOUT INSULATING BOOT

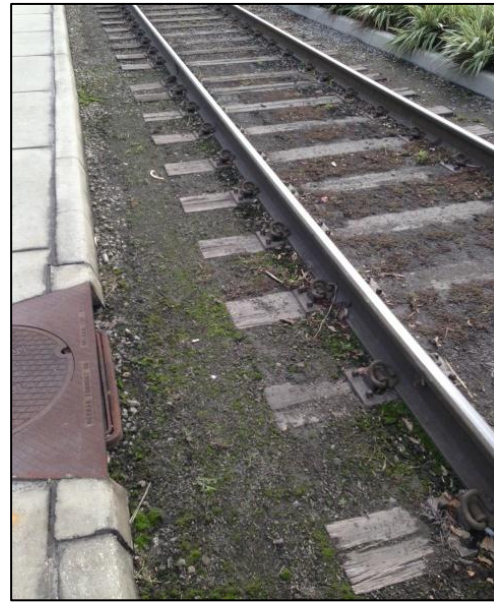
PHOTO 26
TRACKS WITHOUT RAIL BOOT INSULATION

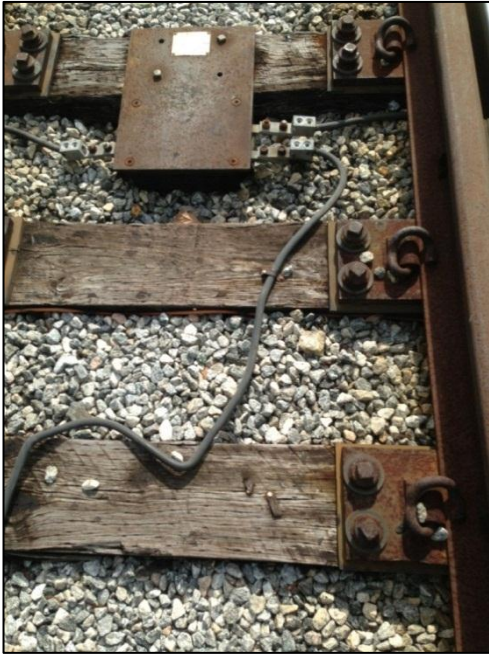
Where the CSX railroad crosses the streetcar track, the design in the plans shows multiple parallel 500 kcmil cables to provide continuity for the negative return circuit around the insulated joints installed by the CSX rail road. During the inspection, cable connections to the rail could not be located that allow the negative return current to get around the insulated joints at the CSX rail road crossing. The impedance bonds installed by CSX on the streetcar tracks contain neutral cable connections to the track that provides a current path around the insulated joint but this cable is too small to support the traction power negative return current and it is totally exposed to the public (see **Photo 27**).

PHOTO 27
NEUTRAL RETURN CABLES AT CSX CROSSING

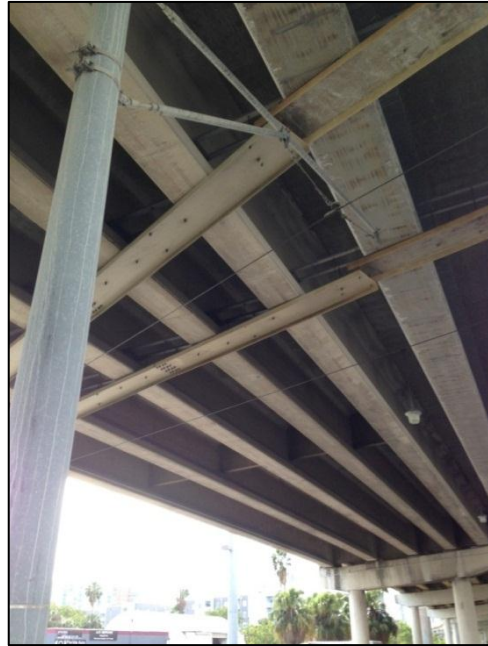
An OCS pole and cantilever arm assembly along with its insulation and contact wire was found totally covered with construction cement spray under the Florida 618/Selmon Expressway toll road overhead bridge. It appears that when work was performed under the bridge, the OCS pole and associated hardware including the contact wire was not properly protected from the overhead construction work (see **Photo 28**).

PHOTO 28
OCS POLE UNDERNEATH BRIDGE

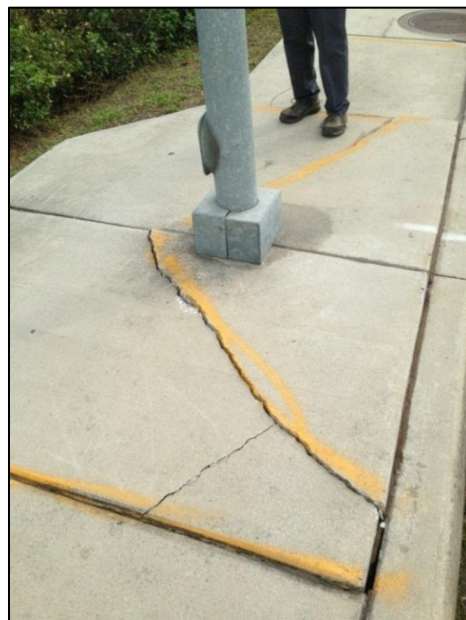
At East Twiggs Street and Channel Drive the track, ties and ballast are subject to frequent flooding. This situation causes the sidewalk to crack at the OCS pole locations in this area (see **Photo 29**). Also, the tracks are not insulated from ground and the clips are not insulated, which causes stray current to leak to ground.

PHOTO 29
SIDEWALK DAMAGE DUE TO FLOODING AT TRACK LEVEL

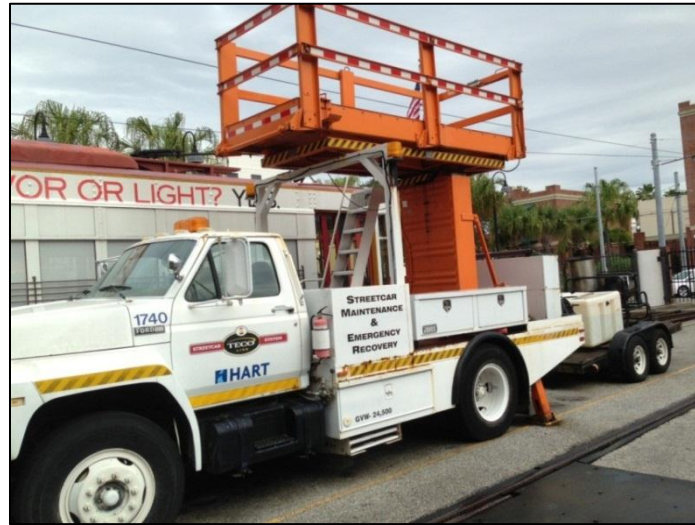
PHOTO 30
HI-RAIL VEHICLE IN NEED OF REPAIR

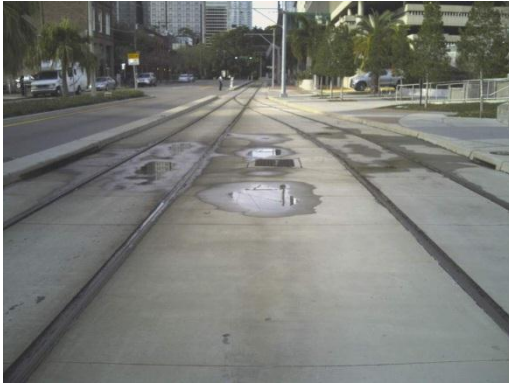
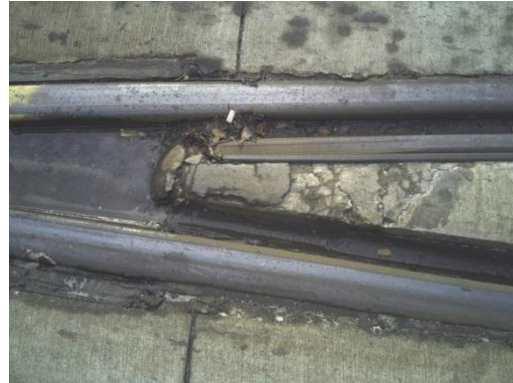
- **1-5** All of Phase II embedded track on Franklin St:

Excellent condition for slab, rail, boot, turnouts; turnouts for siding constructed w/o tubs, encapsulated method (need as-builts/shop drawings); gauge is within tolerance; alignment and cross level are okay; platform and bumping post look good; some mud and vegetation in the siding flangeways due to lack of use (not a problem); *concrete cracking around frogs; loose switch point bolts at north turnout – HART has been notified and will fix.*

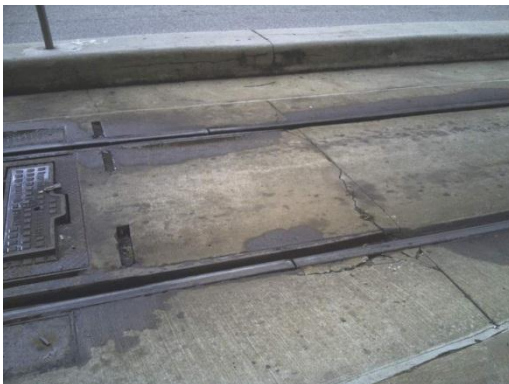
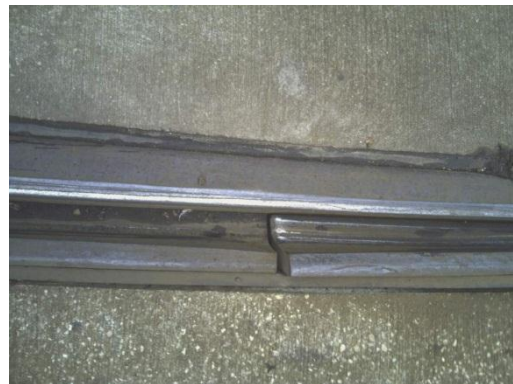
- **6-14** Phase I embedded double track from Franklin St through Greko Plaza, Old Water St to TBT Forum:

Good condition for slab, rail, boot, Franklin turnout; gauge is within tolerance; alignment and cross level are okay; *switch box at segment 6 is flooded; switch point has excessive vertical play; concrete cracking around switch; guard rail is high and vertically mismatched at curve segment 8 and could be a hazard for pedestrian crossing and bikes; ponding in trackway at west end of HSBC stop; a few tactile pavers are broken and chipped.*

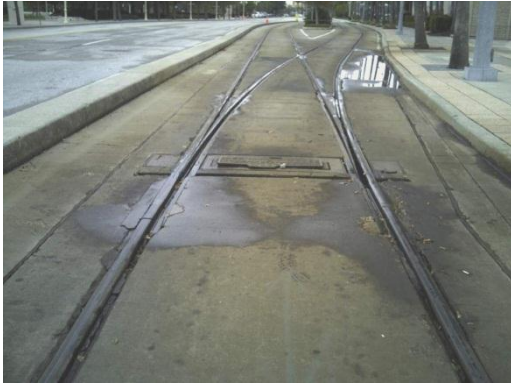
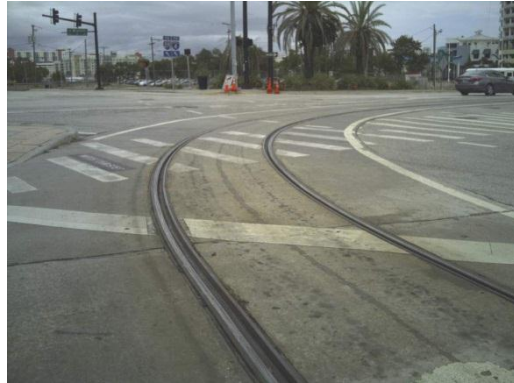
- **15-18** Embedded track, east end of TBT Forum to Channelside Drive:

Good condition for slab, rail, guard rail and elastomeric grout embedment; gauge and guard rail wear are within tolerance; alignment and cross level are okay; drainage is good except at bottom of hill; *turnout at segment 15 is in fair to poor condition – poor drainage, flooded switch machine and rail pockets, broken rail at switch point, broken concrete, eroded rail support (approx. ½” vertical movement under load), suspect welds at points, vertical play in points; guard rail at crosswalk in curve segment 18 sits high and presents tripping hazard. HART is aware of turnout condition and is initiating repair.*

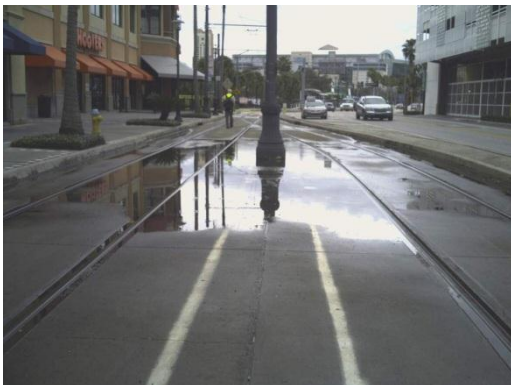
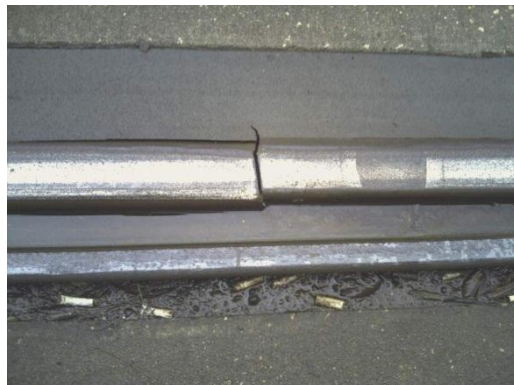
- **19-26** Embedded track, Channelside Drive to Port Authority entrance:

Good condition for slab, rail, guard rail and elastomeric grout embedment; guard rail wear is within tolerance; gauge is generally within tolerance; alignment and cross level are okay; *drainage is fair to poor as this is a level track segment, backed up storm drains were observed, possibly influenced by tides; 57 1/4” gauge at one point across from 12th*

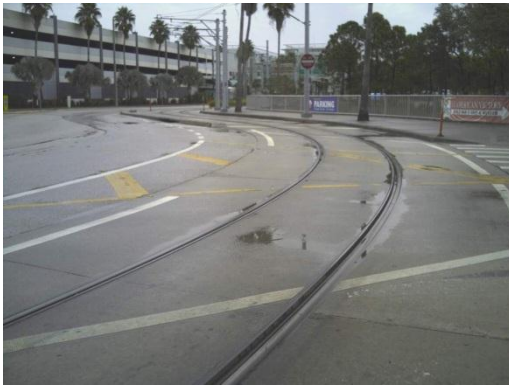
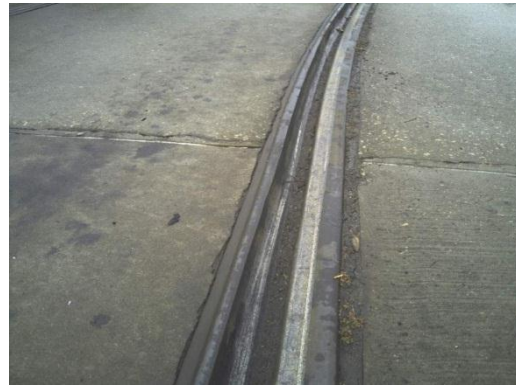
- **27-33** Embedded track, Channelside Drive from Port Authority to Cumberland Ave Station:

Good condition for slab, rail, guard rail and elastomeric grout embedment; guard rail wear is within tolerance; gauge is within tolerance; alignment and cross level are okay; Cumberland Ave Station trackway and platform in very good condition; *drainage is fair as this is a relatively level track segment; guard rail in tight curves at roundabout is showing wear and appears to have been hand-ground (possibly to relieve wheel binding); guard rail is high (1" max), elastomer is low and flangeway is wide (3¼" max) at crosswalks creating tripping hazards; some cracking and settling of sidewalk around OCS poles at roundabout probably due to unstable subgrade (poles look good and plumb).*

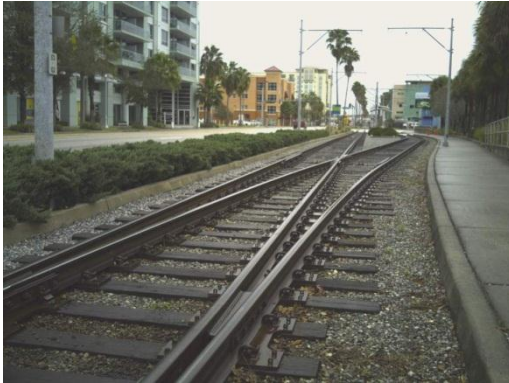
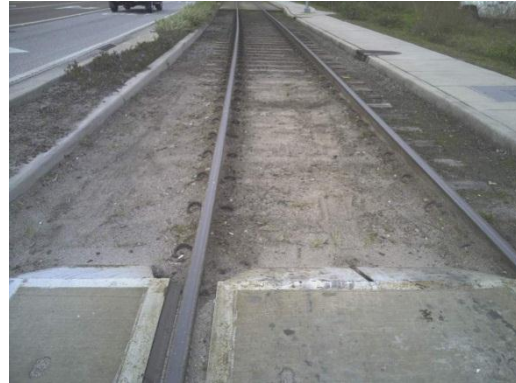
- **34-51** Ballasted track, Channelside Drive from Cumberland Ave Station to E Harbor St:

This segment includes approximately 400 feet of embedded double track in front of the Port Authority building, all in very good condition; very good condition for rail, guard rail, plates, insulators, rail clips, spikes, turnouts, frogs, switches and switch machines; gauge is within tolerance; alignment and cross level appear to be as designed; prefabricated, tie-borne crossing panels and hardware appear to be in good condition, solid and flat; drainage structures are in good condition although grate elevations are variable; underdrain pipes could not be accessed for assessment; *timber ties are in generally good condition with fewer than 10 (randomly scattered) showing significant checking or rot but still holding spikes; a few (less than 5) clips and insulators were broken or missing in segments 45 and 51; all ballasted turnouts were originally installed without insulating rail pads and rail/clip insulators; ballast is in good condition except at most locations where adjacent paved track crossings drain into it and have, over time, fouled the ballast and ties with debris and vegetation leaving ties in fair to poor condition.*

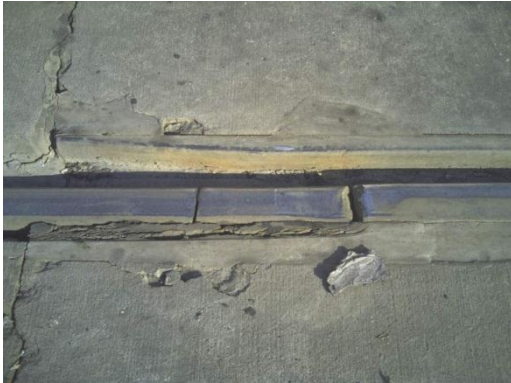
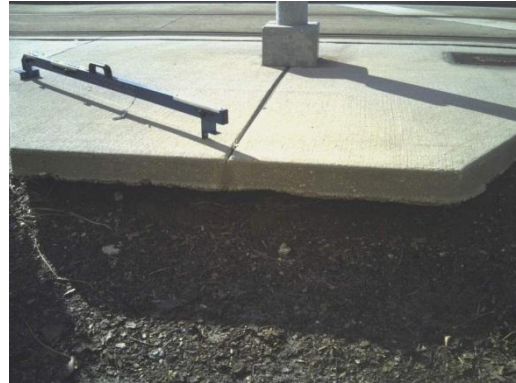
- **52-58** Embedded track, Channelside Drive from E Harbor St to E 4th Ave:

Good condition for slab, rail, guard rail and boot; gauge is within tolerance; alignment and cross level are okay; *some vertical play in switch tongues; broken, uneven, undermined sidewalk in segment 53 likely due to unstable subgrade and vehicles driving on sidewalk, OCS poles appear to be stable; broken rail embedded in deteriorating concrete near switch point in segment 56; fill slope sloughing and sidewalk undermined in segment 57; ponding across rails at low point in segment 58. HART is addressing broken rail.*

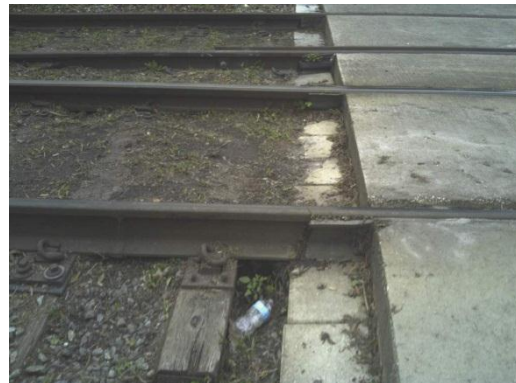
- **58-64** Ballasted track, Channelside/E 4th Ave to E 6th Ave/N 13th St:

Good condition for rail, guard rail, plates, insulators, rail clips, spikes, CSX rail crossing; gauge is within tolerance; alignment and cross level appear to be as designed; prefabricated, tie-borne crossing panels and hardware appear to be in good condition, solid and flat; turnout and upgraded switch machine are in good condition; south of E 5th Ave timber ties, hardware and ballast are in good condition, *ballast is uncontained*

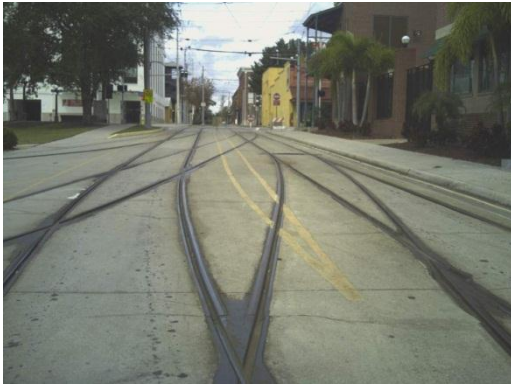
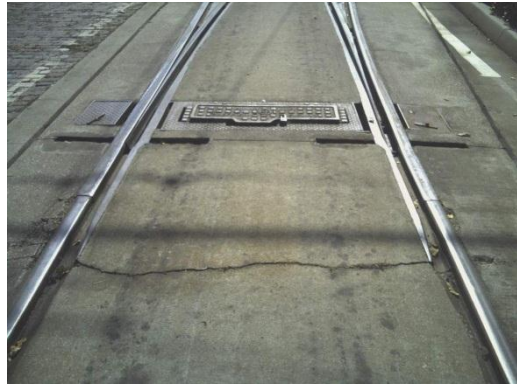
- **65-67** Embedded track, N 13th St from trolley barn to E 8th Ave:

Good condition for slab, rail, guard rail, boot and turnouts; gauge is within tolerance; alignment and cross level are okay; upgraded switch machine is dry and functions well; *old machines are flooded but functional; some vertical play in switch tongues; guardrails at N 13th St/E 8th Ave are uniformly worn from wheel contact and apparent hand grinding but in good condition; minor cracking in turnout infill slabs.*

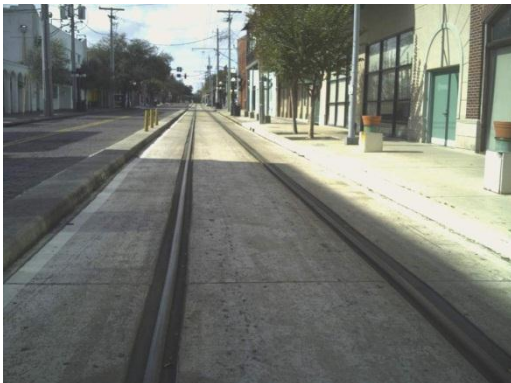
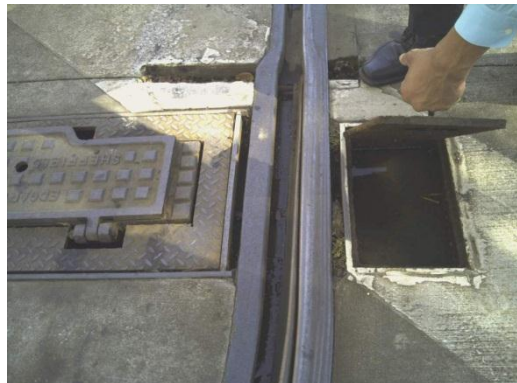
- **68-73** Embedded track, E 8th Ave from N 13th St to N 20th St (North Terminus):

Good condition for slab, rail, guard rail, boot, elastomeric embedment, turnouts and bumping post; gauge is within tolerance; alignment and cross level are okay; *old switch machines are flooded but functional; vertical play in switch tongues; minor cracking in turnout infill slabs, suspect welds on rail heads near switch points.*

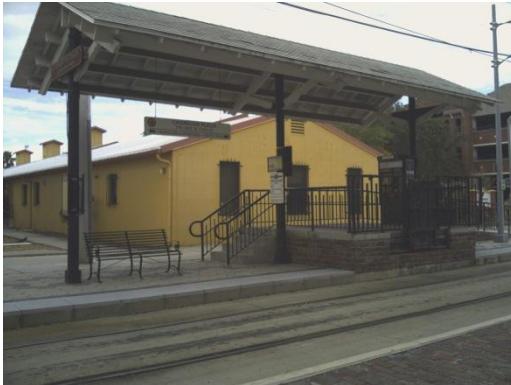
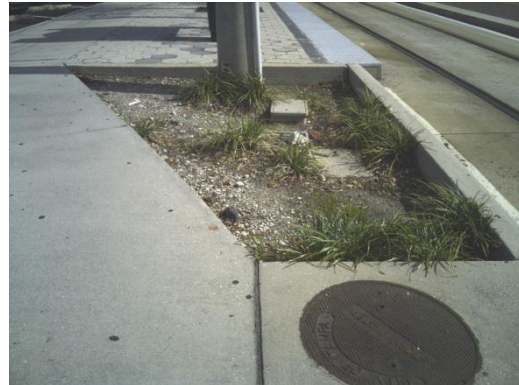
- Ybor City stations (Centennial Park, Tampa Bay Federal Credit Union, Streetcar Society, Cadrecha Plaza):

Platform concrete and paint is in good condition, fair condition for canopies and wheelchair mechanisms. Each stop had two functional trash receptacles. Signage in good condition. *Moderate to severe washout/undermining at landscaping planters near edges of stations along 8th Avenue, causing uniform sinking of pavers on the station walkway; all canopies show signs of weathering, including chipping paint and deterioration of wooden ties and planks; loose handrails at Centennial Park, Streetcar Society, and Tampa Bay Federal Credit Union stations should be regouted where the rail has loosened. Historic-style painted wood signs showing slight wear, however other signage exists.*

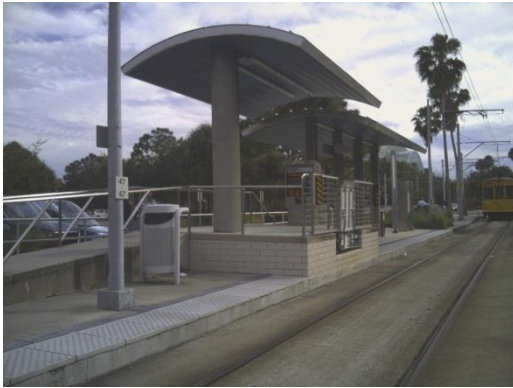
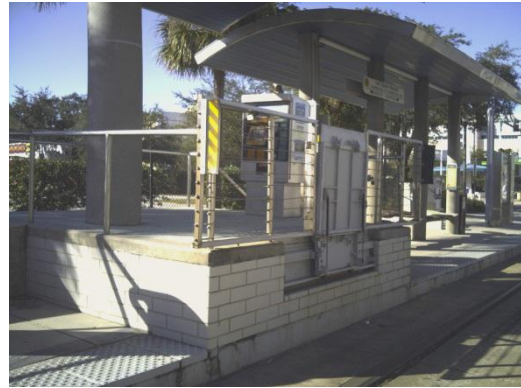
- Channelside and Downtown stations (Port Authority, York Street, Cumberland Avenue, The Tampa Tribune, HSBC, Whiting):

Stop platform concrete, paint, and platforms in fair condition, canopy structures and signage in good condition. Whiting Station was in good condition completely; *loose handrails at Cumberland Avenue, York Street, and The Tampa Tribune stations should be regouted where the rail has loosened. HSBC station had a missing trash receptacle and loose debris on the roof which appeared to be roofing material. Minor pavement cracking existed at the base of the columns supporting the canopy at the stations along Channelside Drive. Moderate pavement cracking around OCS pole location near the station platform. Broken sign support at Port Authority station.*

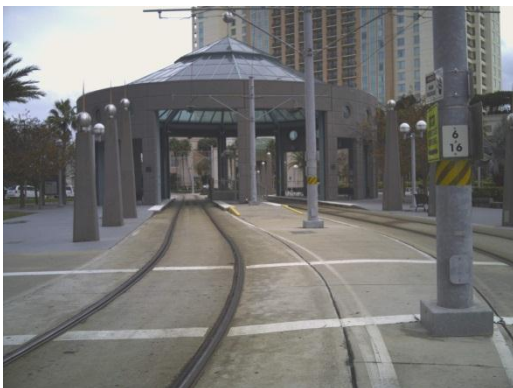
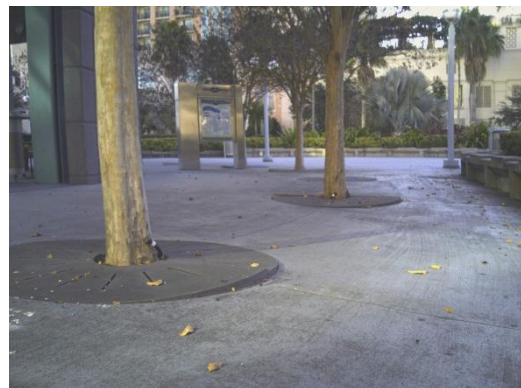
- Dick Greco Plaza Transportation Center:

Good condition for stop platform and canopy; *Leak at one of the downspouts was observed, but cause of the leak was not identified and may have been clogged by debris. Many of the metal tree skirts surrounding the Plaza have been pushed above grade and*
