EXHIBIT "A"
SCOPE OF SERVICES

City of Tampa
Streetcar Extension and Modernization
Feasibility Study
FDOT FPID #437608 1 14 01
City of Tampa RFQ 16-D-00002

2. EXISTING CONDITIONS AND FIELD INSPECTION (TASK 2)

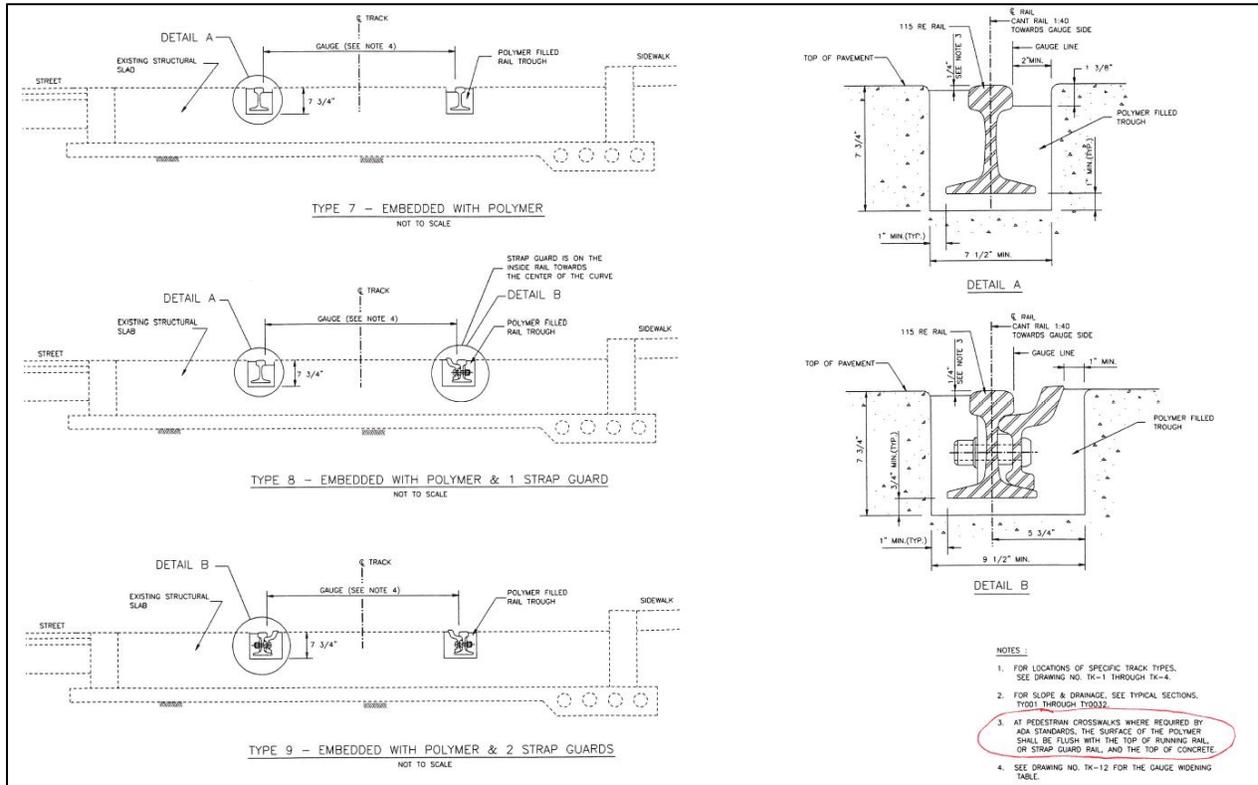
FIGURE 3
TRACK TYPES 7, 8, AND 9

Two notable exceptions to this design are at the Channelside and Centro Ybor developments. At these locations, the street and track structure was put in place prior to the initial rail project. A slot was formed in the concrete and the rail set in place at a later date. The rail was set into place and embedded in elastomeric grout (see **Figure 3**).

The construction tolerance for the slot and subsequent placement of grout was not fully met in the initial construction and there are locations where the rail either protrudes slightly above the concrete surface or it is slightly recessed. The variance in the worst locations is approximately ½-inch. This poses a concern at the pedestrian crossings where the lip could pose a tripping hazard.

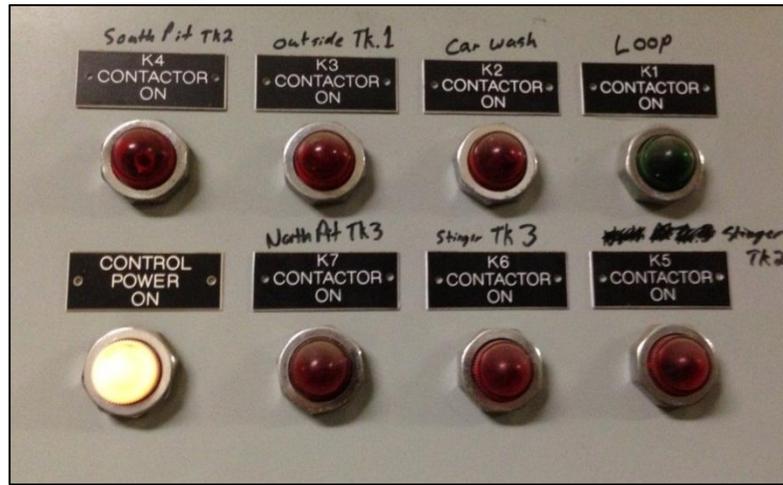
PHOTO 9
CONTACTOR PANEL

Two of the seven contactors were found open and out of service. The contactors were originally feeding track 1 and track 6 OCS outside in the yard which are now fed by the mainline North Substation. See **Photo 10** for view of yard tracks.

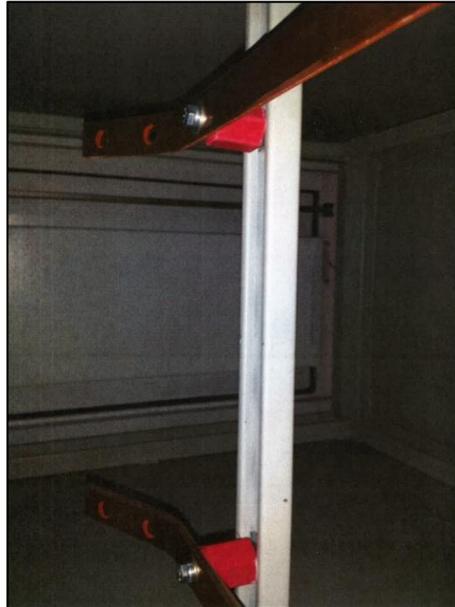
PHOTO 18
FNAG SWITCH WITH NO CONNECTING CABLES

Inspection of the negative drainage cubicle could not be made at the time of inspection without disrupting the streetcar operation because the compartments doors are interlocked with the breakers, which would cause the breakers to trip. The negative return cables at the track level are properly connected back to the North Substation.

The electrical supervisor examined the negative drainage compartment at a later date when no streetcar was running and advised that the Floating Neutral Automatic Grounding Switch (FNAGS) had no cables connected at the bottom of the switch (see **Photo 18**). This immediate hazard was corrected by URS Traction Power Engineers working via telephone with the HART maintenance staff to ensure that the FNAGS was wired properly and placed back into service safely and efficiently.

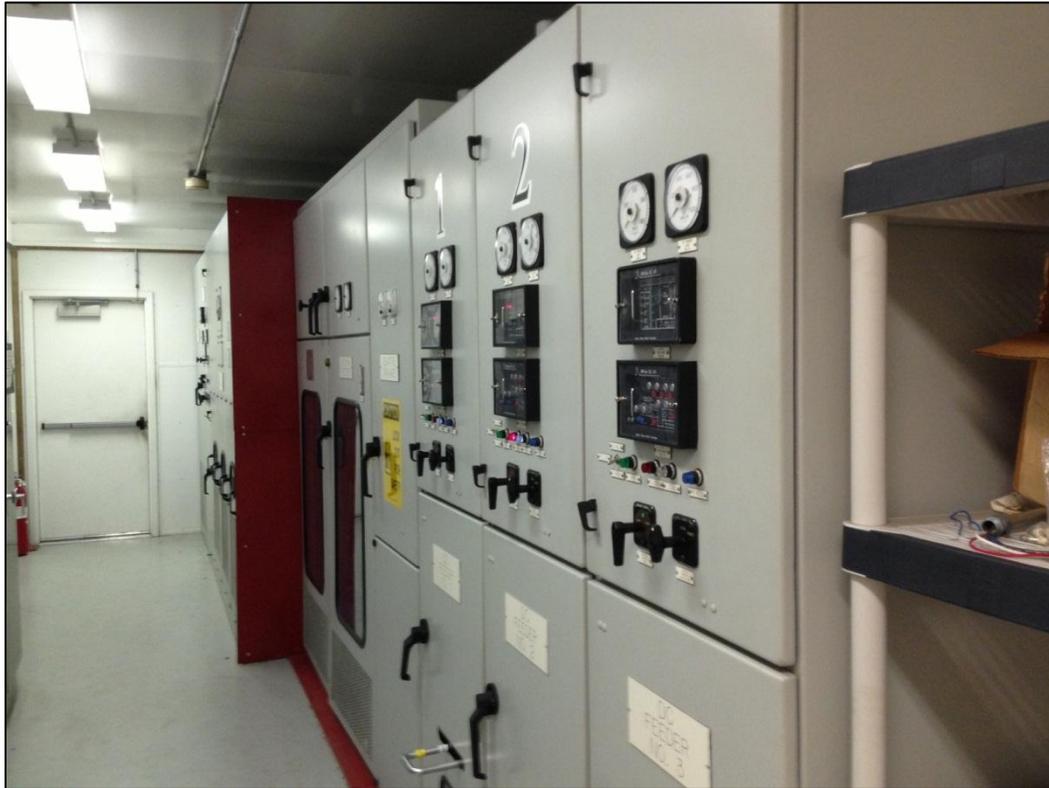
PHOTO 19
SOUTH TRACTION POWER SUBSTATION

The batteries were found to have been recently replaced. The South Substation was found to be clean and operating accordingly (see **Photo 19**), similarly to the North and VMF Substations. No alarms were noted on the annunciator panel. DC Feeder #2 was found to be in service feeding the OCS, while DC Feeder #1 is on standby. DC Feeder #3 is not connected or in service and slated for future use.

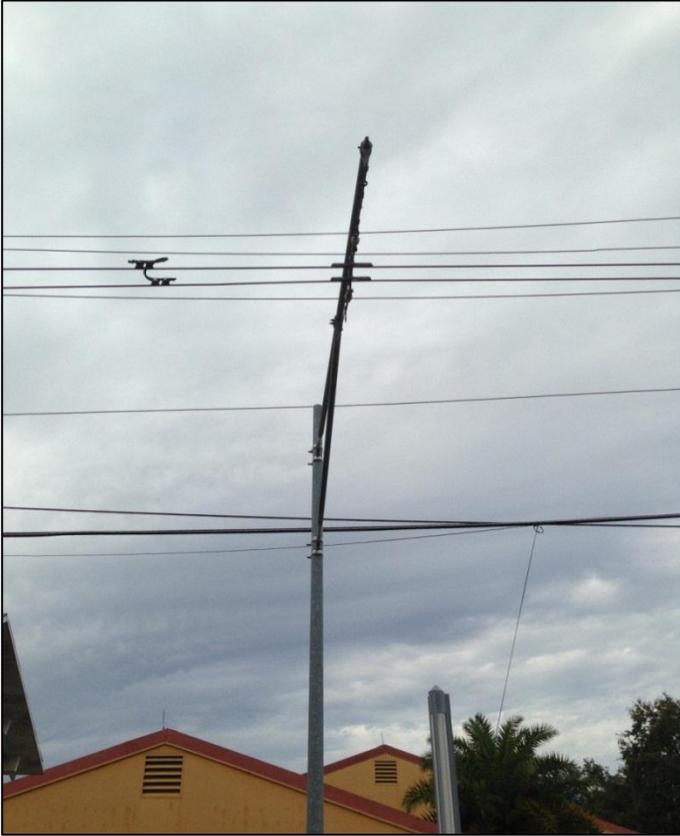
PHOTO 20
CANTILEVER ARM SHOWN NOT PERPENDICULAR TO
THE TRACK NORTH OF CADRECHA PLAZA STATION

Several cantilever arms (see **Photo 20**) starting north of Cadrecha Plaza Station and along 8th Avenue are slightly pointing north and should be perpendicular to the track at the temperature encountered during the inspection (60 degrees Fahrenheit). This could be caused by cantilever arms that were not constructed entirely perpendicular to the track and should be adjusted. The plans of the existing system indicate that pole number 101+84 is at a location where the cantilever is not properly aligned. However, during the inspection, this pole was found to be labeled 101+85 (see **Photo 21**).

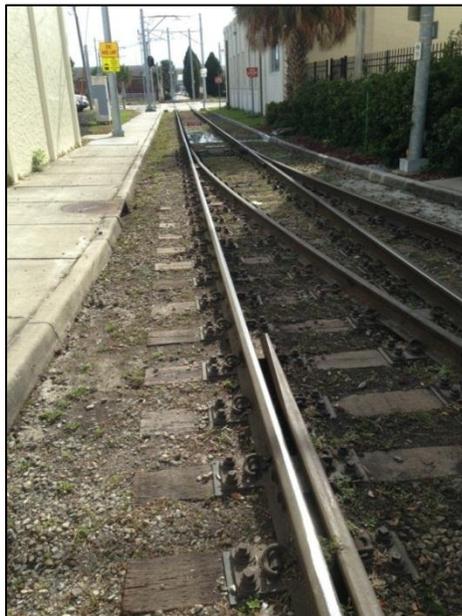
PHOTO 24
RAILS INSULATED WITH RAIL BOOTS, FLOODING PRESENT

Just south of the VMF, the track is insulated from earth with rubber boots but there is evidence of flooding which can cause current to leak to ground and can be hazardous to the public nearby while the vehicle is operating in the vicinity (see **Photo 24**).

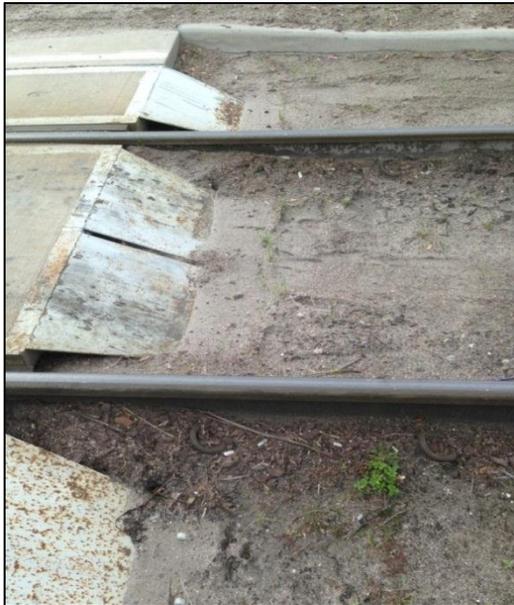
PHOTO 25
RAIL WITHOUT INSULATING BOOT

Continuing south from the VMF there are a number of locations where the rail is not properly insulated from earth and there is evidence of flooding creating a public hazard and greater potential for stray current corrosion subsurface utilities and rail fasteners (see **Photos 25 and 26**).

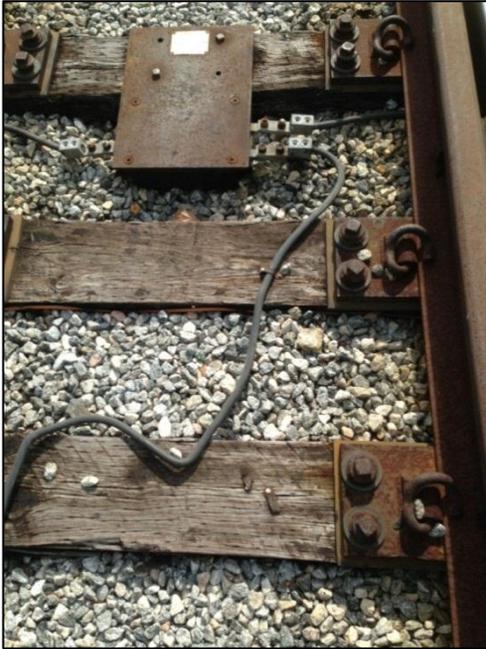
PHOTO 27
NEUTRAL RETURN CABLES AT CSX CROSSING

Where the CSX railroad crosses the streetcar track, the design in the plans shows multiple parallel 500 kcmil cables to provide continuity for the negative return circuit around the insulated joints installed by the CSX rail road. During the inspection, cable connections to the rail could not be located that allow the negative return current to get around the insulated joints at the CSX rail road crossing. The impedance bonds installed by CSX on the streetcar tracks contain neutral cable connections to the track that provides a current path around the insulated joint but this cable is too small to support the traction power negative return current and it is totally exposed to the public (see **Photo 27**).

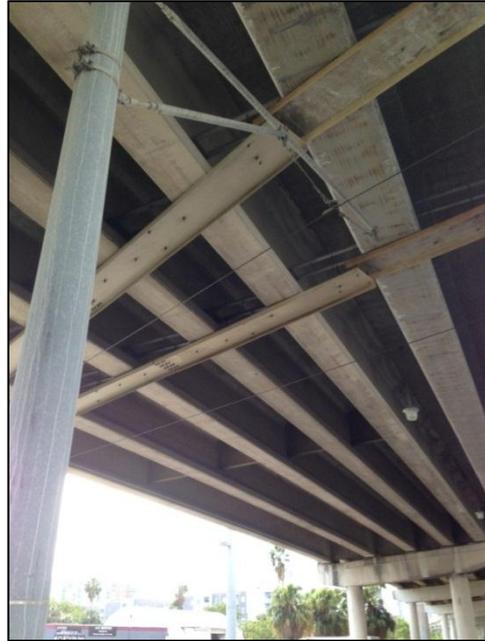
PHOTO 28
OCS POLE UNDERNEATH BRIDGE

An OCS pole and cantilever arm assembly along with its insulation and contact wire was found totally covered with construction cement spray under the Florida 618/Selmon Expressway toll road overhead bridge. It appears that when work was performed under the bridge, the OCS pole and associated hardware including the contact wire was not properly protected from the overhead construction work (see **Photo 28**).

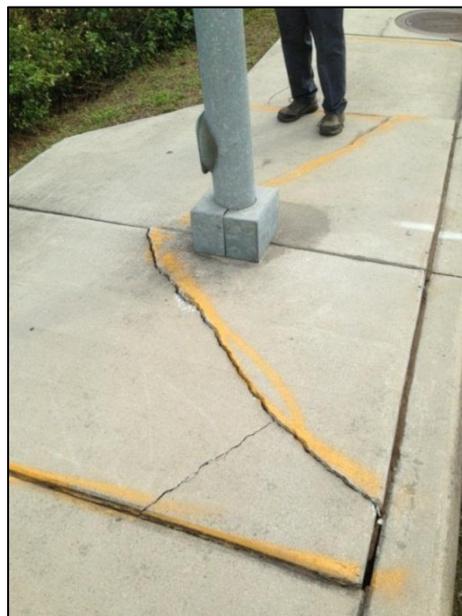
PHOTO 29
SIDEWALK DAMAGE DUE TO FLOODING AT TRACK LEVEL

At East Twiggs Street and Channel Drive the track, ties and ballast are subject to frequent flooding. This situation causes the sidewalk to crack at the OCS pole locations in this area (see **Photo 29**). Also, the tracks are not insulated from ground and the clips are not insulated, which causes stray current to leak to ground.

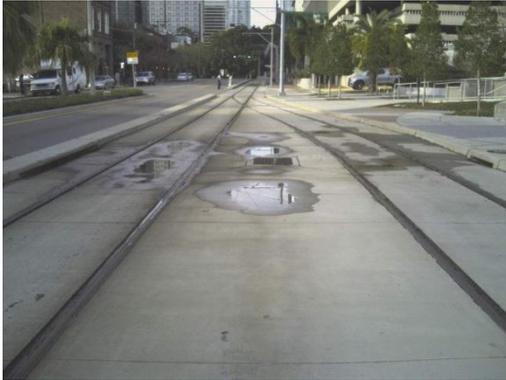
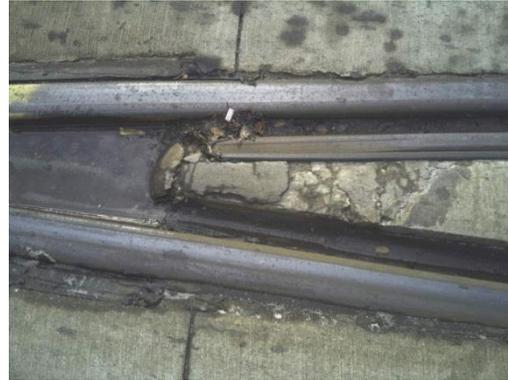
- **1-5** All of Phase II embedded track on Franklin St:

Excellent condition for slab, rail, boot, turnouts; turnouts for siding constructed w/o tubs, encapsulated method (need as-builts/shop drawings); gauge is within tolerance; alignment and cross level are okay; platform and bumping post look good; some mud and vegetation in the siding flangeways due to lack of use (not a problem); *concrete cracking around frogs; loose switch point bolts at north turnout – HART has been notified and will fix.*

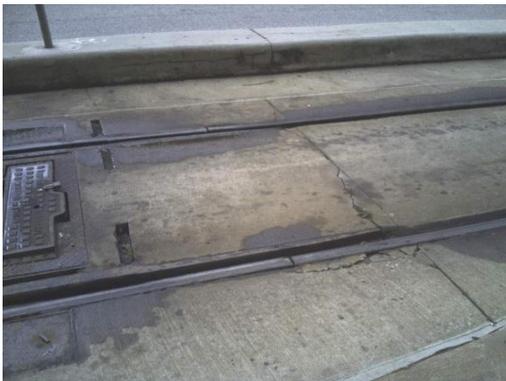
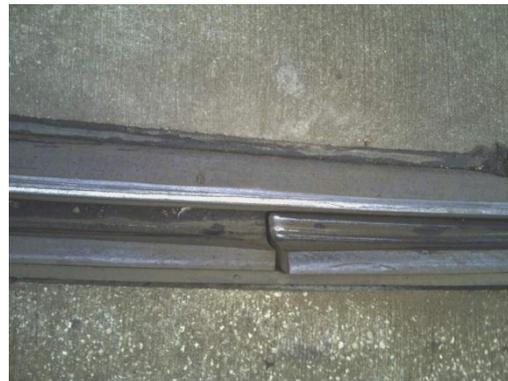
- **6-14** Phase I embedded double track from Franklin St through Greko Plaza, Old Water St to TBT Forum:

Good condition for slab, rail, boot, Franklin turnout; gauge is within tolerance; alignment and cross level are okay; *switch box at segment 6 is flooded; switch point has excessive vertical play; concrete cracking around switch; guard rail is high and vertically mismatched at curve segment 8 and could be a hazard for pedestrian crossing and bikes; ponding in trackway at west end of HSBC stop; a few tactile pavers are broken and chipped.*

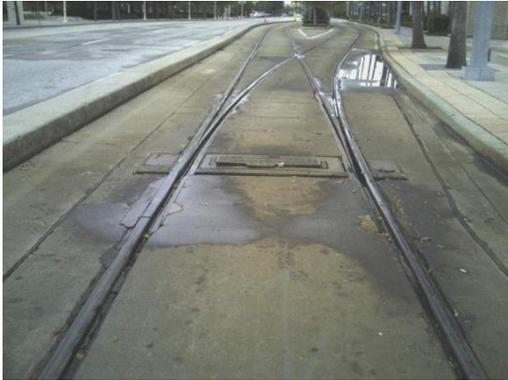
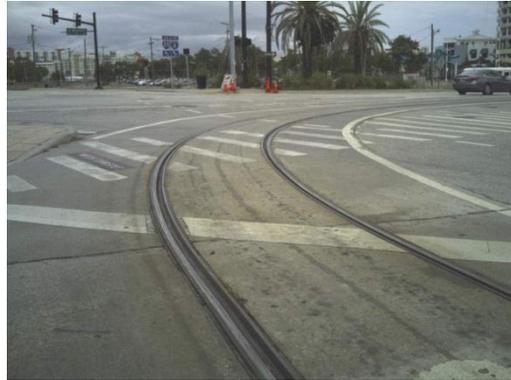
- **15-18** Embedded track, east end of TBT Forum to Channelside Drive:

Good condition for slab, rail, guard rail and elastomeric grout embedment; gauge and guard rail wear are within tolerance; alignment and cross level are okay; drainage is good except at bottom of hill; *turnout at segment 15 is in fair to poor condition – poor drainage, flooded switch machine and rail pockets, broken rail at switch point, broken concrete, eroded rail support (approx. ½” vertical movement under load), suspect welds at points, vertical play in points; guard rail at crosswalk in curve segment 18 sits high and presents tripping hazard. HART is aware of turnout condition and is initiating repair.*

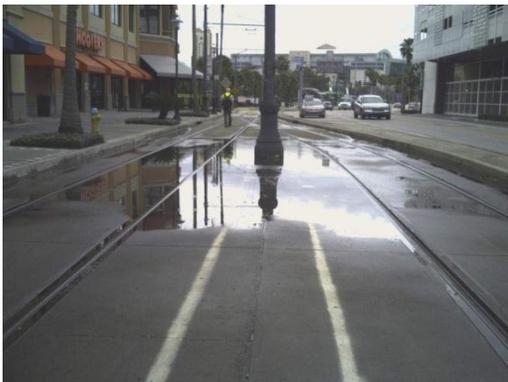
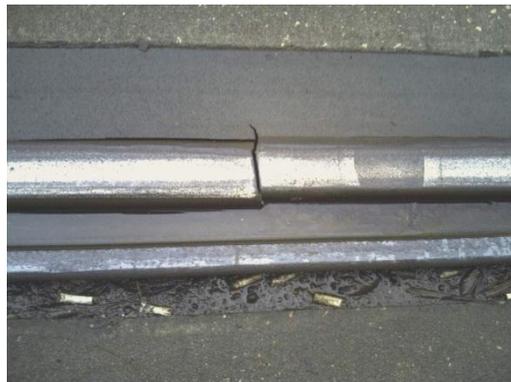
- **19-26** Embedded track, Channelside Drive to Port Authority entrance:

Good condition for slab, rail, guard rail and elastomeric grout embedment; guard rail wear is within tolerance; gauge is generally within tolerance; alignment and cross level are okay; *drainage is fair to poor as this is a level track segment, backed up storm drains were observed, possibly influenced by tides; 57 1/4” gauge at one point across from 12th*

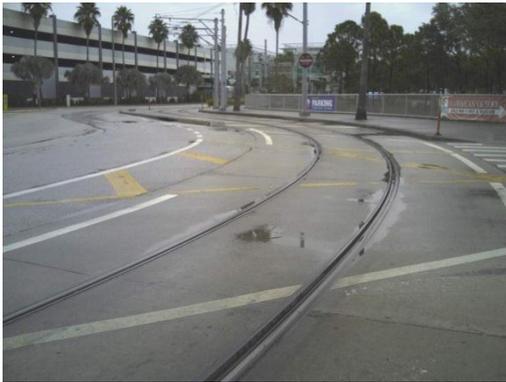
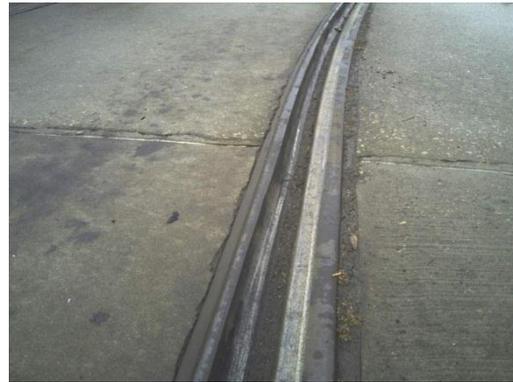
- **27-33** Embedded track, Channelside Drive from Port Authority to Cumberland Ave Station:

Good condition for slab, rail, guard rail and elastomeric grout embedment; guard rail wear is within tolerance; gauge is within tolerance; alignment and cross level are okay; Cumberland Ave Station trackway and platform in very good condition; *drainage is fair as this is a relatively level track segment; guard rail in tight curves at roundabout is showing wear and appears to have been hand-ground (possibly to relieve wheel binding); guard rail is high (1" max), elastomer is low and flangeway is wide (3¼" max) at crosswalks creating tripping hazards; some cracking and settling of sidewalk around OCS poles at roundabout probably due to unstable subgrade (poles look good and plumb).*

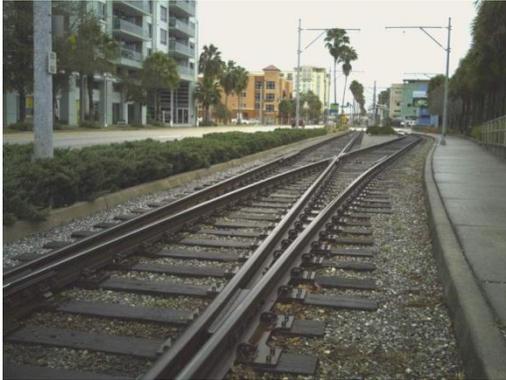
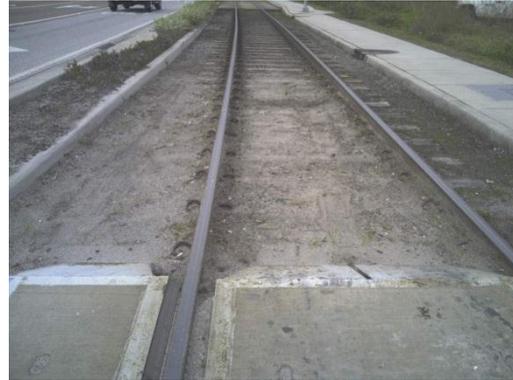
- **34-51** Ballasted track, Channelside Drive from Cumberland Ave Station to E Harbor St:

This segment includes approximately 400 feet of embedded double track in front of the Port Authority building, all in very good condition; very good condition for rail, guard rail, plates, insulators, rail clips, spikes, turnouts, frogs, switches and switch machines; gauge is within tolerance; alignment and cross level appear to be as designed; prefabricated, tie-borne crossing panels and hardware appear to be in good condition, solid and flat; drainage structures are in good condition although grate elevations are variable; underdrain pipes could not be accessed for assessment; *timber ties are in generally good condition with fewer than 10 (randomly scattered) showing significant checking or rot but still holding spikes; a few (less than 5) clips and insulators were broken or missing in segments 45 and 51; all ballasted turnouts were originally installed without insulating rail pads and rail/clip insulators; ballast is in good condition except at most locations where adjacent paved track crossings drain into it and have, over time, fouled the ballast and ties with debris and vegetation leaving ties in fair to poor condition.*

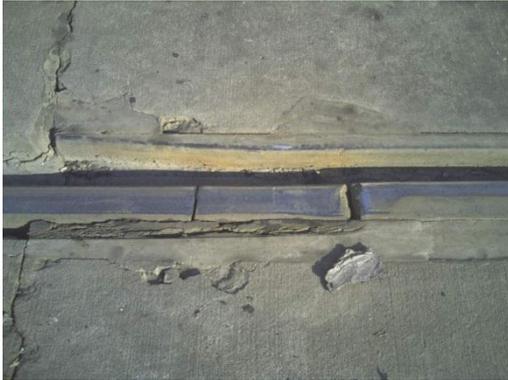
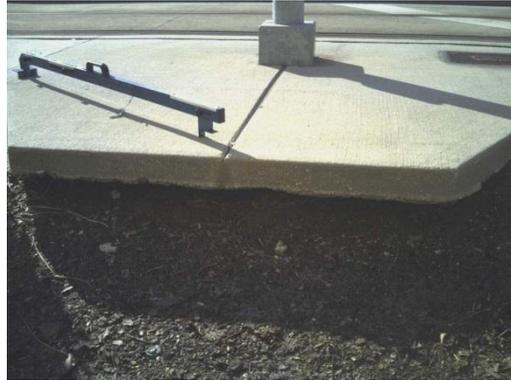
- **52-58** Embedded track, Channelside Drive from E Harbor St to E 4th Ave:

Good condition for slab, rail, guard rail and boot; gauge is within tolerance; alignment and cross level are okay; *some vertical play in switch tongues; broken, uneven, undermined sidewalk in segment 53 likely due to unstable subgrade and vehicles driving on sidewalk, OCS poles appear to be stable; broken rail embedded in deteriorating concrete near switch point in segment 56; fill slope sloughing and sidewalk undermined in segment 57; ponding across rails at low point in segment 58. HART is addressing broken rail.*

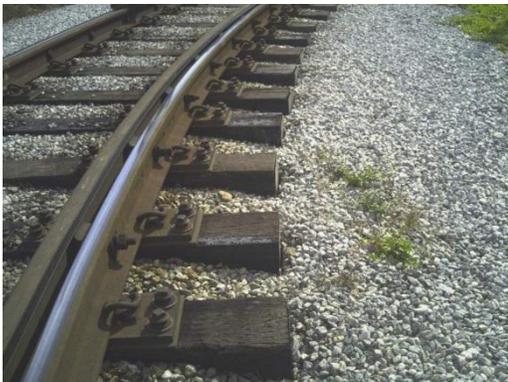
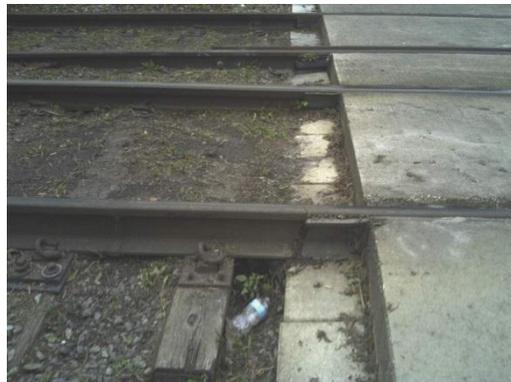
- **58-64** Ballasted track, Channelside/E 4th Ave to E 6th Ave/N 13th St:

Good condition for rail, guard rail, plates, insulators, rail clips, spikes, CSX rail crossing; gauge is within tolerance; alignment and cross level appear to be as designed; prefabricated, tie-borne crossing panels and hardware appear to be in good condition, solid and flat; turnout and upgraded switch machine are in good condition; south of E 5th Ave timber ties, hardware and ballast are in good condition, *ballast is uncontained*

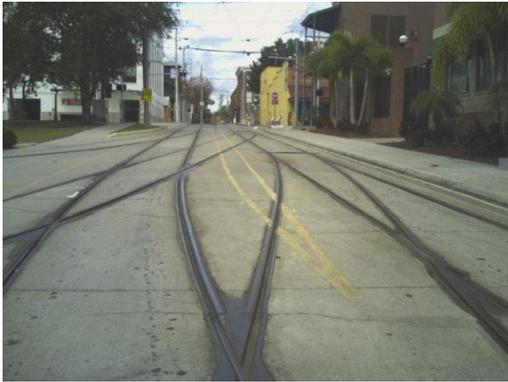
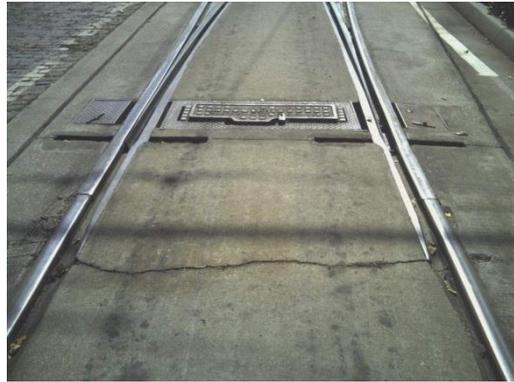
- **65-67** Embedded track, N 13th St from trolley barn to E 8th Ave:

Good condition for slab, rail, guard rail, boot and turnouts; gauge is within tolerance; alignment and cross level are okay; upgraded switch machine is dry and functions well; *old machines are flooded but functional; some vertical play in switch tongues; guardrails at N 13th St/E 8th Ave are uniformly worn from wheel contact and apparent hand grinding but in good condition; minor cracking in turnout infill slabs.*

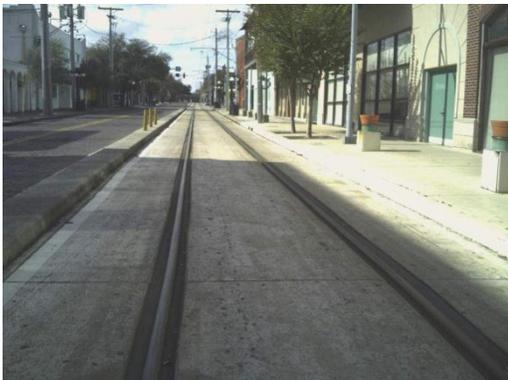
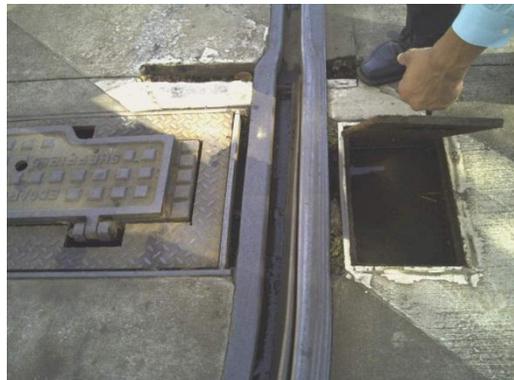
- **68-73** Embedded track, E 8th Ave from N 13th St to N 20th St (North Terminus):

Good condition for slab, rail, guard rail, boot, elastomeric embedment, turnouts and bumping post; gauge is within tolerance; alignment and cross level are okay; *old switch machines are flooded but functional; vertical play in switch tongues; minor cracking in turnout infill slabs, suspect welds on rail heads near switch points.*

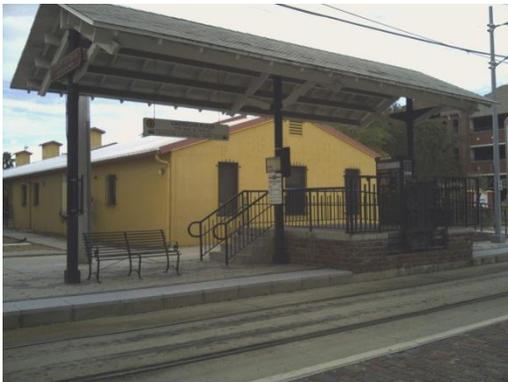
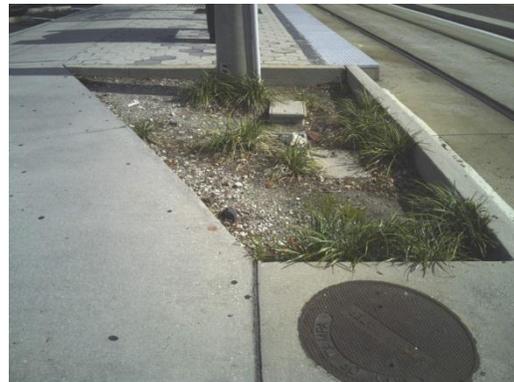
- Ybor City stations (Centennial Park, Tampa Bay Federal Credit Union, Streetcar Society, Cadrecha Plaza):

Platform concrete and paint is in good condition, fair condition for canopies and wheelchair mechanisms. Each stop had two functional trash receptacles. Signage in good condition. *Moderate to severe washout/undermining at landscaping planters near edges of stations along 8th Avenue, causing uniform sinking of pavers on the station walkway; all canopies show signs of weathering, including chipping paint and deterioration of wooden ties and planks; loose handrails at Centennial Park, Streetcar Society, and Tampa Bay Federal Credit Union stations should be regouted where the rail has loosened. Historic-style painted wood signs showing slight wear, however other signage exists.*

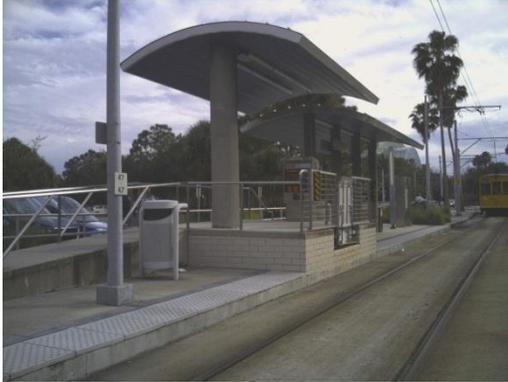
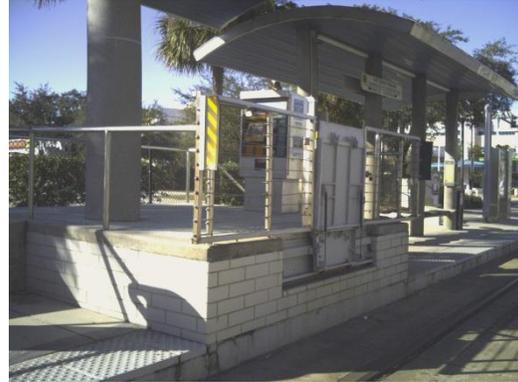
- Channelside and Downtown stations (Port Authority, York Street, Cumberland Avenue, The Tampa Tribune, HSBC, Whiting):

Stop platform concrete, paint, and platforms in fair condition, canopy structures and signage in good condition. Whiting Station was in good condition completely; *loose handrails at Cumberland Avenue, York Street, and The Tampa Tribune stations should be regouted where the rail has loosened. HSBC station had a missing trash receptacle and loose debris on the roof which appeared to be roofing material. Minor pavement cracking existed at the base of the columns supporting the canopy at the stations along Channelside Drive. Moderate pavement cracking around OCS pole location near the station platform. Broken sign support at Port Authority station.*

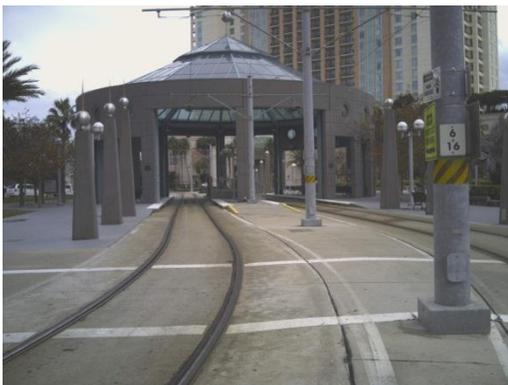
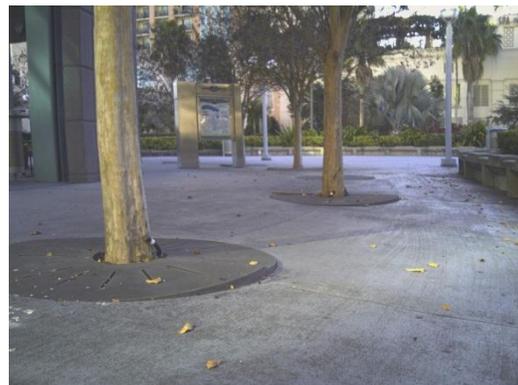
- Dick Greco Plaza Transportation Center:

Good condition for stop platform and canopy; *Leak at one of the downspouts was observed, but cause of the leak was not identified and may have been clogged by debris. Many of the metal tree skirts surrounding the Plaza have been pushed above grade and*
