Krause Force Main Assessment and Replacement Alignment Study

**City of Tampa
Wastewater Department**

FINAL DRAFT – March 2013

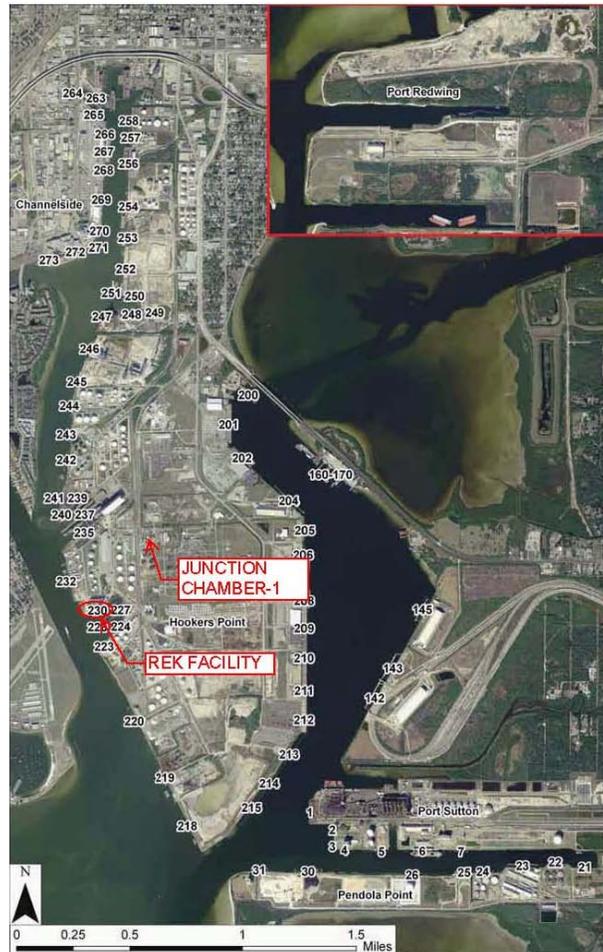
**Photo 5 - Location of R.E.K. Facility,
No Dredged is Planned for Sparkman Channel North of this Facility**

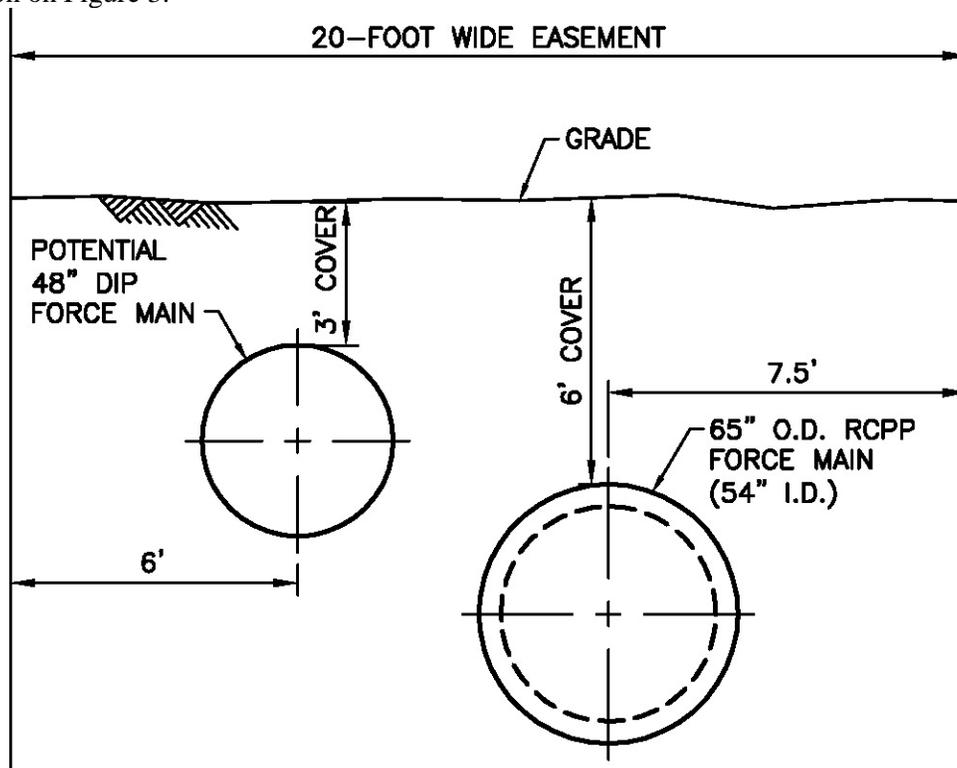
Figure 3 – Section Looking North, Scale: 1/4" = 1'-0"

In summary, the pipe generally had 6 feet of cover or more, except at specific locations where the grade was less built up from development. This somewhat deep characteristic has two significant implications. First; emergency repair access would be difficult and adjacent structures could be impacted. Second; while the 20-foot wide easement is relatively narrow for this size pipeline, the depth of the existing pipe does accommodate the addition of another shallower pipeline placed in the same corridor as shown in the cross section on Figure 3.

This does not imply that sufficient temporary construction easement is available for this crowded permanent easement arrangement. Of course, maintenance access to the old pipeline would be further impaired, but the newer pipeline could possibly be a replacement, thus negating the need to access the older pipeline. Alternatively, the newer pipeline could provide temporary bypass to allow detailed assessment or rehabilitation of the older pipeline perhaps by slip lining or swagelining.

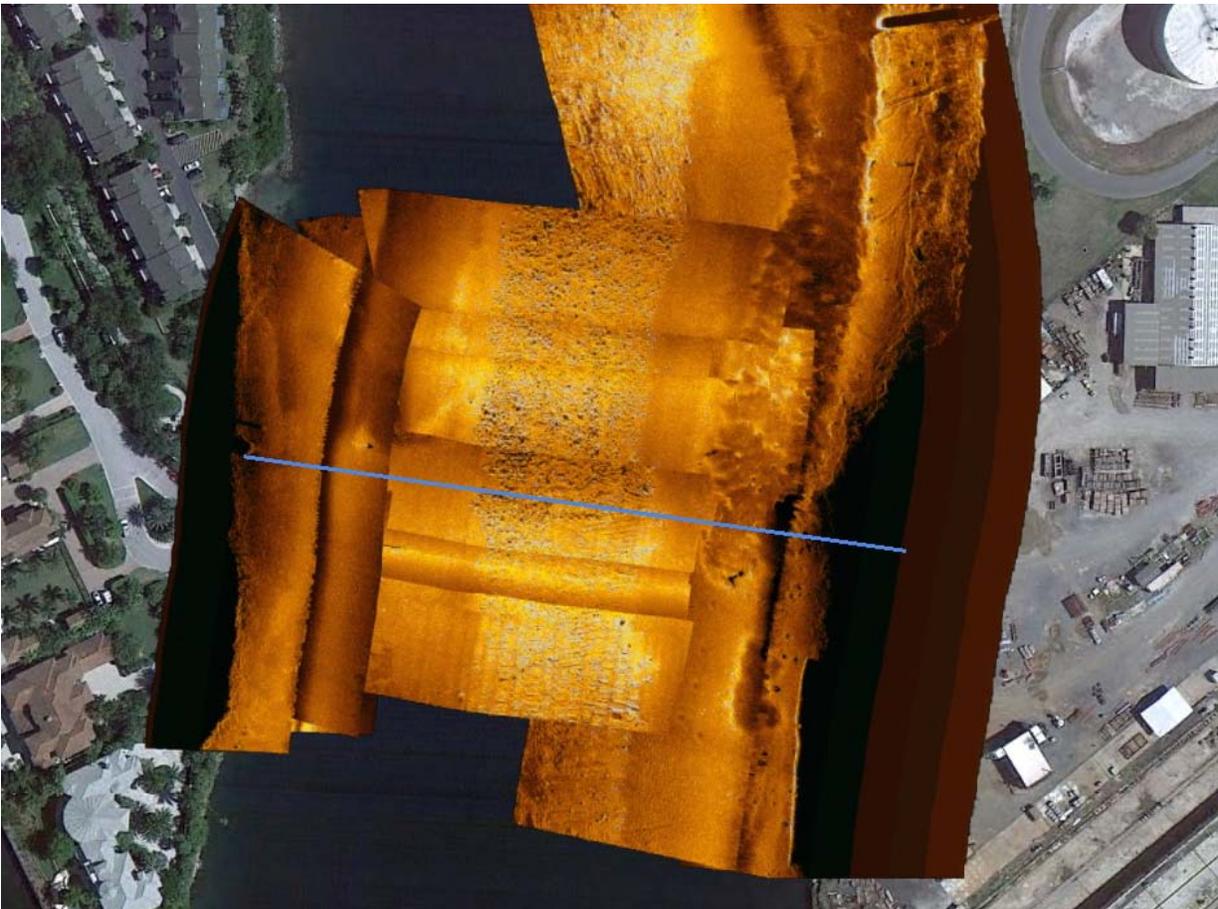
Figure 4 – Sidescan Sonar Image Mosaic of Bottom of Sparkman Channel. The blue line is location of buried force main. Force main is not exposed and therefore not visible.

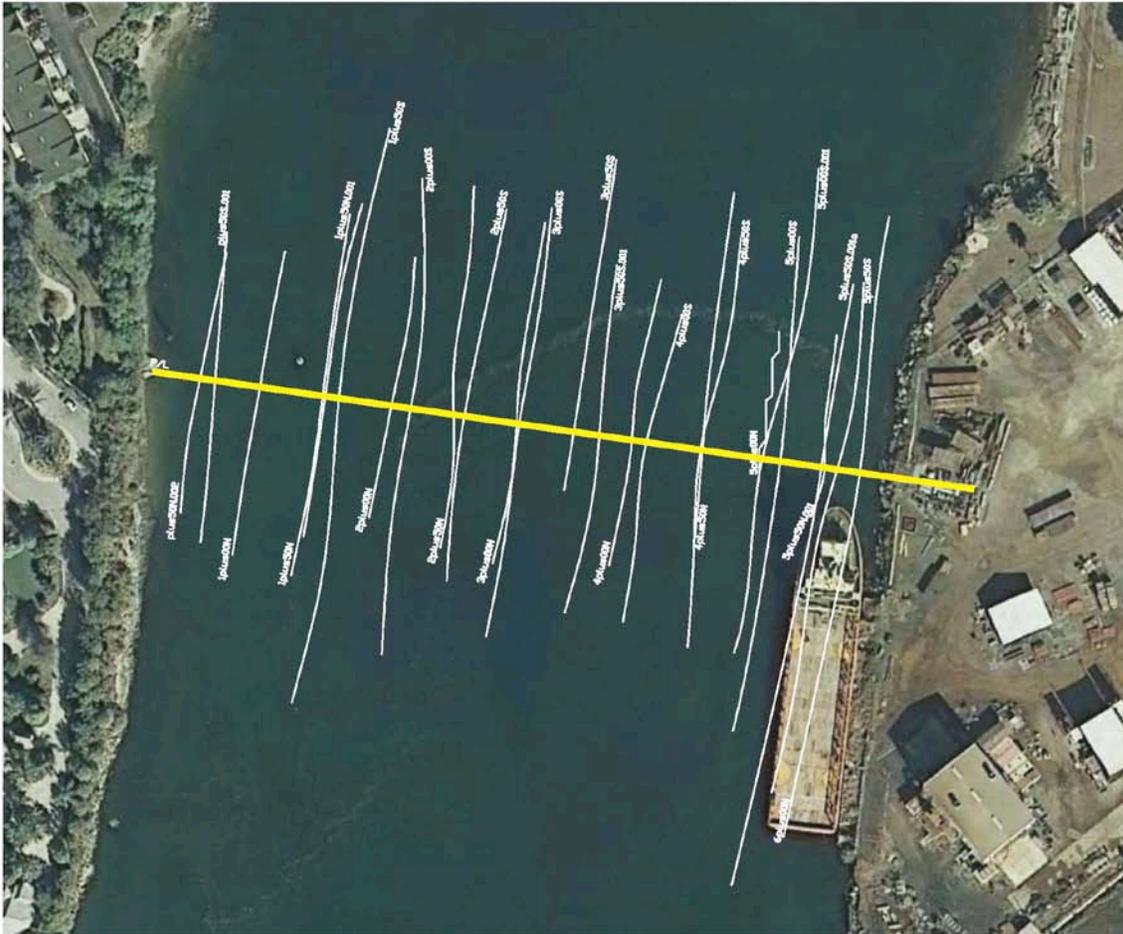
Figure 5 – Survey Vessel Tracks Crossing Pipeline

Figure 5 shows approximately 25 survey vessel tracks crossing the pipeline alignment. Not all of the tracks detected the target pipeline with confidence. On the east side of the channel, the soils are granular, as indicated by the record drawings and the plotted top of rock probing results. Here the pipe was detected

with confidence with between 2 and 5 feet of cover. See Figure 6. Where the record drawings indicate the pipe was installed in rock, the pipe was detected with covers ranging from 2 to 3 feet; however, the cover material returns a dense signal implying it consists of rocky material above the pipe/bedding envelope. Rock removed during excavation of the trench may have been placed back on top of the bedded pipeline which may provide excellent protection from erosion or mechanical impacts such as boat anchors. See Figure 7. Along the east side of the channel, the pipe was detected with as little as 1 foot of cover, but generally more. Frequent ship docking and traffic here, as well as shallower water depths, may explain an apparent loss of cover material.

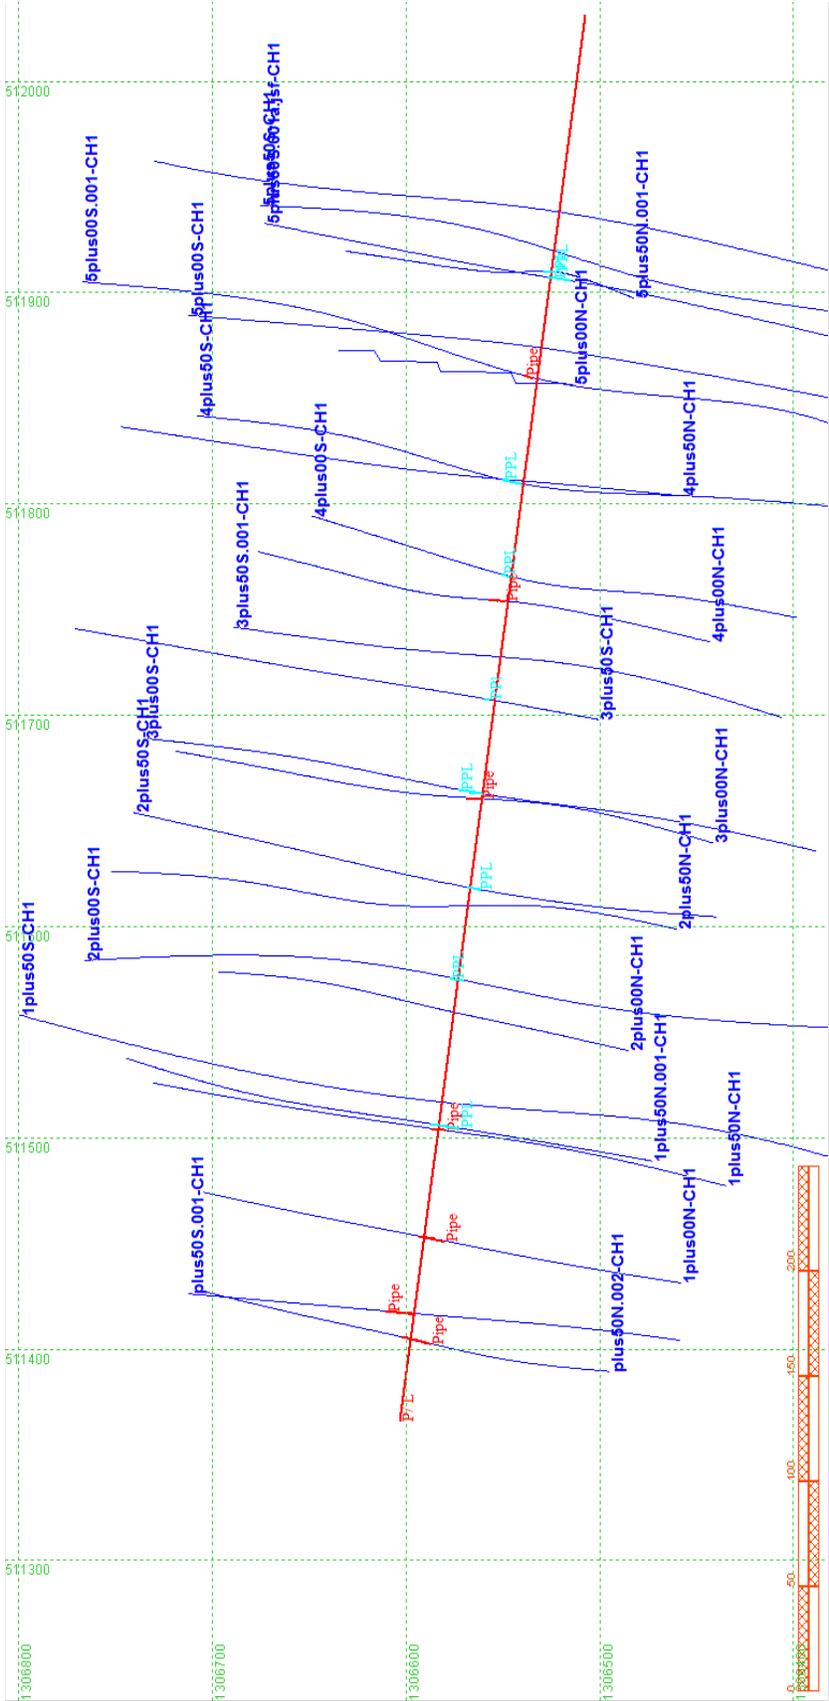
Figure 3. Track Map Survey Lines:

Pipe detections in red, Possible Pipe detections (PPL) in cyan, survey track lines in blue, pre-plot of pipeline (P/L) from the as built drawing is in red. Green grid is FL State Plane West Zone, U.S Feet, NAD83.

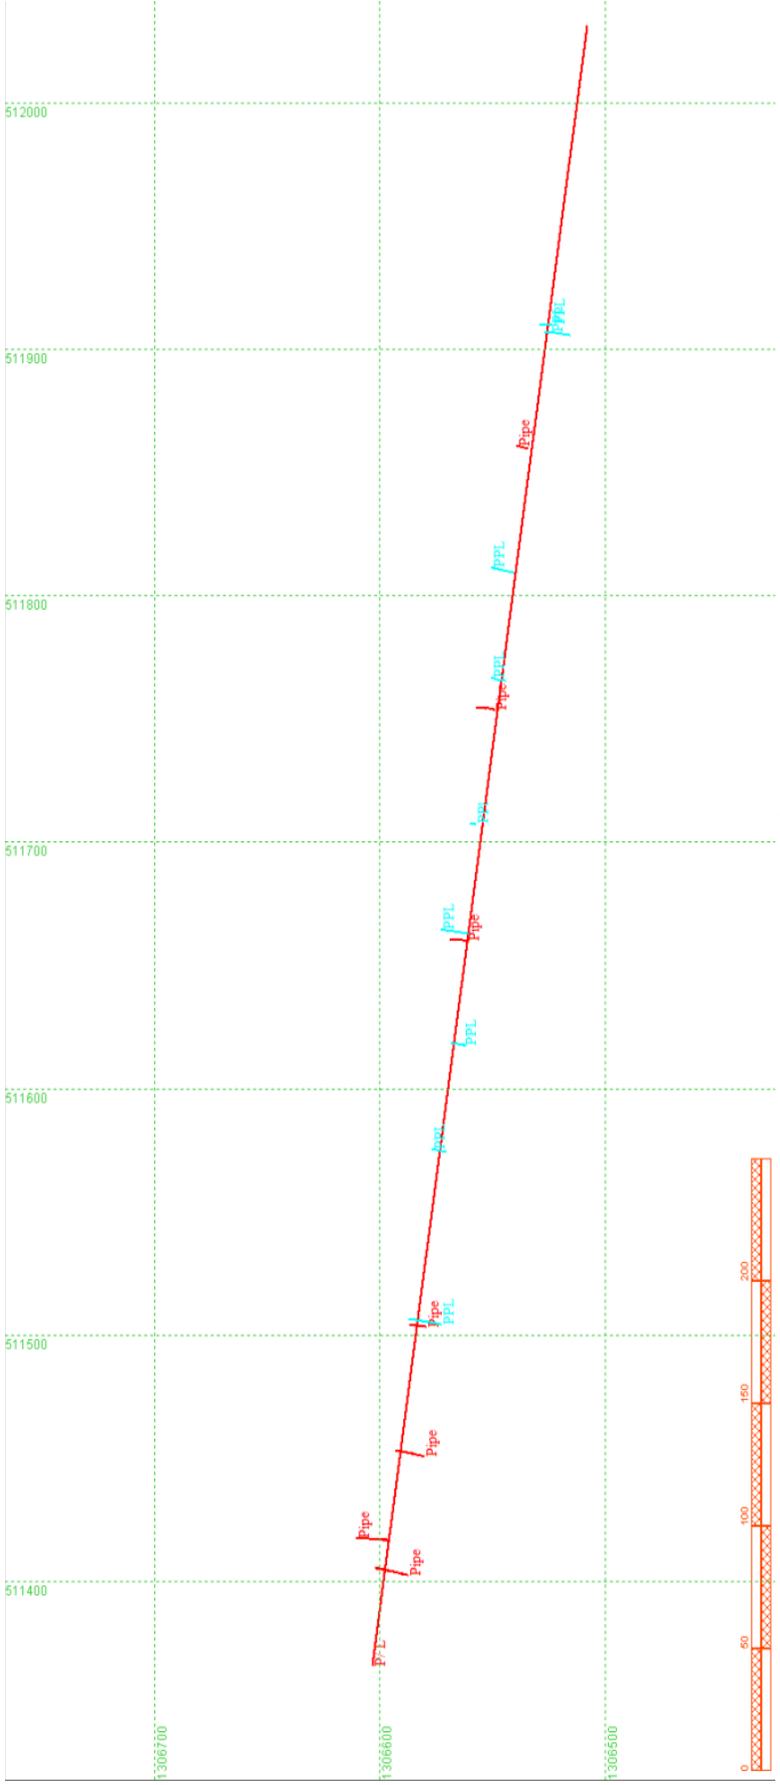
Figure 4. Pipe and Possible Pipeline detections:

Pipe detections in red, Possible pipe detections (PPL) in cyan and pre-plot of pipeline (P/L) from the as built drawing is in red. Green grid is FL State Plane West Zone, U.S Feet, NAD83.
