Krause Force Main Assessment and Replacement Alignment Study

**City of Tampa
Wastewater Department**

FINAL DRAFT – March 2013

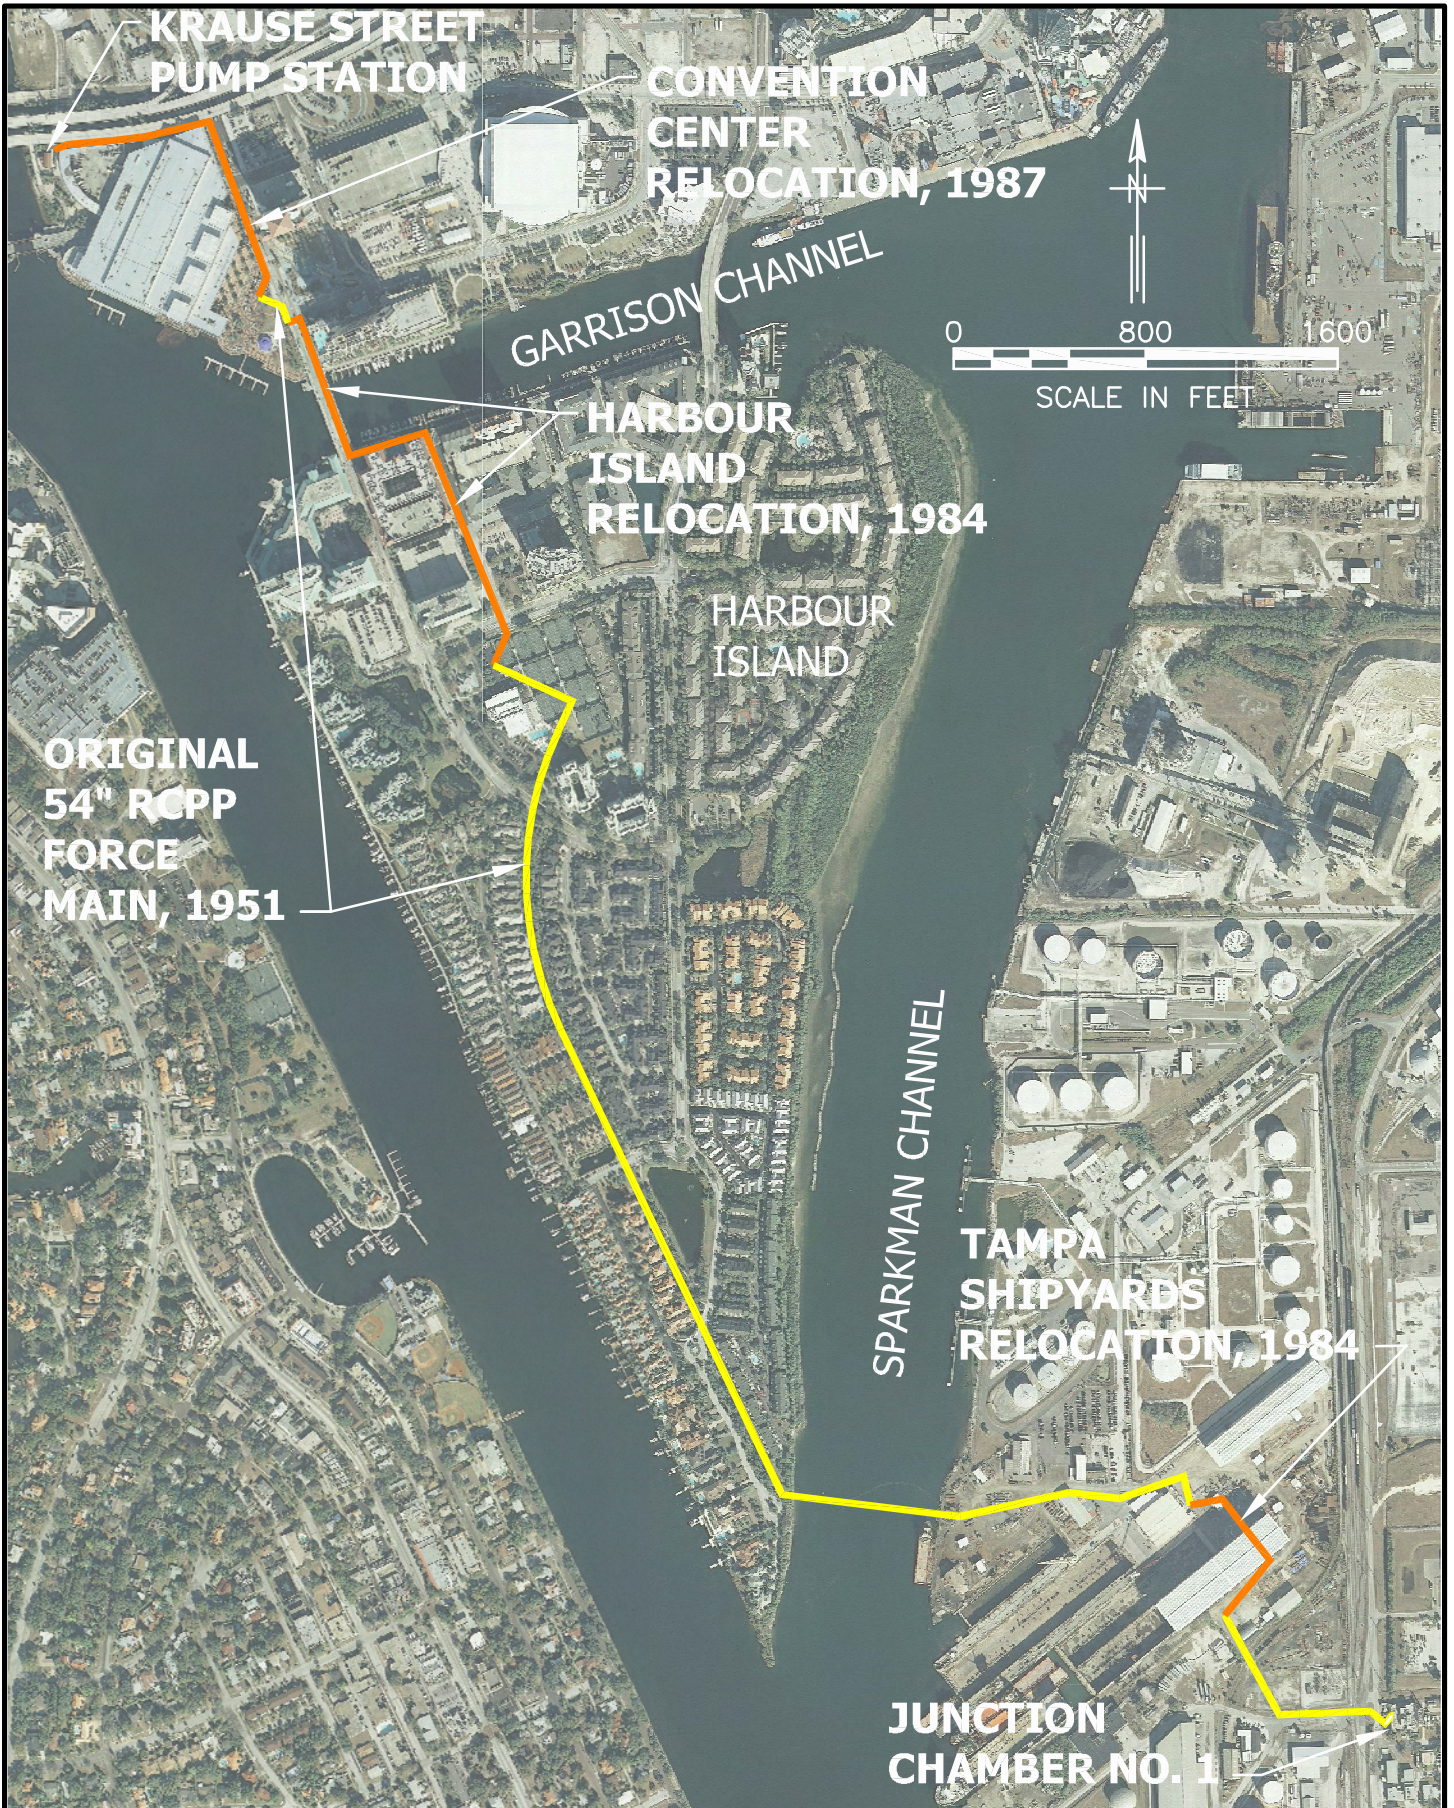
FIGURE 2
RELOCATIONS AND CURRENT
FORCE MAIN CONFIGURATION

All three relocations are shown on Figure 2. Pipe used in the construction of all three relocations is Prestressed Concrete Cylinder Pipe (PCCP) conforming AWWA C 301 Standard. This pipe is not expected to contain class IV defective prestressing wire commonly used in the late 1970's and early 1980's.

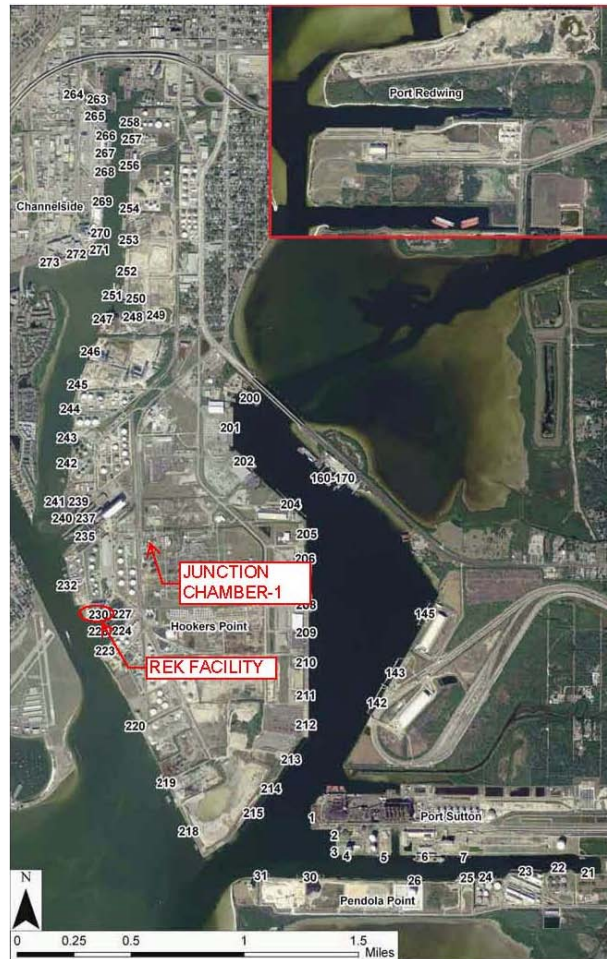
The Tampa Port Authority 2008 Master Plan indicates that significant dredging projects are planned in the near term; however, discussions with the Tampa Port Authority Engineering Department staff (Mr. Bruce Laurion) indicate that they recognize this utility and many others which cross Sparkman Channel in the vicinity, including TECO power lines. He mentioned that the Sparkman Channel maintained navigational depth north of the R.E.K facility is 34 feet and south of the facility is 41 feet, and that no deepening or widening of the channel is planned north of the R.E.K. facility. The R.E.K. facility is located near Berth 230, north of the tip of Hooker's Point as shown in Photo 5. The Tampa Port Authority regulations requirements regarding new pipeline crossings are addressed hereinafter in this report in the section headed "Alternatives".

**Photo 5 - Location of R.E.K. Facility,
No Dredged is Planned for Sparkman Channel North of this Facility**

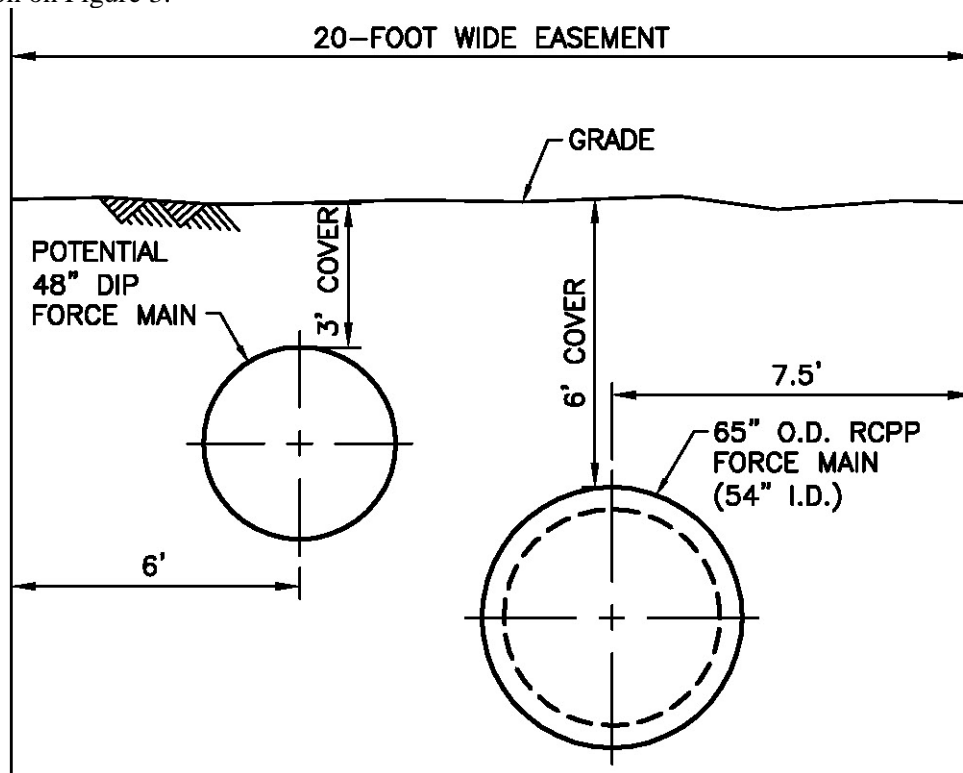
Figure 3 – Section Looking North, Scale: 1/4" = 1'-0"

In summary, the pipe generally had 6 feet of cover or more, except at specific locations where the grade was less built up from development. This somewhat deep characteristic has two significant implications. First; emergency repair access would be difficult and adjacent structures could be impacted. Second; while the 20-foot wide easement is relatively narrow for this size pipeline, the depth of the existing pipe does accommodate the addition of another shallower pipeline placed in the same corridor as shown in the cross section on Figure 3.

This does not imply that sufficient temporary construction easement is available for this crowded permanent easement arrangement. Of course, maintenance access to the old pipeline would be further impaired, but the newer pipeline could possibly be a replacement, thus negating the need to access the older pipeline. Alternatively, the newer pipeline could provide temporary bypass to allow detailed assessment or rehabilitation of the older pipeline perhaps by slip lining or swagelining.

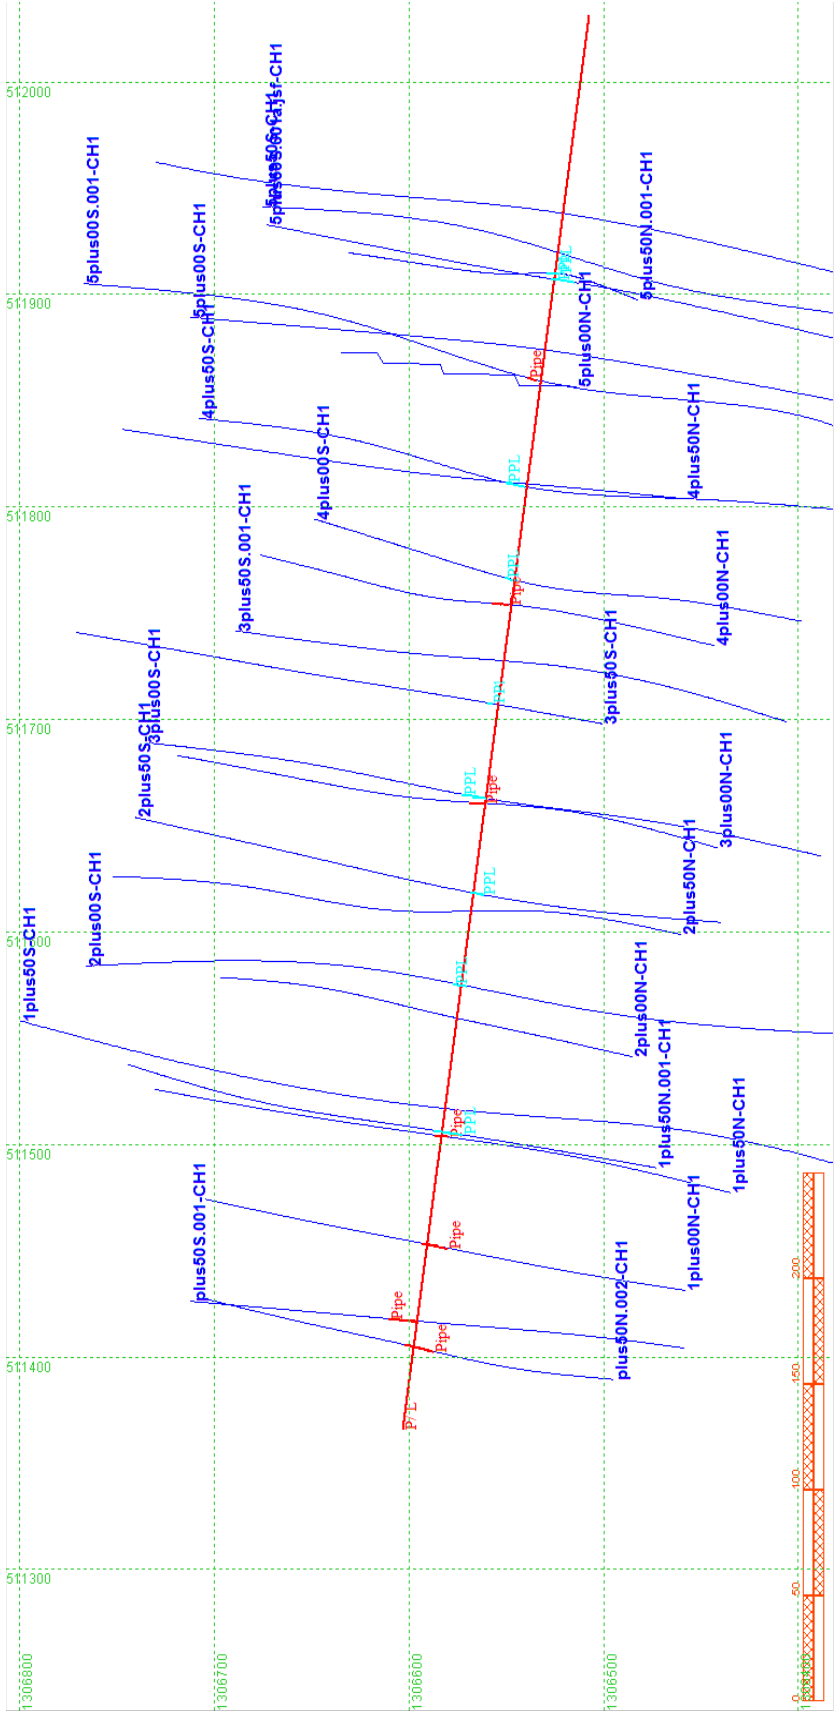
Figure 3. Track Map Survey Lines:

Pipe detections in red, Possible Pipe detections (PPL) in cyan, survey track lines in blue, pre-plot of pipeline (P/L) from the as built drawing is in red. Green grid is FL State Plane West Zone, U.S Feet, NAD83.

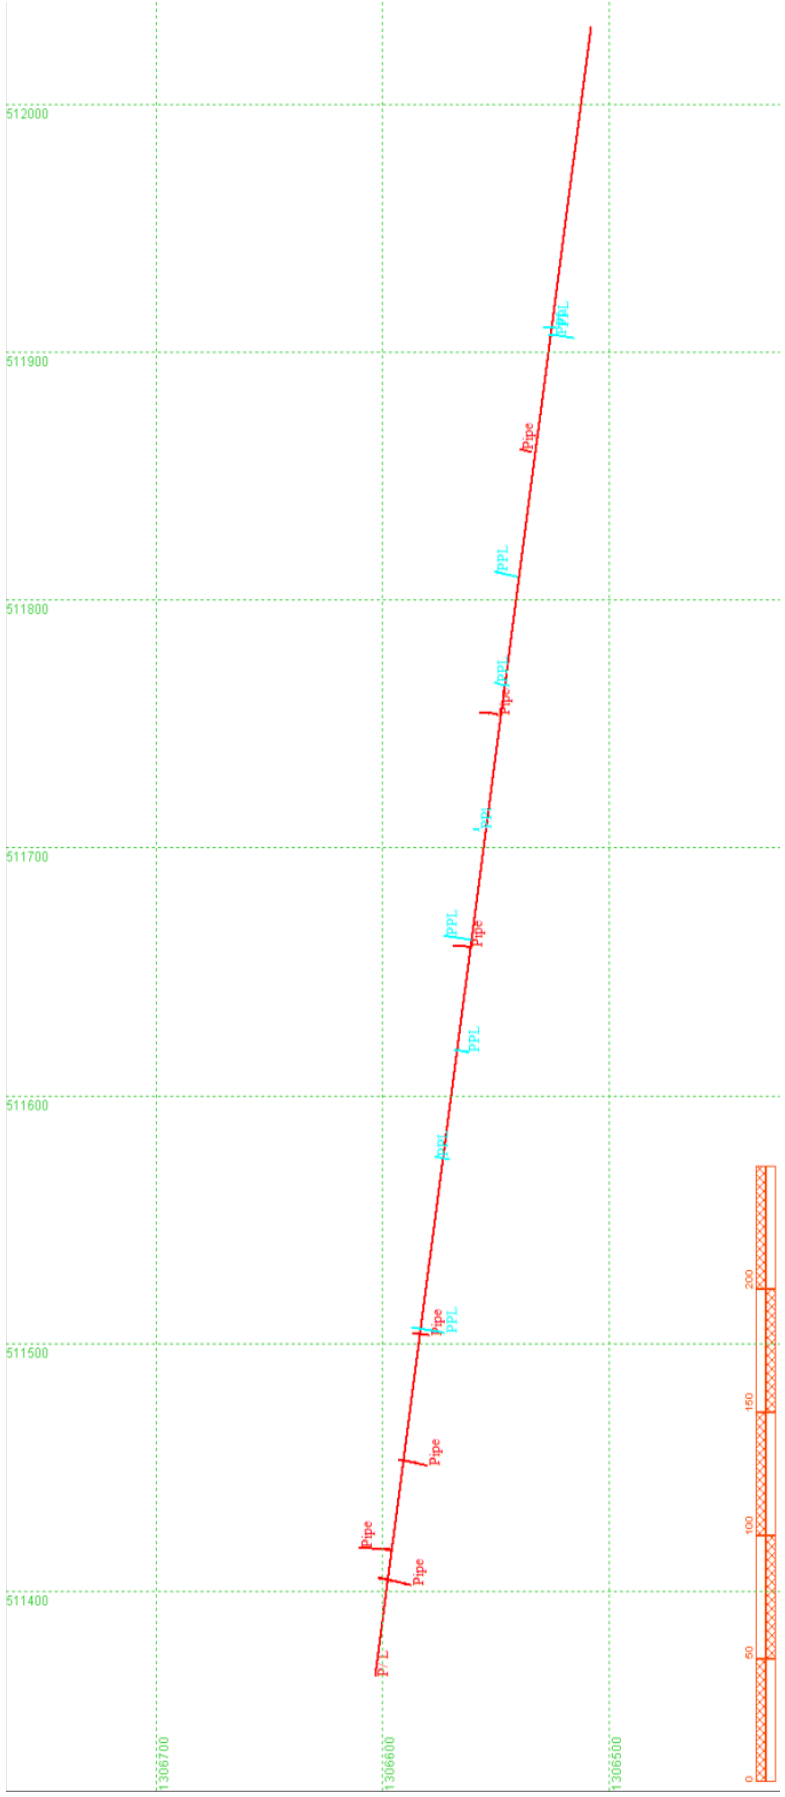
Figure 4. Pipe and Possible Pipeline detections:

Pipe detections in red, Possible pipe detections (PPL) in cyan and pre-plot of pipeline (P/L) from the as built drawing is in red. Green grid is FL State Plane West Zone, U.S Feet, NAD83.
