MAJOR ROADWAY PROJECT

PRELIMINARY ENGINEERING REPORT

**W COLUMBUS DR. / E COLUMBUS DR.
FROM DALE MABRY HWY TO N 13TH ST**

CIP No. 69631.105

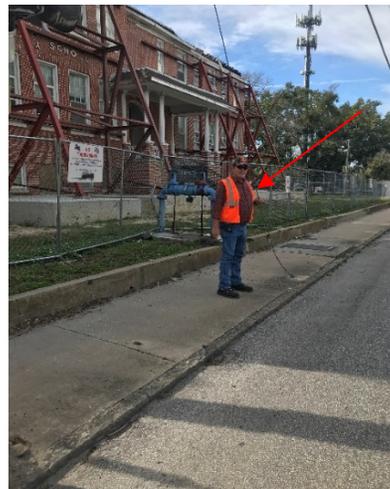
- a. Evaluate safety hazard for the items listed below and provide recommendations.
 - i. The location of guy wires within the sidewalk is creating a safety hazard for the pedestrians.

Guy wire

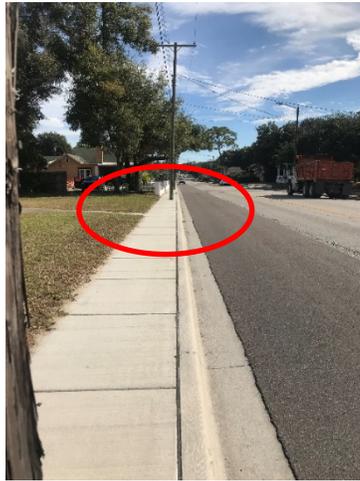
- ii. Poles are located within the sidewalk, some area have as little as 30" in width, which does not meet the minimum 36" at a point for ADA access.

Minimum sidewalk width < 3'

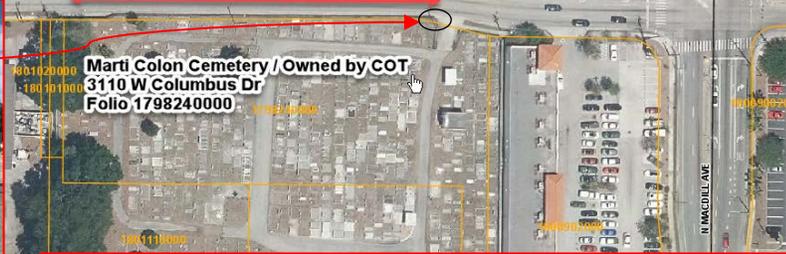
- **Along the Cemetery frontage property:** the sidewalk in front of Marti Colon Cemetery is narrow and unsafe. The cemetery retaining wall (+/- 350') is located within the sidewalk path and have less than 30" in width, which does not meet the minimum 36". Based on the Hillsborough County GIS data, the headwall appears to be on County Right-of-way. Coordinate with the COT to provide option for a safer passage. Following are possible options to considered:
 - i. Allow pedestrian and bicycle to walk and ride along the cemetery pathway (coordination with the cemetery will be required)
 - ii. Reduce lane width to provide wider sidewalk; proper transition must be provided.
 - iii. Provide pedestrian crossing before and after the cemetery.

Sidewalk width along the cemetery wall - 1'10"

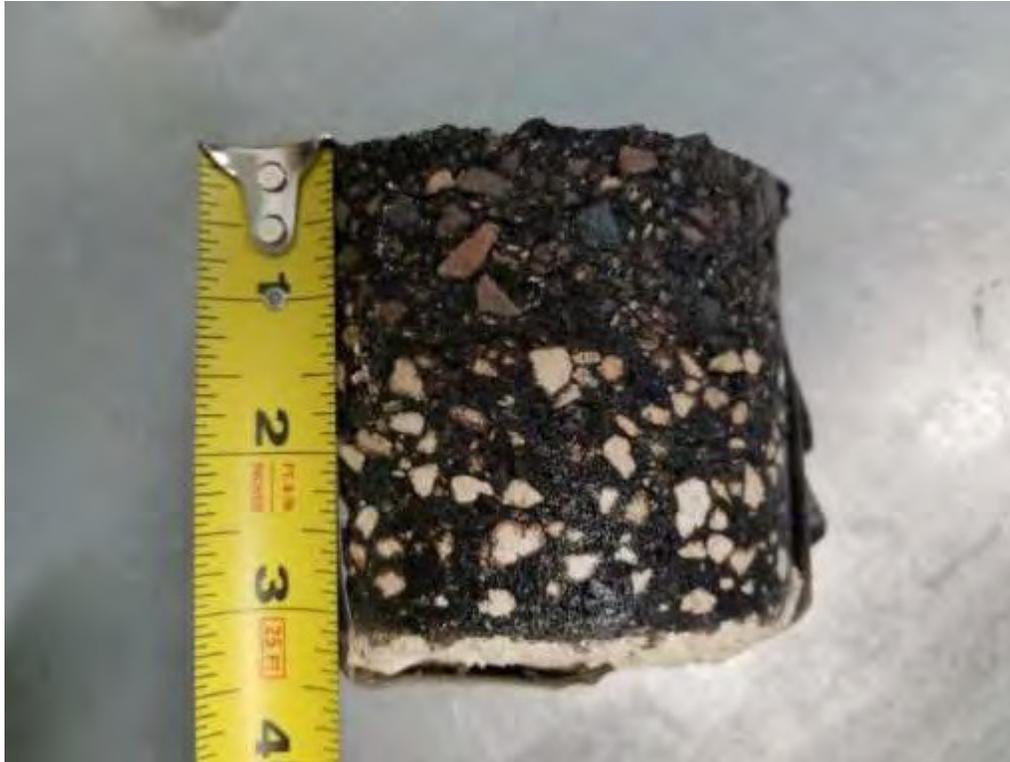
PROJECT NAME:	<u>HC Major Roads FY19</u>	CORE ID:	<u>C-01</u>
PROJECT NO.:	<u>T051812.101</u>	STREET:	<u>W. Columbus Drive</u>
CLIENT:	<u>HC Public Works</u>	LANE:	<u>Outside EB Lane</u>
DATE PERFORMED:	<u>7/25/18</u>	LOCATION:	<u>Approx. 310-ft. E of Dale Mabry Hwy.</u>

Layer Depth (in)		Thickness (in)	Description
From	To		
0	3	3	Asphalt
3	12	9	LIMEROCK Base
12	36	24	Silty, clayey SAND (A-2-4)
36	54	30	SAND with silt (A-3)

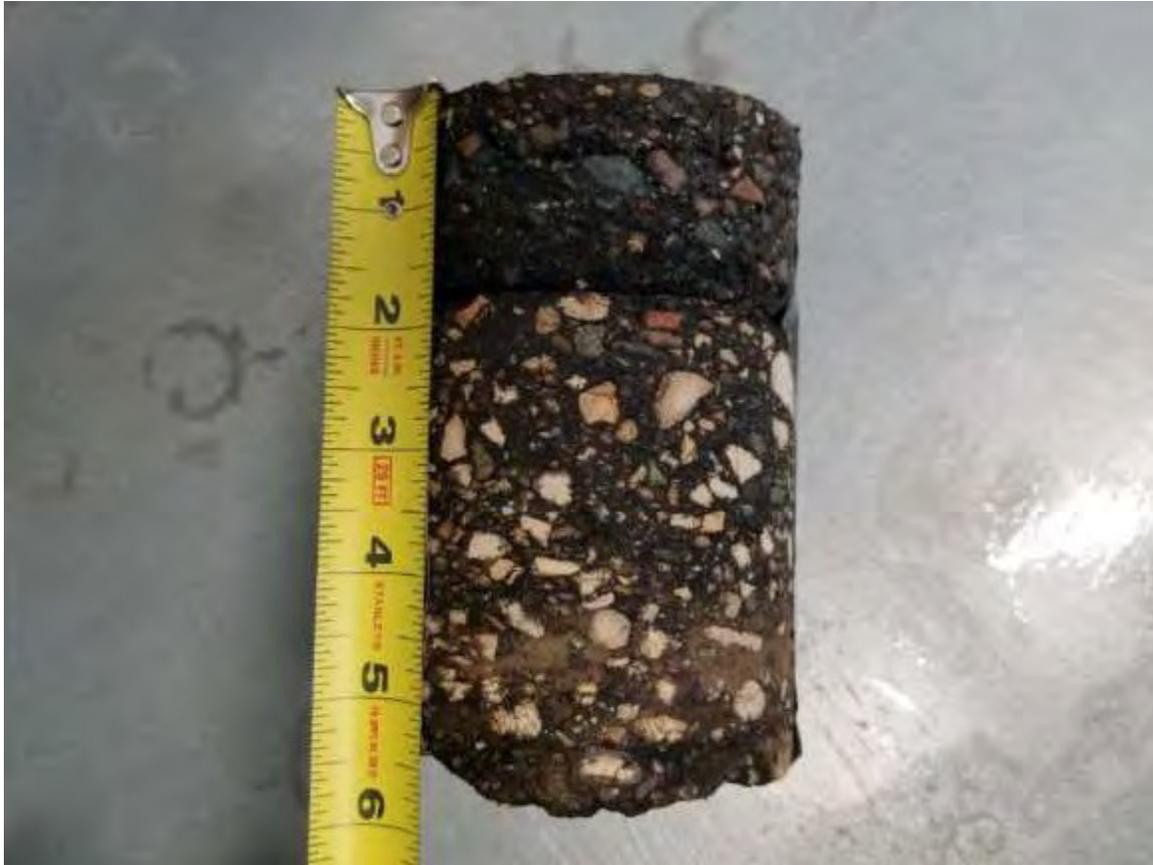
PROJECT NAME:	<u>HC Major Roads FY19</u>	CORE ID:	<u>C-02</u>
PROJECT NO.:	<u>T051812.101</u>	STREET:	<u>W. Columbus Drive</u>
CLIENT:	<u>HC Public Works</u>	LANE:	<u>Outside WB Lane</u>
DATE PERFORMED:	<u>7/25/18</u>	LOCATION:	<u>Approx. 300-ft. W of N. Himes Ave.</u>

Layer Depth (in)		Thickness (in)	Description
From	To		
0	10	10	Asphalt (bottom crumbled apart)
10	18	8	Silty, clayey SAND (A-2-4)
18	60	42	SAND with silt (A-3)

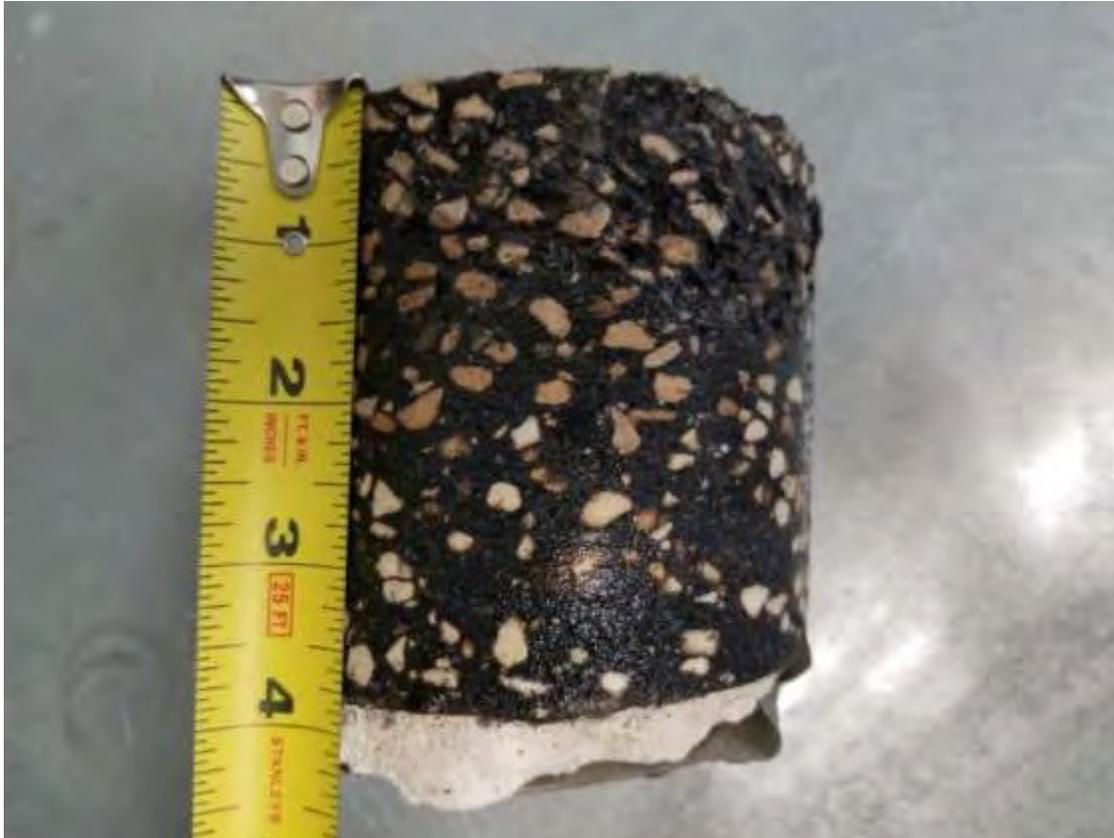
PROJECT NAME:	<u>HC Major Roads FY19</u>	CORE ID:	<u>C-03</u>
PROJECT NO.:	<u>T051812.101</u>	STREET:	<u>W. Columbus Drive</u>
CLIENT:	<u>HC Public Works</u>	LANE:	<u>Outside EB Lane</u>
DATE PERFORMED:	<u>7/25/18</u>	LOCATION:	<u>Approx. 80-ft. E of N. Glen Ave.</u>

Layer Depth (in)		Thickness (in)	Description
From	To		
0	3 ¾	3 ¾	Asphalt
3 ¾	12	8 ¼	LIMEROCK Base
12	60	48	SAND with silt (A-3)

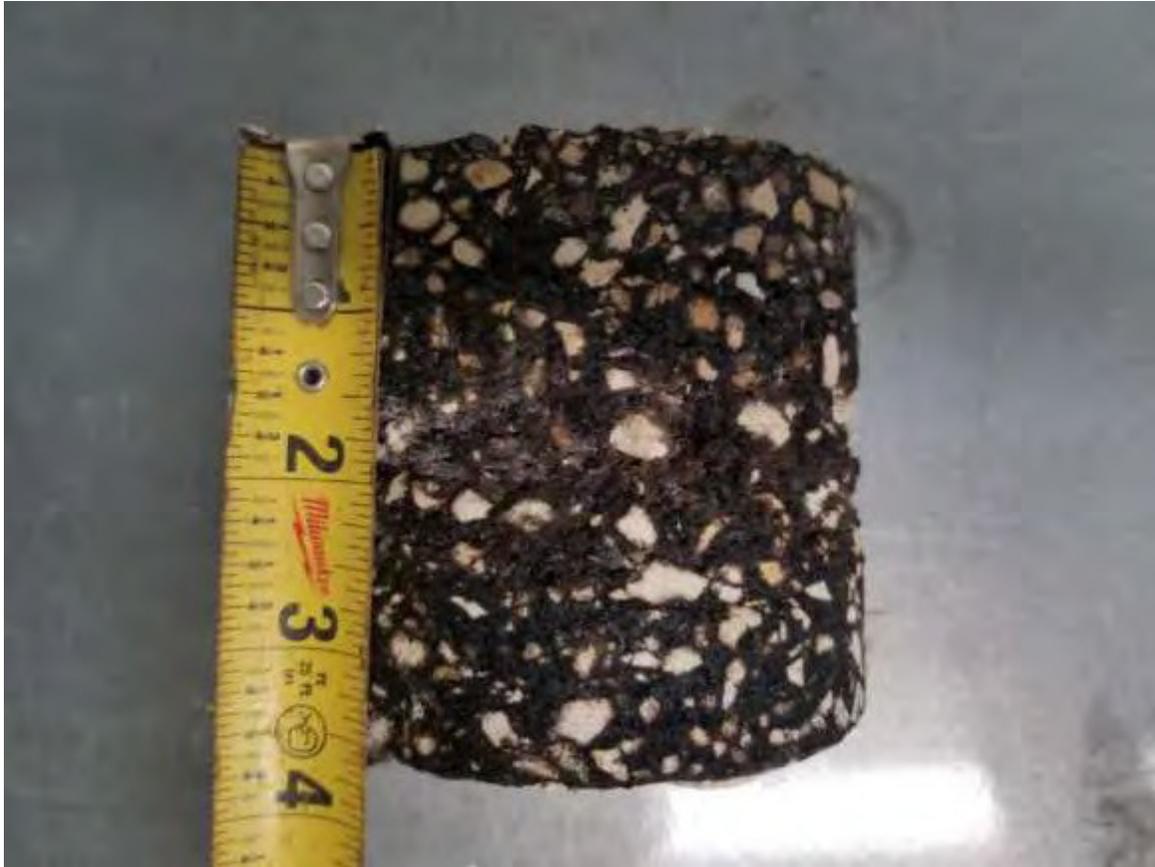
PROJECT NAME:	<u>HC Major Roads FY19</u>	CORE ID:	<u>C-04</u>
PROJECT NO.:	<u>T051812.101</u>	STREET:	<u>W. Columbus Drive</u>
CLIENT:	<u>HC Public Works</u>	LANE:	<u>Outside WB Lane</u>
DATE PERFORMED:	<u>7/20/18</u>	LOCATION:	<u>Approx. 90-ft. W of N. St. Vincent St.</u>

Layer Depth (in)		Thickness (in)	Description
From	To		
0	3 ½	3 ½	Asphalt
3 ½	14	10 ½	LIMEROCK Base
14	60	46	SAND with silt (A-3)

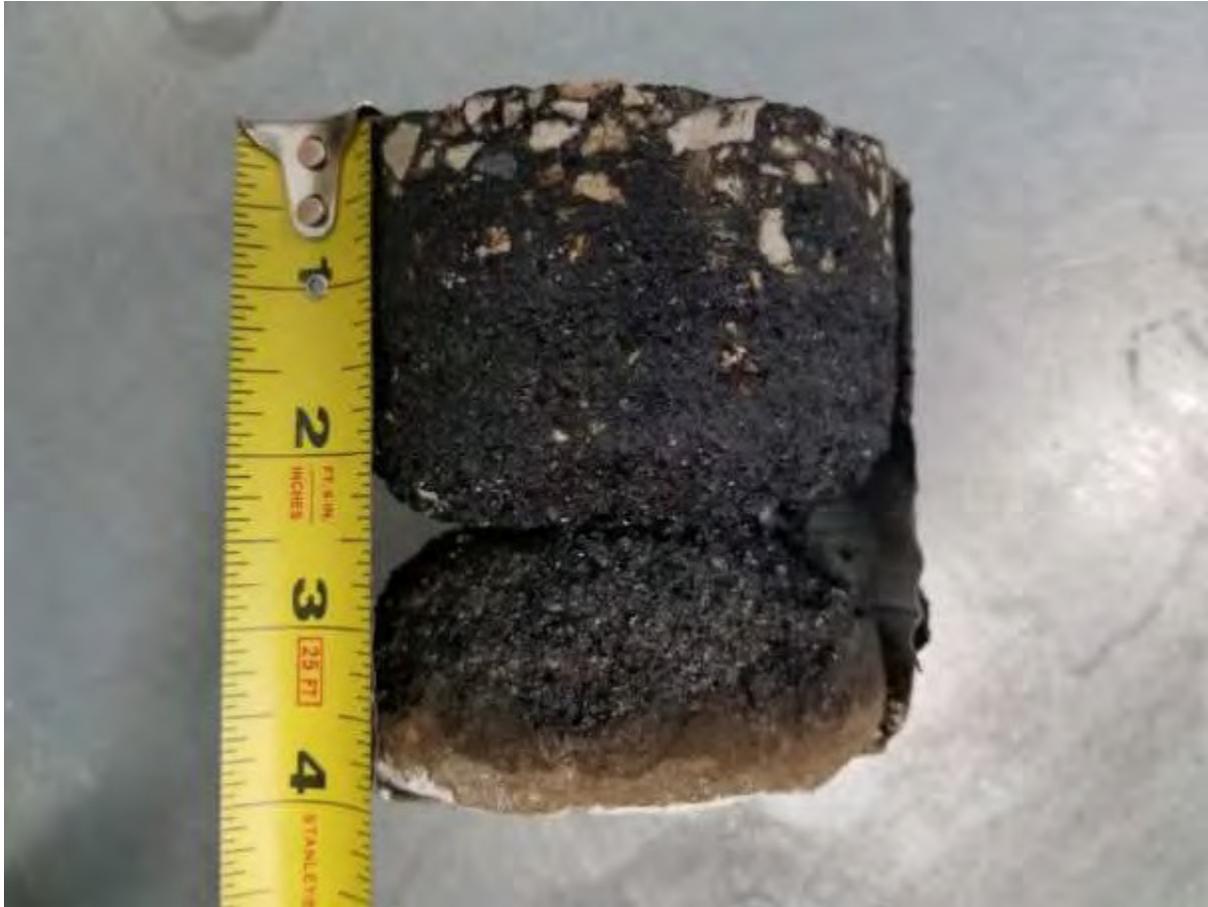
PROJECT NAME:	<u>HC Major Roads FY19</u>	CORE ID:	<u>C-05</u>
PROJECT NO.:	<u>T051812.101</u>	STREET:	<u>W. Columbus Drive</u>
CLIENT:	<u>HC Public Works</u>	LANE:	<u>Outside EB Lane</u>
DATE PERFORMED:	<u>7/25/18</u>	LOCATION:	<u>Approx. 180-ft. E of N. MacDill</u>

Layer Depth (in)		Thickness (in)	Description
From	To		
0	3 ¾	3 ¾	Asphalt (pavement degradation)
3 ¾	12	8 ¾	LIMEROCK Base
12	60	48	SAND with silt (A-3)

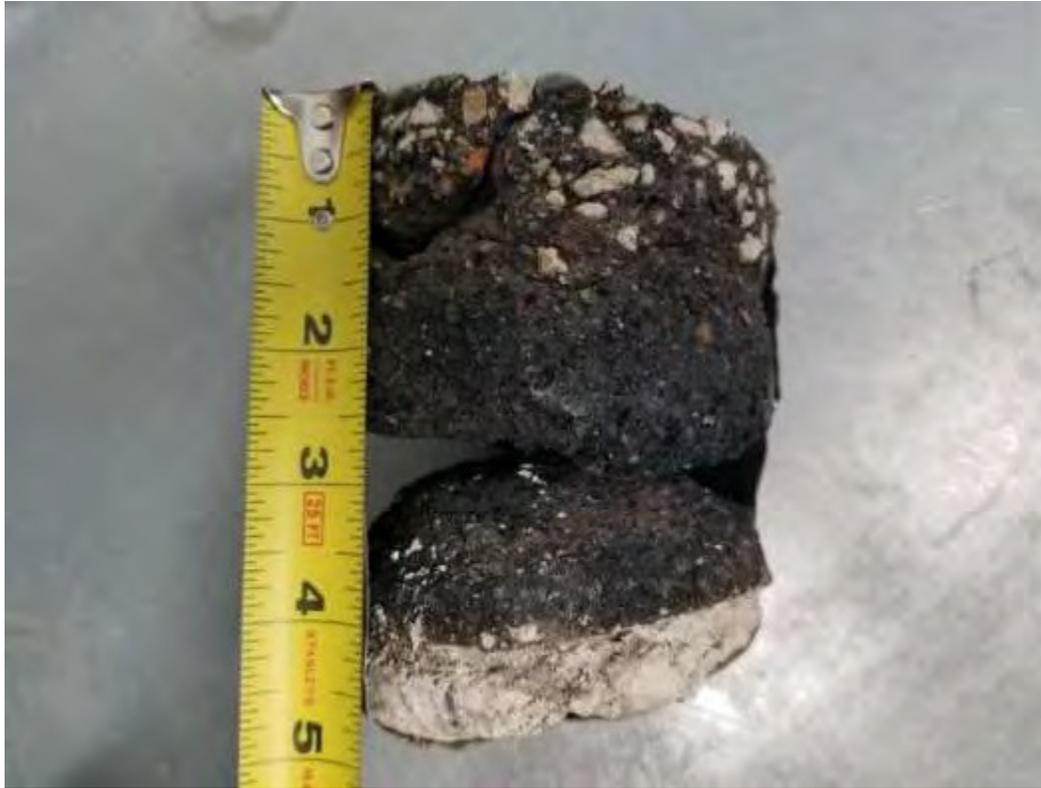
PROJECT NAME:	<u>HC Major Roads FY19</u>	CORE ID:	<u>C-06</u>
PROJECT NO.:	<u>T051812.101</u>	STREET:	<u>W. Columbus Drive</u>
CLIENT:	<u>HC Public Works</u>	LANE:	<u>Outside EB Lane</u>
DATE PERFORMED:	<u>7/25/18</u>	LOCATION:	<u>Approx. 270-ft. W of N. Habana Ave.</u>

Layer Depth (in)		Thickness (in)	Description
From	To		
0	3 ½	3 ½	Asphalt (cracked; pavement degradation)
3 ½	13	9 ½	LIMEROCK Base
13	36	23	SAND with silt (A-3)
36	60	24	Silty, clayey SAND (A-2-4)

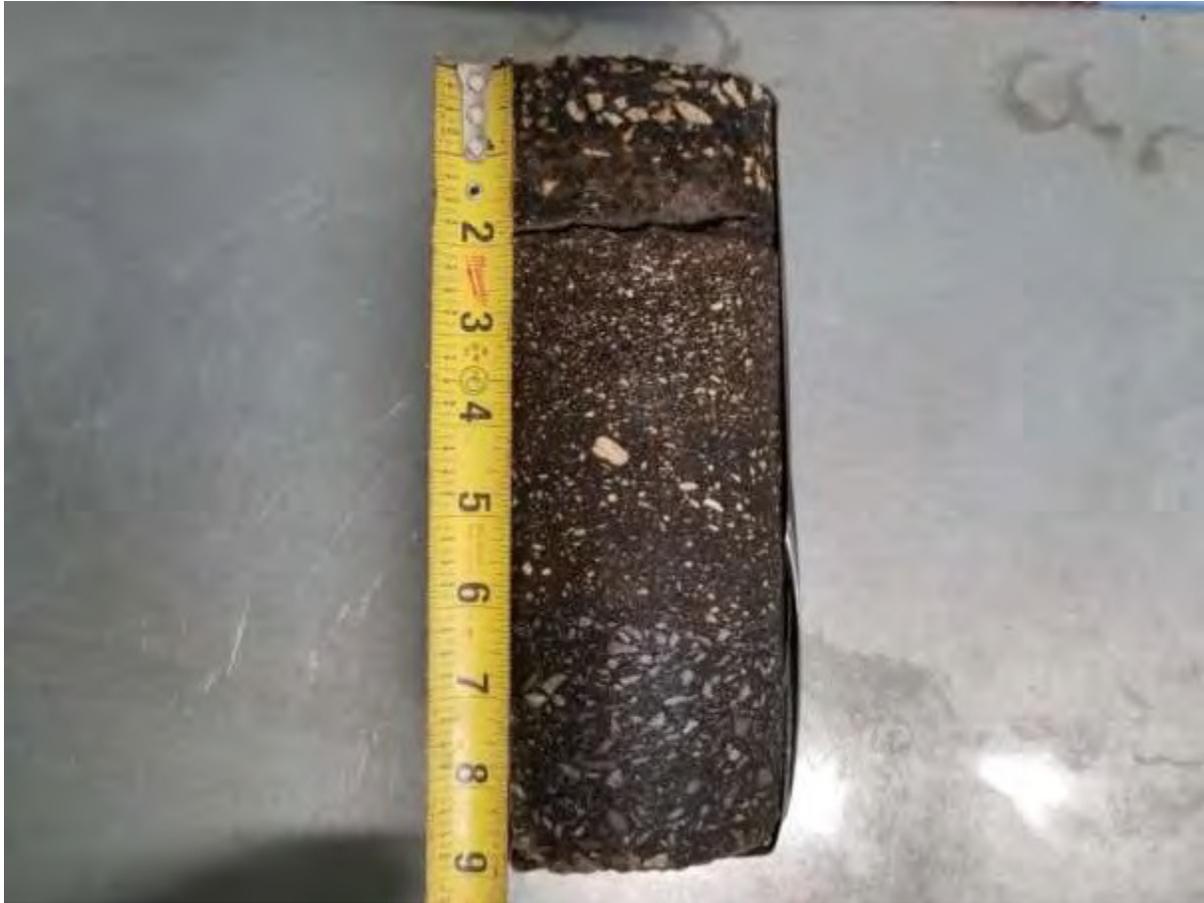
PROJECT NAME: HC Major Roads FY19 CORE ID: C-07
 PROJECT NO.: T051812.101 STREET: W. Columbus Drive
 CLIENT: HC Public Works LANE: Outside WB Lane
 DATE PERFORMED: 7/20/18 LOCATION: Approx. 20-ft. E of N. Tampania Ave.

Layer Depth (in)		Thickness (in)	Description
From	To		
0	9	9	Asphalt
9	12	3	Shell Base
12	60	48	SAND with silt (A-3)

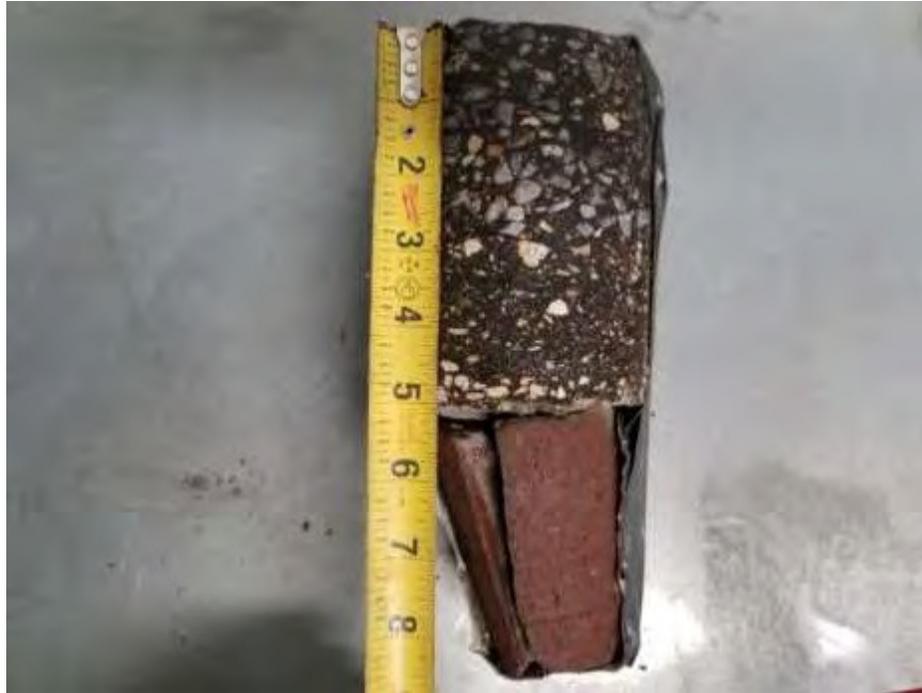
PROJECT NAME:	<u>HC Major Roads FY19</u>	CORE ID:	<u>C-08</u>
PROJECT NO.:	<u>T051812.101</u>	STREET:	<u>W. Columbus Drive</u>
CLIENT:	<u>HC Public Works</u>	LANE:	<u>Outside EB Lane</u>
DATE PERFORMED:	<u>7/20/18</u>	LOCATION:	<u>Approx. 120-ft. E of N. Howard Ave.</u>

Layer Depth (in)		Thickness (in)	Description
From	To		
0	5	5	Asphalt
5	8 ½	3 ½	Paver
8 ½	18	9 ½	SAND with silt (A-3) and shell fragments
18	42	24	Silty, clayey SAND (A-2-4) with shell fragments
42	54	12	CLAY (A-7)
54	60	6	SAND with silt (A-3)

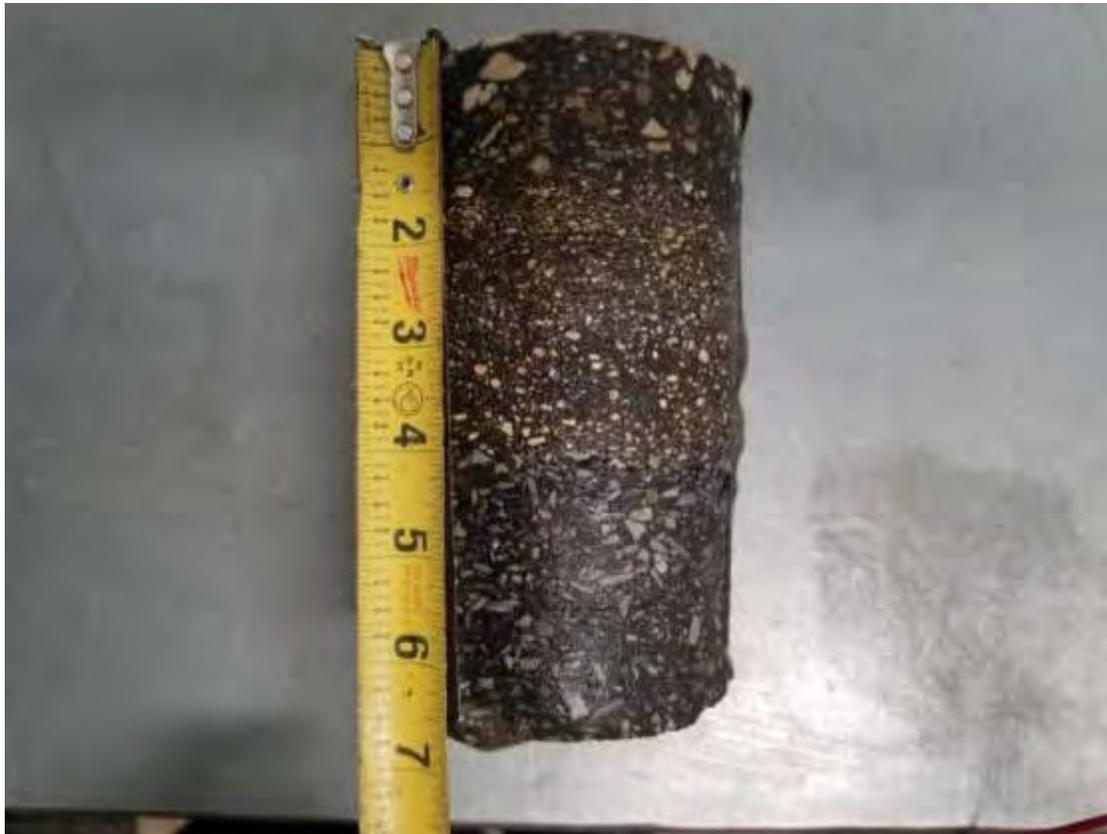
PROJECT NAME:	<u>HC Major Roads FY19</u>	CORE ID:	<u>C-09</u>
PROJECT NO.:	<u>T051812.101</u>	STREET:	<u>W. Columbus Drive</u>
CLIENT:	<u>HC Public Works</u>	LANE:	<u>Outside EB Lane</u>
DATE PERFORMED:	<u>7/20/18</u>	LOCATION:	<u>Approx. 210-ft. W of N. Fremont Ave.</u>

Layer Depth (in)		Thickness (in)	Description
From	To		
0	6 ½	6 ½	Asphalt
6 ½	12	5 ½	SAND with silt (A-3) with shell fragments
12	60	48	SAND with silt (A-3)

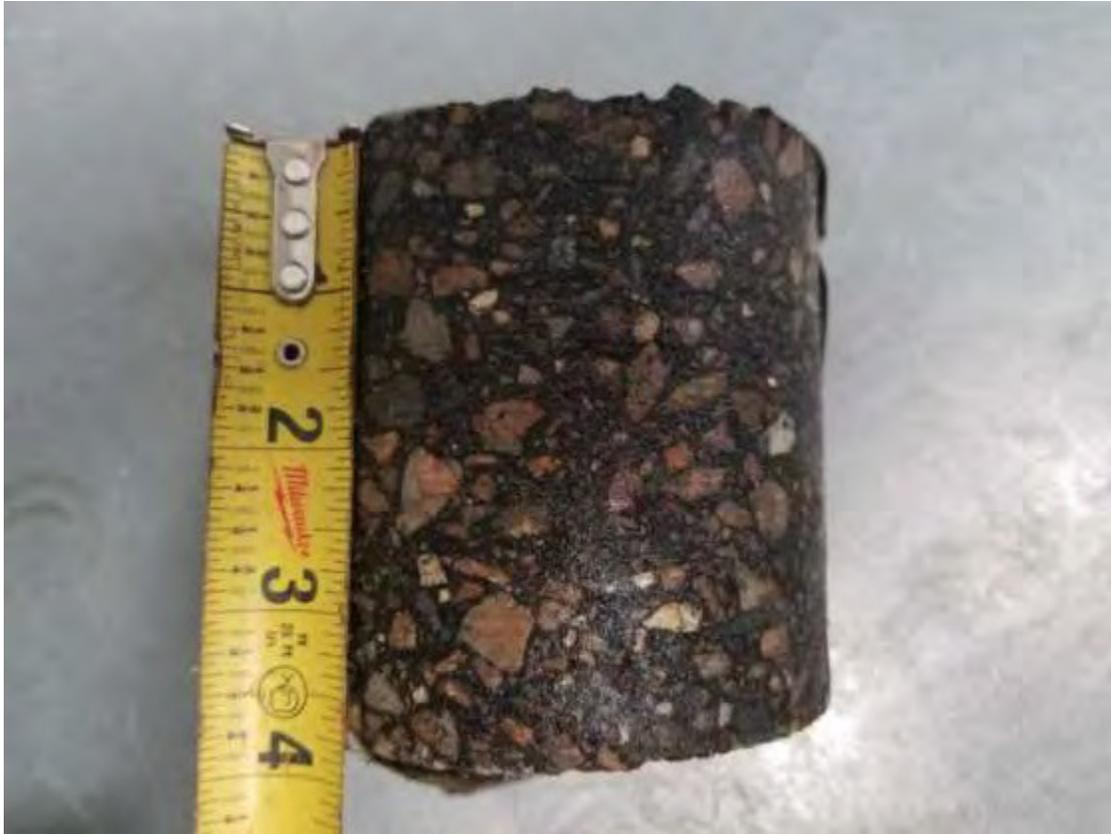
PROJECT NAME:	<u>HC Major Roads FY19</u>	CORE ID:	<u>C-10</u>
PROJECT NO.:	<u>T051812.101</u>	STREET:	<u>W. Columbus Drive</u>
CLIENT:	<u>HC Public Works</u>	LANE:	<u>Outside WB Lane</u>
DATE PERFORMED:	<u>7/20/18</u>	LOCATION:	<u>Approx. 80-ft. E of N Riverside Dr.</u>

Layer Depth (in)		Thickness (in)	Description
From	To		
0	4	4	Asphalt
4	6	2	SAND with silt (A-3) with shell and brick fragments
6	60	54	SAND with silt (A-3)

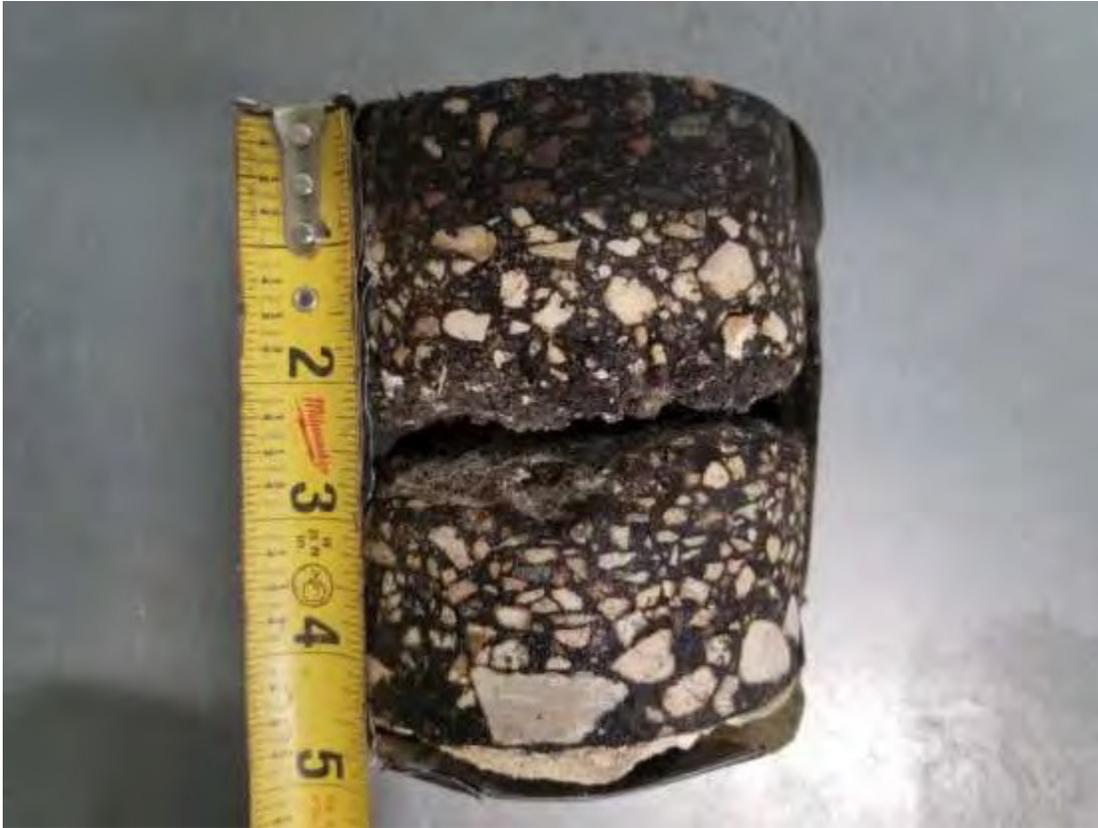
PROJECT NAME:	<u>HC Major Roads FY19</u>	CORE ID:	<u>C-11</u>
PROJECT NO.:	<u>T051812.101</u>	STREET:	<u>W. Columbus Drive</u>
CLIENT:	<u>HC Public Works</u>	LANE:	<u>Outside EB Lane</u>
DATE PERFORMED:	<u>7/20/18</u>	LOCATION:	<u>Approx. 20-ft. W of Royal Ct.</u>

Layer Depth (in)		Thickness (in)	Description
From	To		
0	4 ½	4 ½	Asphalt
4 ½	14	9 ½	LIMEROCK Base
14	30	16	Silty, clayey SAND (A-2-4)
30	60	30	SAND with silt (A-3)

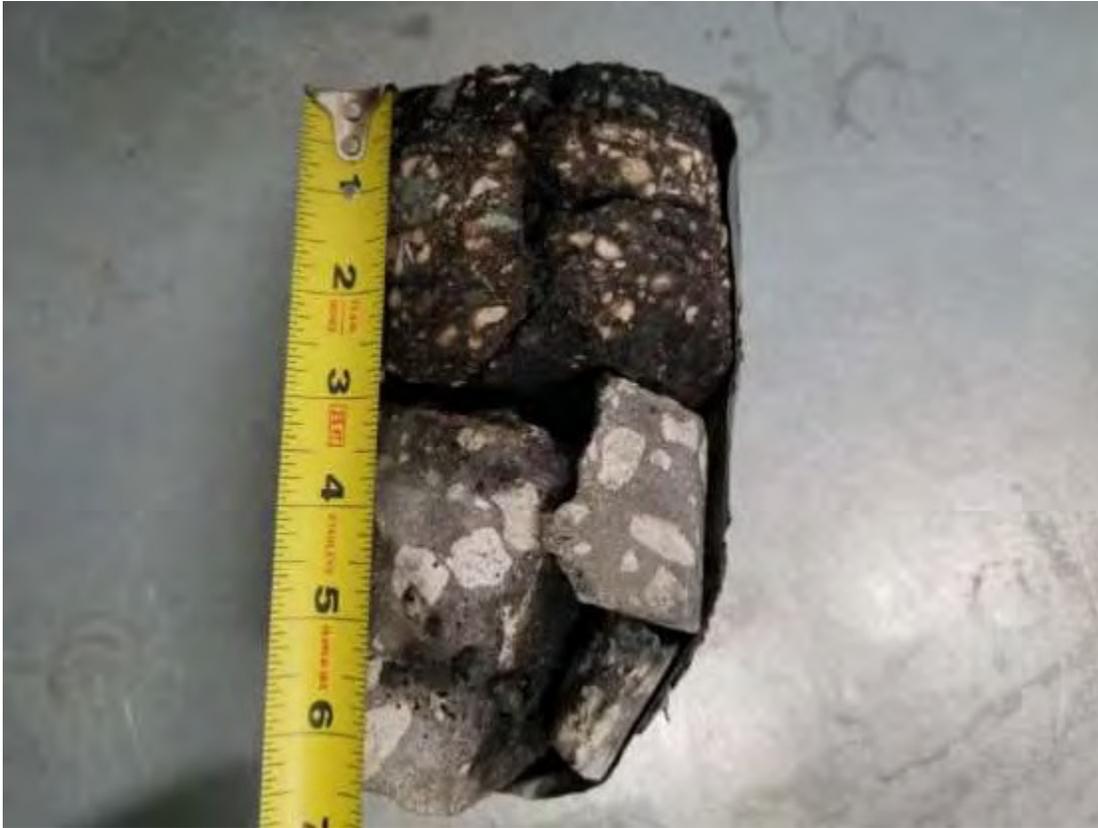
PROJECT NAME:	<u>HC Major Roads FY19</u>	CORE ID:	<u>C-12</u>
PROJECT NO.:	<u>T051812.101</u>	STREET:	<u>W. Columbus Drive</u>
CLIENT:	<u>HC Public Works</u>	LANE:	<u>WB Through Lane</u>
DATE PERFORMED:	<u>7/26/18</u>	LOCATION:	<u>Approx. 110-ft. E of North Blvd.</u>

Layer Depth (in)		Thickness (in)	Description
From	To		
0	3	3	Asphalt (cracked through)
3	7	4	Concrete (cracked through)
7	15 ½	8 ½	LIMEROCK Base
15 ½	60	44 ½	SAND with silt (A-3)

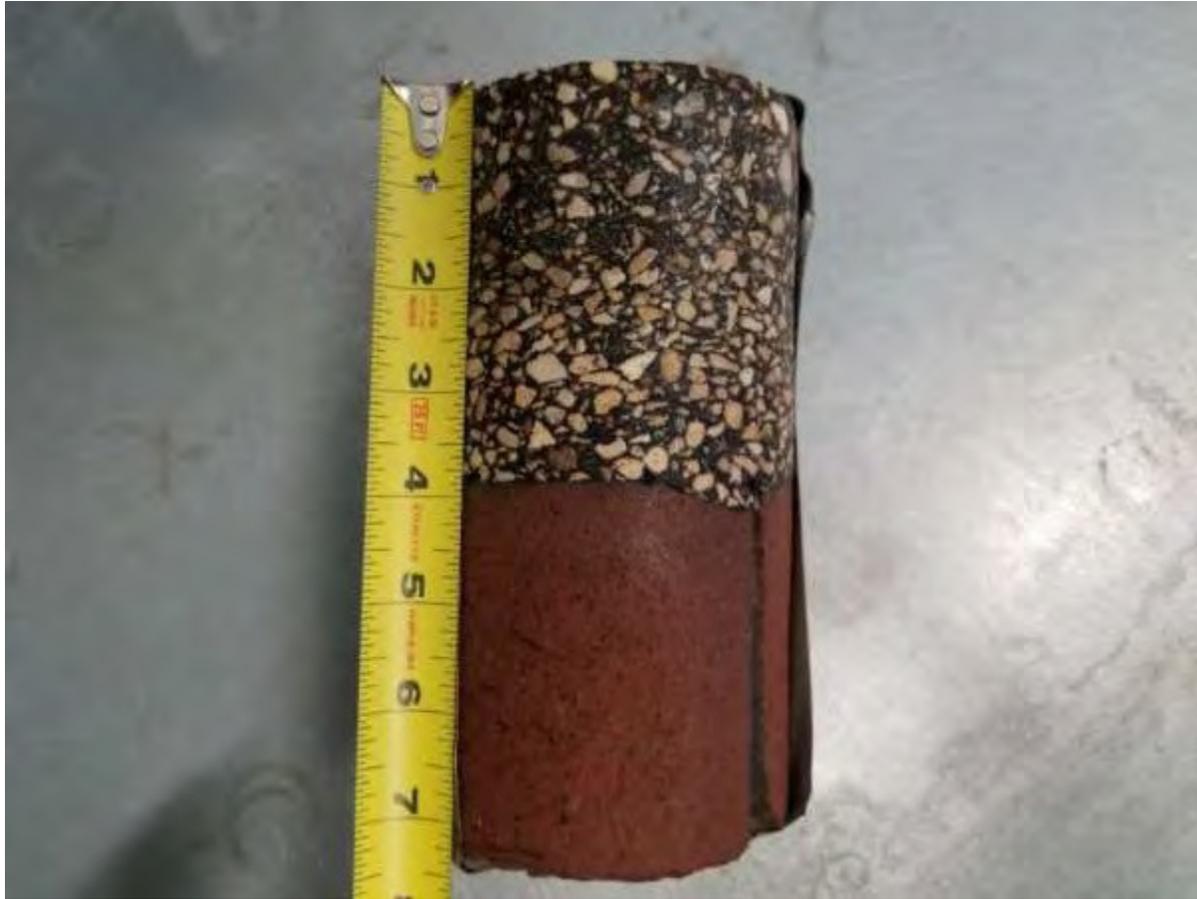
PROJECT NAME:	<u>HC Major Roads FY19</u>	CORE ID:	<u>C-13</u>
PROJECT NO.:	<u>T051812.101</u>	STREET:	<u>W. Columbus Drive</u>
CLIENT:	<u>HC Public Works</u>	LANE:	<u>EB Lane</u>
DATE PERFORMED:	<u>7/26/18</u>	LOCATION:	<u>Approx. 170-ft. of Nevada Ave.</u>

Layer Depth (in)		Thickness (in)	Description
From	To		
0	4	4	Asphalt
4	7 ½	3 ½	Paver
7 ½	60	52 ½	SAND with silt (A-3)

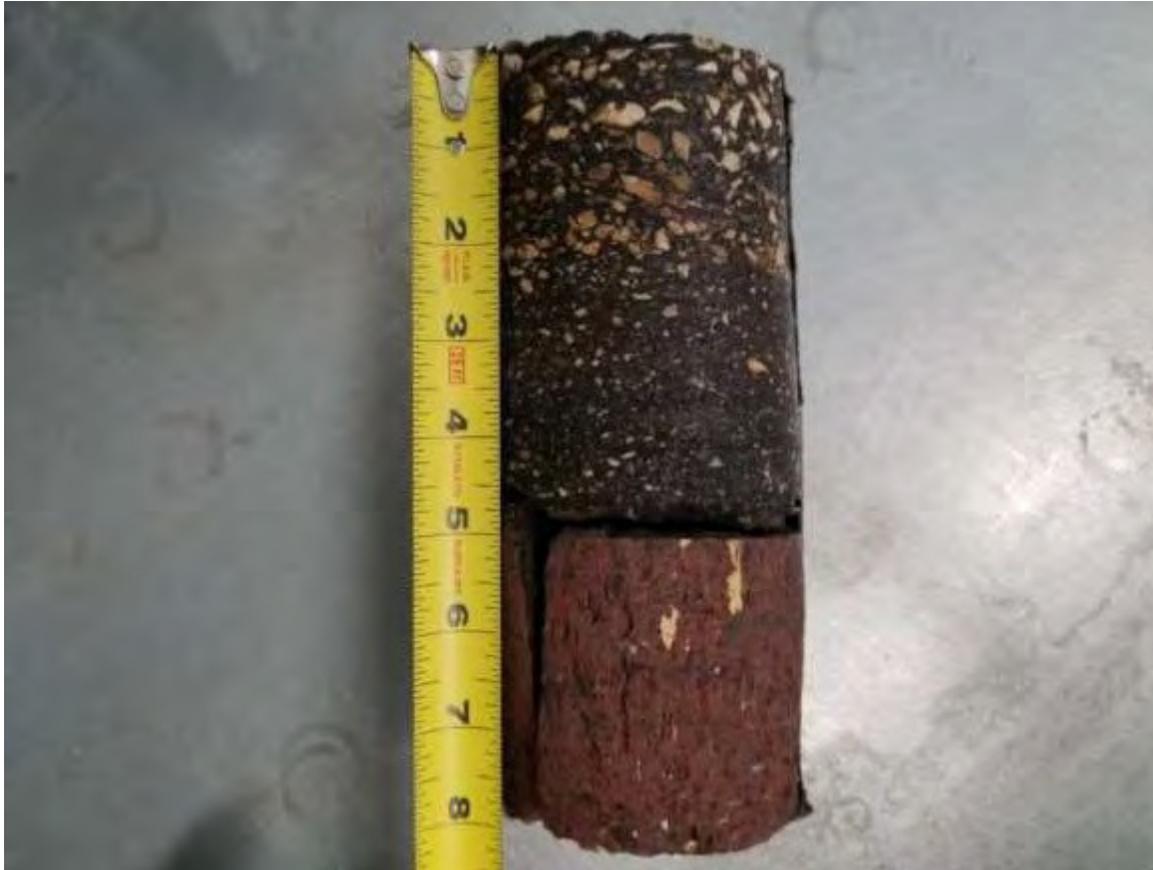
PROJECT NAME:	<u>HC Major Roads FY19</u>	CORE ID:	<u>C-14</u>
PROJECT NO.:	<u>T051812.101</u>	STREET:	<u>W. Columbus Drive</u>
CLIENT:	<u>HC Public Works</u>	LANE:	<u>WB Lane</u>
DATE PERFORMED:	<u>7/24/18</u>	LOCATION:	<u>Approx. 210-ft. E of N. Highland Ave.</u>

Layer Depth (in)		Thickness (in)	Description
From	To		
0	5	5	Asphalt
5	8	3	Paver
8	60	52	SAND with silt (A-3)

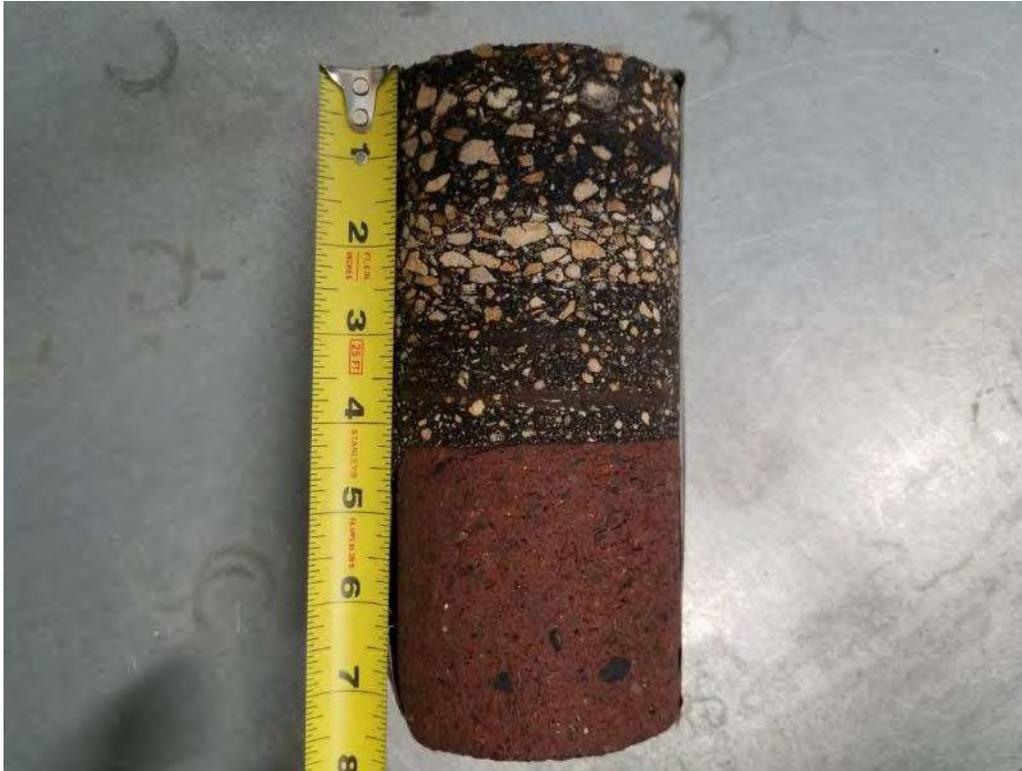
PROJECT NAME:	<u>HC Major Roads FY19</u>	CORE ID:	<u>C-15</u>
PROJECT NO.:	<u>T051812.101</u>	STREET:	<u>W. Columbus Drive</u>
CLIENT:	<u>HC Public Works</u>	LANE:	<u>EB Lane</u>
DATE PERFORMED:	<u>7/24/18</u>	LOCATION:	<u>Approx. 150-ft. E of N. Florida Ave.</u>

Layer Depth (in)		Thickness (in)	Description
From	To		
0	4 ¼	4 ¼	Asphalt
4 ¼	7 ½	3 ¼	Paver
7 ½	60	52 ½	SAND with silt (A-3)

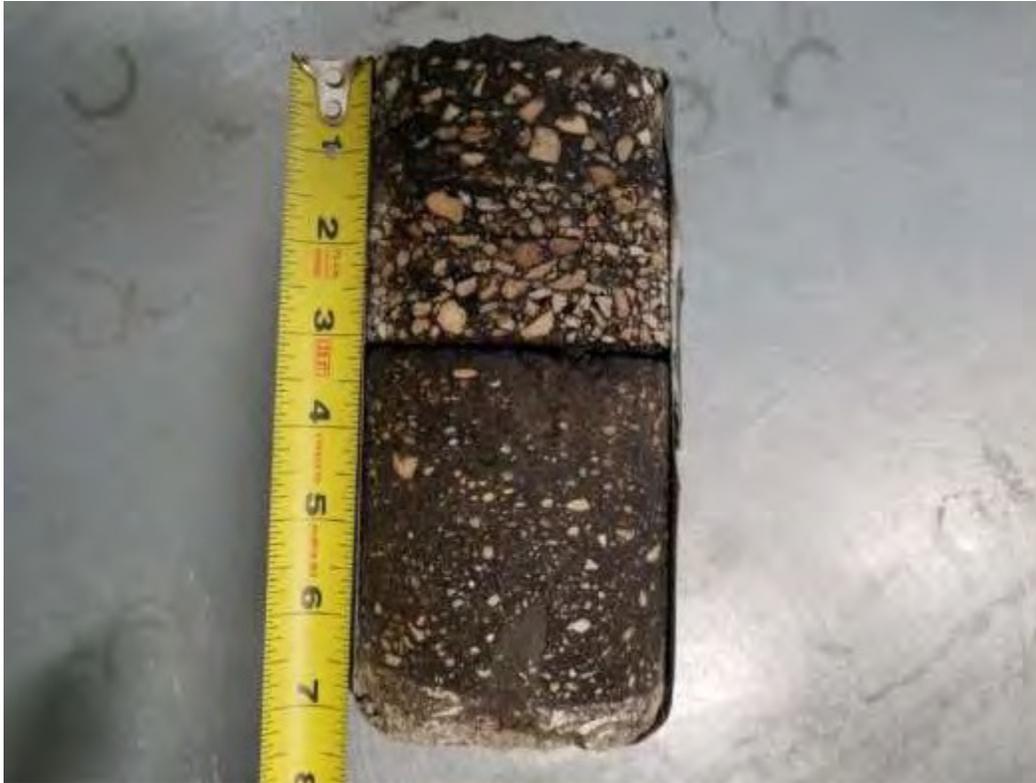
PROJECT NAME:	<u>HC Major Roads FY19</u>	CORE ID:	<u>C-16</u>
PROJECT NO.:	<u>T051812.101</u>	STREET:	<u>W. Columbus Drive</u>
CLIENT:	<u>HC Public Works</u>	LANE:	<u>WB Lane</u>
DATE PERFORMED:	<u>7/24/18</u>	LOCATION:	<u>Approx. 180-ft. W of N. Central Ave.</u>

Layer Depth (in)		Thickness (in)	Description
From	To		
0	7	7	Asphalt
7	13	6	Shell Base
13	60	47	SAND with silt (A-3)

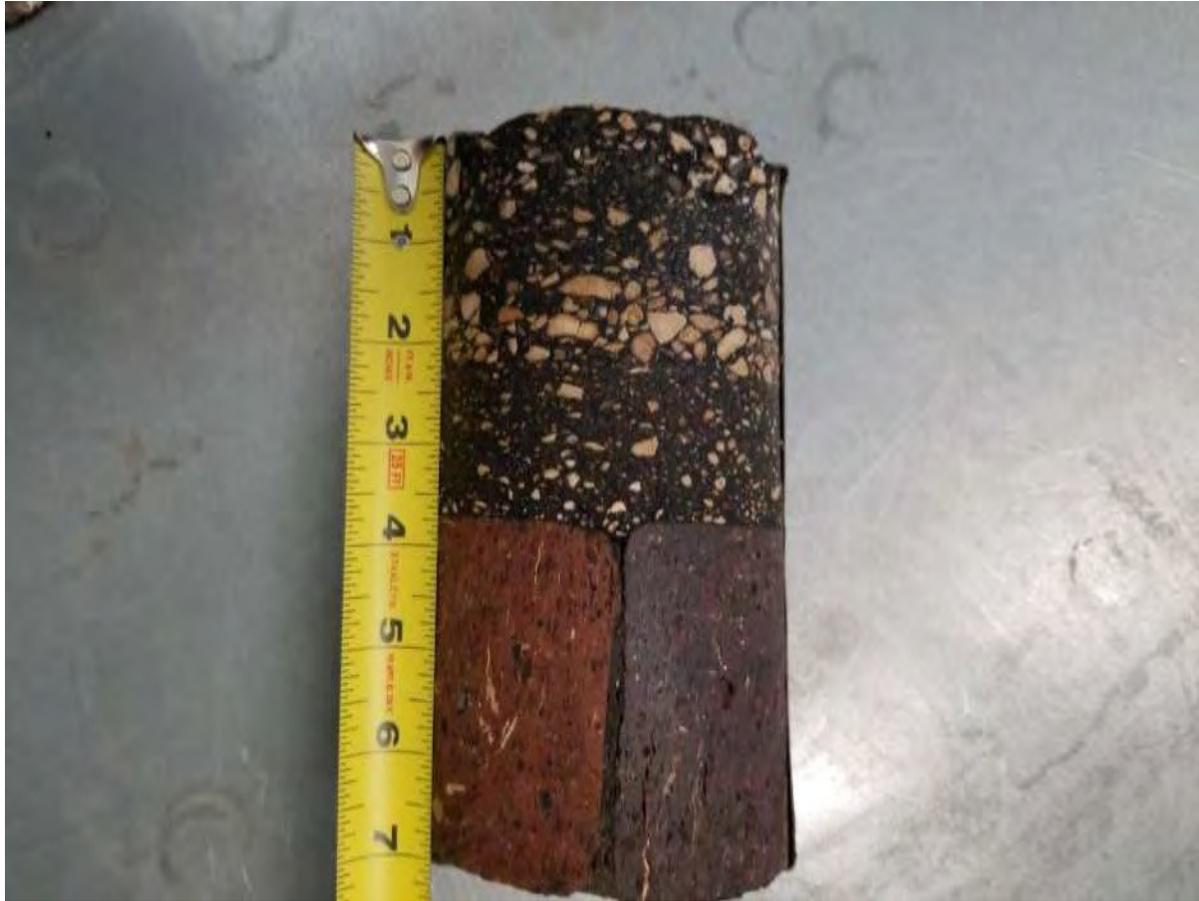
PROJECT NAME: HC Major Roads FY19 CORE ID: C-17
 PROJECT NO.: T051812.101 STREET: W. Columbus Drive
 CLIENT: HC Public Works LANE: EB Lane
 DATE PERFORMED: 7/24/18 LOCATION: Approx. 110-ft. E of N. Taliaferro Ave.

Layer Depth (in)		Thickness (in)	Description
From	To		
0	3 ¾	3 ¾	Asphalt
3 ¾	7	3 ¾	Paver
7	60	53	SAND with silt (A-3)

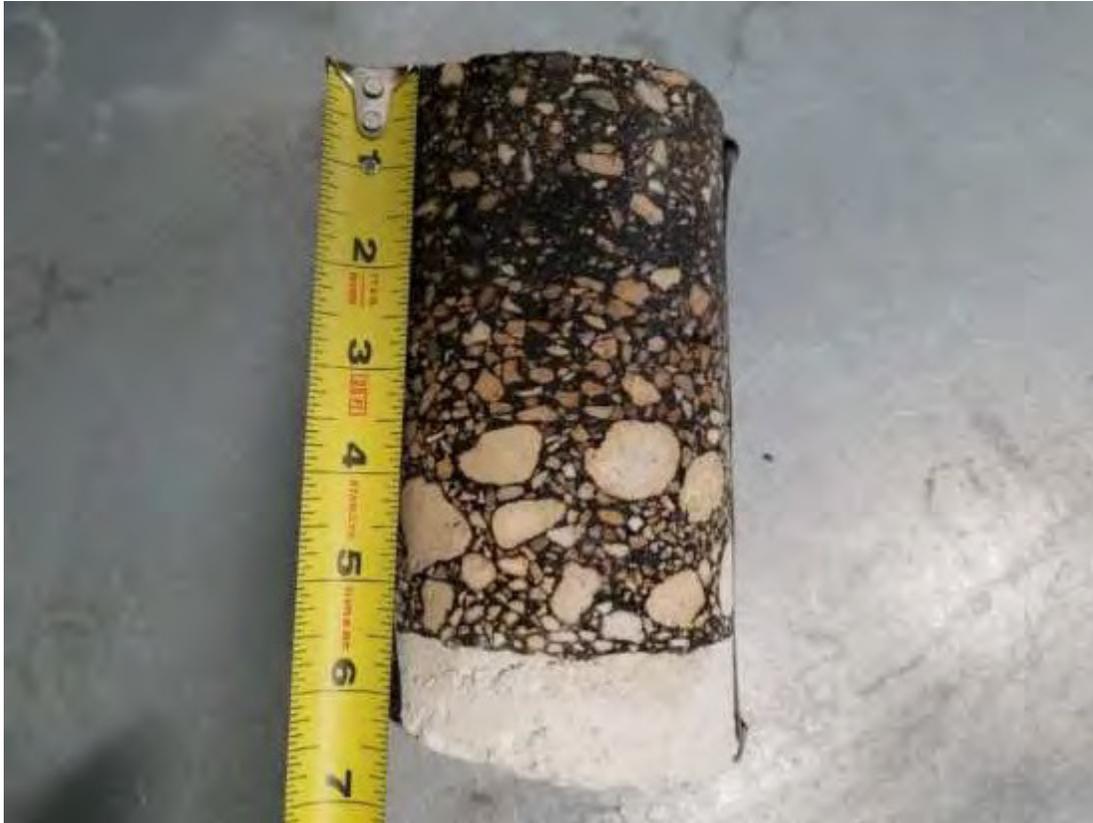
PROJECT NAME:	<u>HC Major Roads FY19</u>	CORE ID:	<u>C-18</u>
PROJECT NO.:	<u>T051812.101</u>	STREET:	<u>W. Columbus Drive</u>
CLIENT:	<u>HC Public Works</u>	LANE:	<u>WB Lane</u>
DATE PERFORMED:	<u>7/24/18</u>	LOCATION:	<u>Approx. 160-ft. W of N. 10th St.</u>

Layer Depth (in)		Thickness (in)	Description
From	To		
0	5 ½	5 ½	Asphalt
5 ½	16	10 ½	LIMEROCK Base
16	60	44	SAND with silt (A-3)

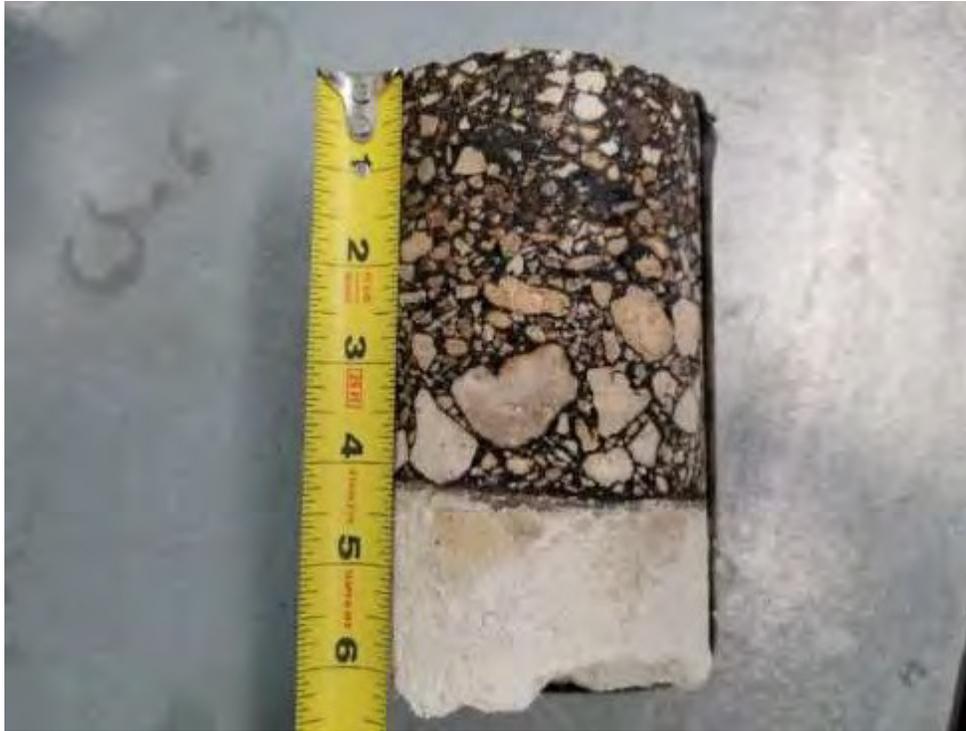
PROJECT NAME:	<u>HC Major Roads FY19</u>	CORE ID:	<u>C-19</u>
PROJECT NO.:	<u>T051812.101</u>	STREET:	<u>W. Columbus Drive</u>
CLIENT:	<u>HC Public Works</u>	LANE:	<u>EB Lane</u>
DATE PERFORMED:	<u>7/24/18</u>	LOCATION:	<u>Approx. 80-ft. E of N. 12th St.</u>

Layer Depth (in)		Thickness (in)	Description
From	To		
0	4 ¼	4 ¼	Asphalt
4 ¼	14	9 ¾	LIMEROCK Base
14	48	34	SAND with silt (A-3)
48	60	12	Clayey SAND (A-2-6)
