TAMPA WATER WORKS

The David L. Tippin Water Treatment Facility Master Plan

July 2018
Volume 1 of 2

DAVID L. TIPPIN WATER TREATMENT FACILITY MASTER PLAN

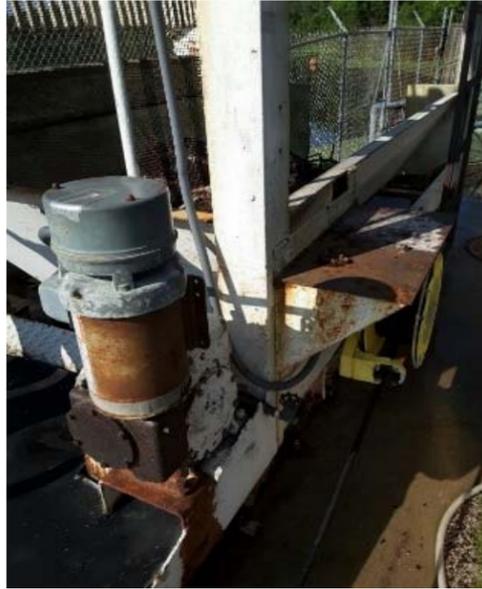
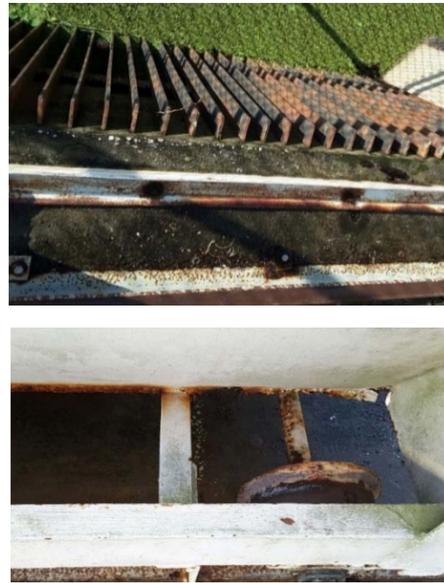
Photo
Left: Grass Rake Hooper and Motor with Corrosion.
Top Right: Intake Bar Rack.
Bottom Right: Grass Rake Guide Rail and Wheels with Corrosion.

The piping and valves associated with Raw Water Pumps No. 1 through 5 are in fair condition, mostly because of age. The lower level pump station tilting disc valves (shown in Figure 2.1) associated with Raw Water Pumps No. 6 through 9 are in poor condition because of limited spare parts availability and age. These valves should be replaced when the pumps are replaced.

The City is ordering parts and scheduling repair of Screens No. 2 and No. 3. City staff recently repaired Screen No. 1. As a result, the 15-year CIP did not include repairs of the screens. However, reevaluating the screens after year 10 is recommended to determine if replacement is required. Figure 2.1 shows the equipment's condition.

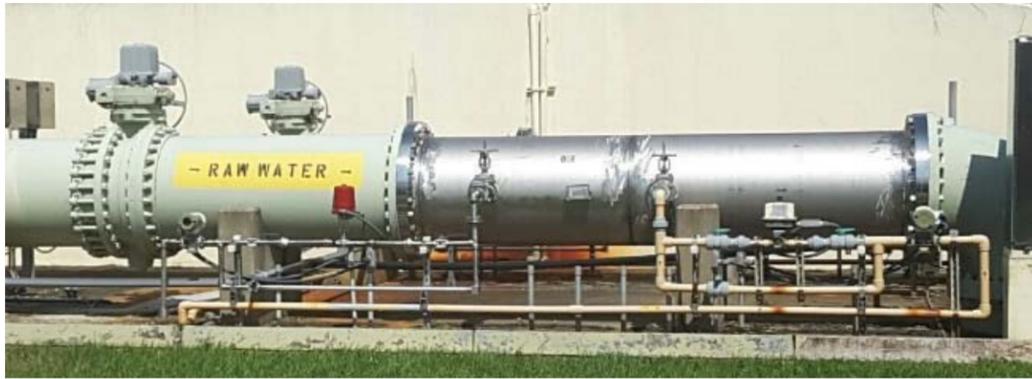
The stainless steel portions of the influent raw water piping just before the Actiflo™ treatment trains are in good condition, and ultrasonic measurements confirmed a consistent thickness of 0.4 inches throughout. However, the interior condition of the ductile iron piping is unknown. Sulfuric acid is dosed in-line, resulting in a pH of approximately 4.5. At times of low alkalinity, the water is aggressive. Thus, investigating the internal condition of this piping is recommended.

Raw water piping prior to Actiflo™ where sulfuric acid and ferric sulfate are dosed.

The carbon steel supports need to be replaced, and a new stainless steel coupling is needed on the pressure relief valve. Torque switch issues were reported due to non-use. The valve actuators on both feed pipes are in good condition. The sulfuric acid and ferric sulfate feed piping and valves are also in good condition. Appendix A includes more information on the scoring and calculated risks for these assets. Figure 2.3 shows a photo of the raw water piping.

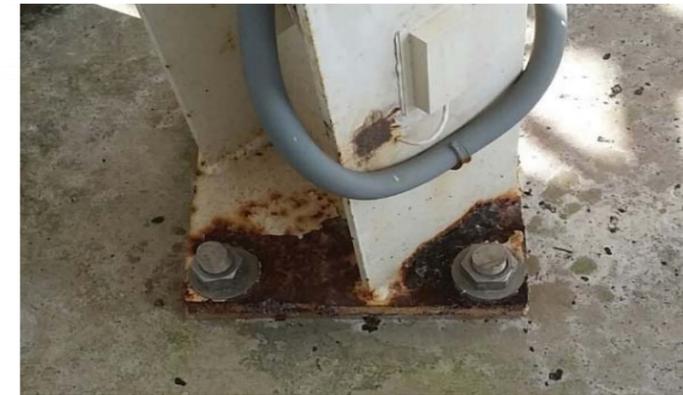
Top: Coating Failure at Structure Base Plate.

Right: Sand Silo Building that houses Silo Tank.

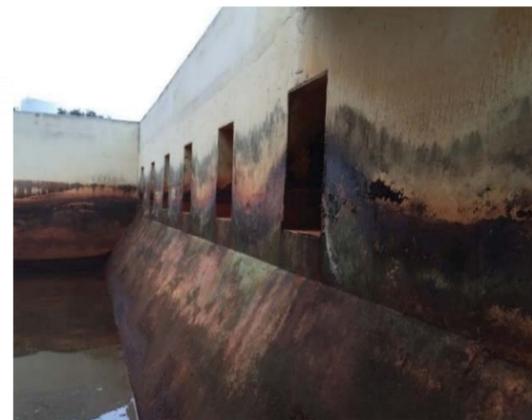
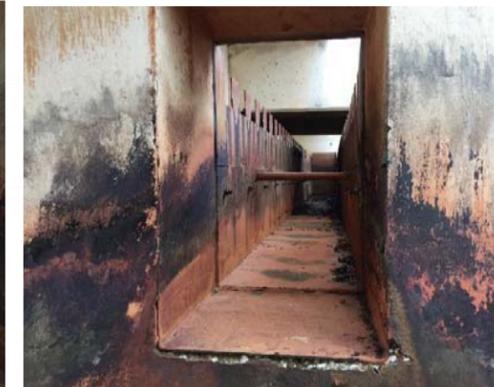
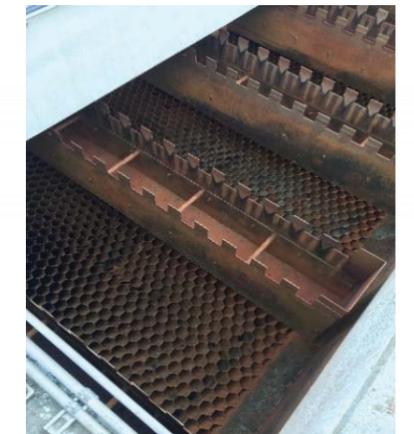
- Left: End of Collection Trough into Effluent Channel Basin.

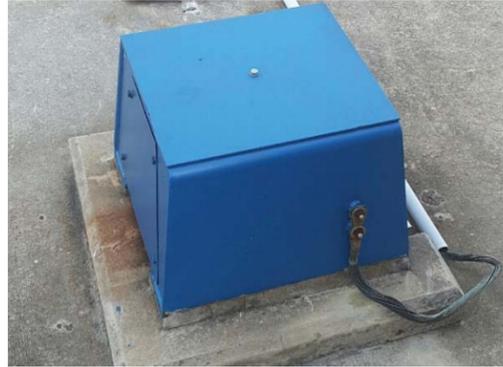
The 15-hp injection tank mixer and the 20-hp maturation tank mixer for Train 1 are in good condition, although the conduits are deteriorating and may need to be replaced. The mixer blades are 316 stainless steel and are in good condition. Table 2.7 lists the year installed, original useful life, criticality, condition, and condition fraction for the mixers. Figure 2.4 shows photos of these assets.

Above: Coagulation Tank Mixer 1 out of service.

Right: Maturation Tank Mixer 1 Blades.

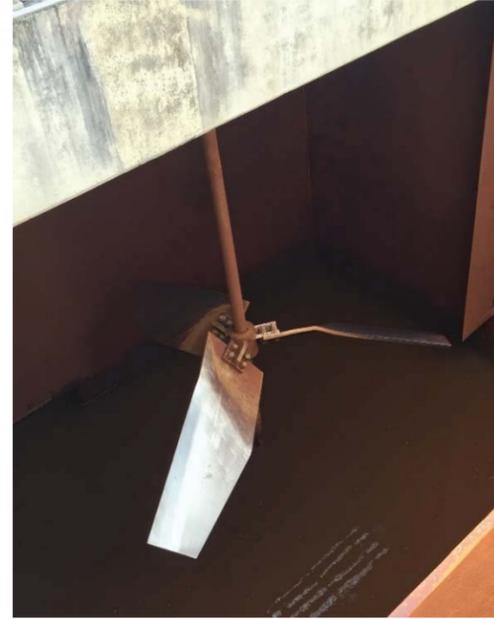
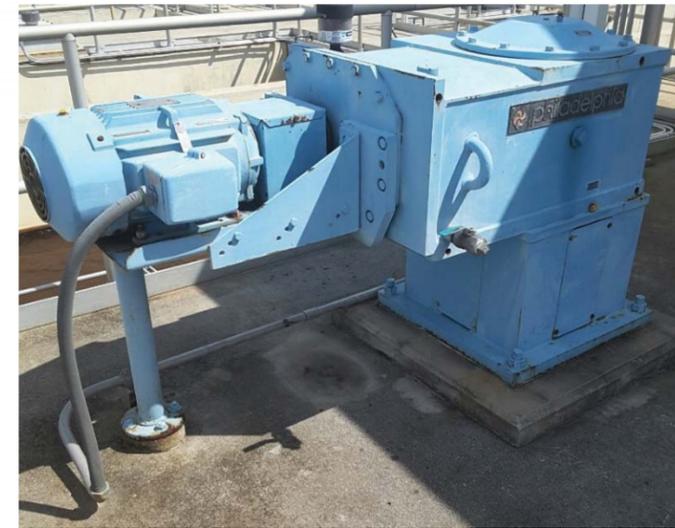
Left: Maturation Tank Mixer 2.

Right: Infrared image showing Maturation Tank Mixer 2 internal temperature in comparison with ambient temperature.

The mixer is experiencing significant noise, vibration, and heat. As shown in Figure 2.4, the infrared camera noted an internal motor temperature of 144 degrees Fahrenheit. The bearings are likely in very poor condition, and the conduits feeding the mixer are deteriorating. The mixer blades are 316 stainless steel and in good condition. Table 2.8 lists the year installed, original useful life, criticality, condition, and condition fraction for these mixers.

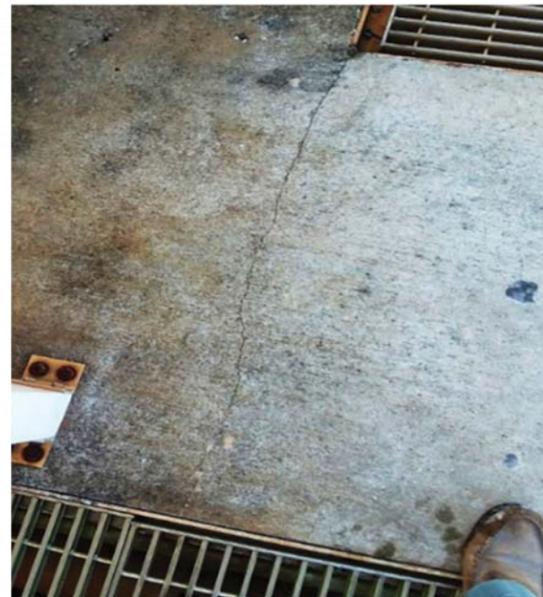
Hairline crack at top slab of Injection Tank for Train 2.

As with Train 1, the concrete Actiflo™ tanks for Train 2 are in fair condition. The injection tank top concrete slab had a hairline crack, as shown in Figure 2.4.

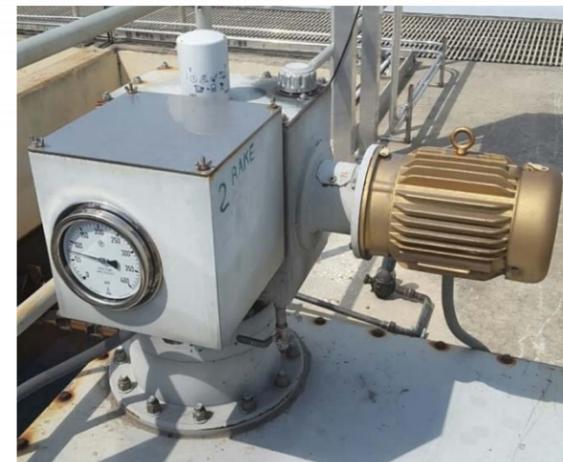
Left: Motor assembly for Scraper 2.

Right: Electrical VFD Enclosure for Scraper 2.

The structural components of the scrapers were not accessible during the assessment but are made of 316 stainless steel and are thought to be in fair condition. Table 2.9 provides information on the condition of these scrapers. Figure 2.4 shows photos of the motor assembly and VFD enclosure for Scraper 2.

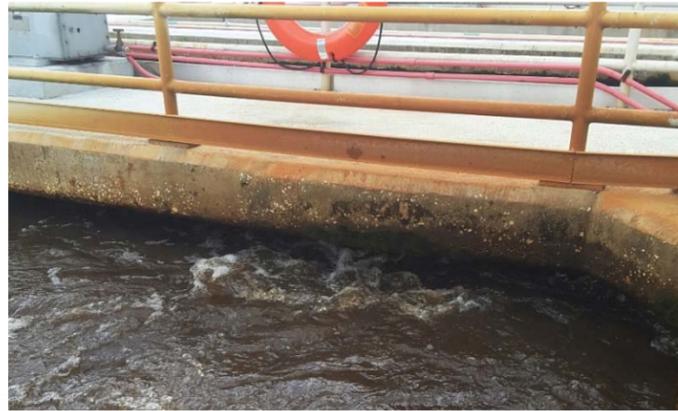
Trains 5 and 6 share a common influent box, which is in fair structural condition. The rapid mixer and Water Champ for Treatment Trains 5 and 6, respectively, are currently not in service. Because mixing is achieved hydraulically, the system does not have coagulation mixers. In the event the treatment process is modified, as detailed in Chapters 3 and 5, the rapid mixers will become more critical to process operation and therefore have been assigned moderate criticality. The influent structure has two gates that provide the ability to isolate Train 5 or 6, as shown in Figure 2.6. Appendix A includes more information on the scoring and calculated risks for these assets.

Photo
Top: Common influent box servicing Trains 5 & 6
Bottom: Coagulation basin with minor corrosion and concrete spalling

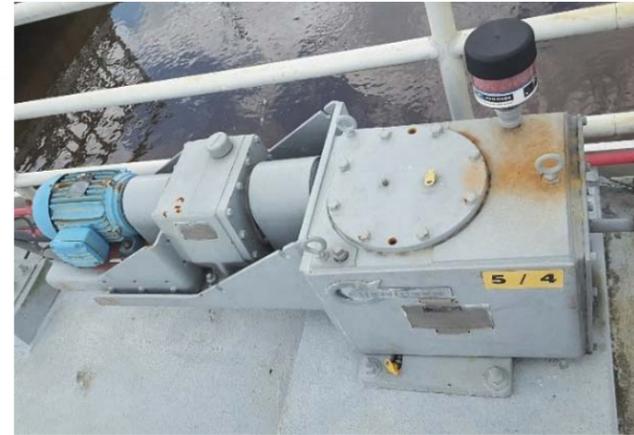
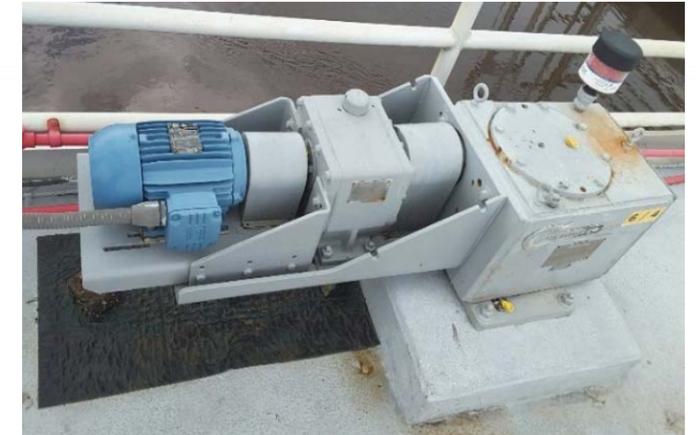
Photo
 Flocculators 5-4 and 6-4 in fair condition.

Each treatment train has a total of four flocculation basins, all of which are in fair structural condition. Because the flocculators associated with Trains 5 and 6 have routine scheduled maintenance and refurbishment, they are in similar condition.

The flocculators are approximately 30 years old but are in fair condition because the motors, VFDs, and components have been rebuilt. The original gearboxes have not been rebuilt. Staff noted the stainless steel flocculator paddles to be in good condition.

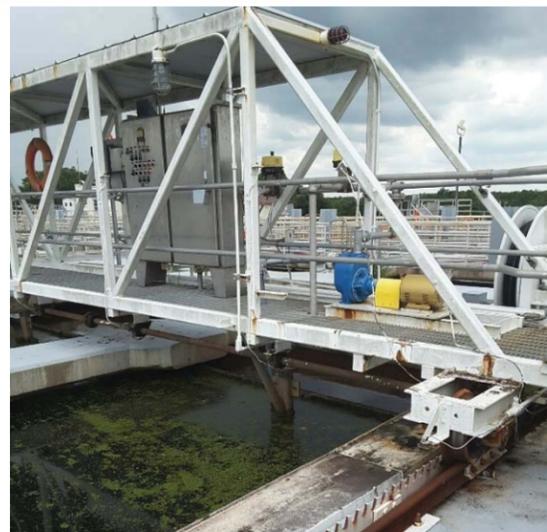
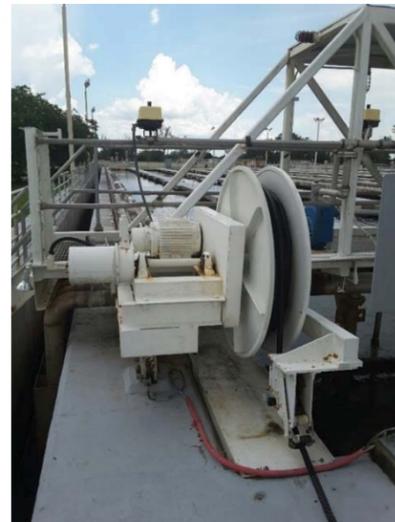
Photo
 Bridge equipment for Trains 5 & 6.

Sludge is collected via a traveling bridge and siphon system. The bridges were originally installed in the early 1980s. The motors associated with the sludge collection siphon were replaced in 2015. Replaced in 2005, the motors for the traveling bridge are in fair condition. The bridge rail system wheels are in poor condition and are recommended for replacement.

As Figure 2.6 shows, some of the bridge's structural cross members need to be replaced. The electrical cable reels for Bridge 5 and 6 are in poor condition and are obsolete technologies. Due to the condition and inefficiencies, replacing this system with a different sludge collection technology is recommended.

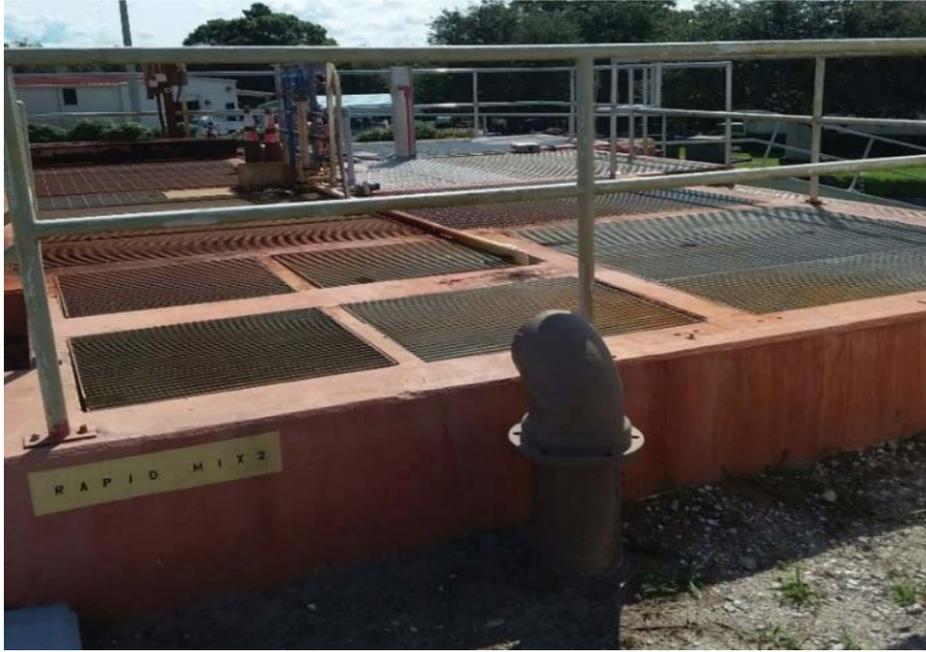
The influent basin is in fair structural condition, with minor corrosion noted and minor ferric deposit build-up. The rapid mixer and Water Champ for Treatment Trains 7 and 8 are not in service. As Figure 2.7 shows, this system lacks coagulation mixers, since mixing is achieved hydraulically. In the event the treatment process is modified, as detailed in Chapters 3 and 5, the rapid mixers will become more critical to process operation and therefore have been assigned moderate criticality. The influent structure has two gates that provide the capability of isolating Train 7 or 8. Appendix A includes more information on the scoring and calculated risks for these assets.

Photo
Influent Basin servicing Trains 7 & 8

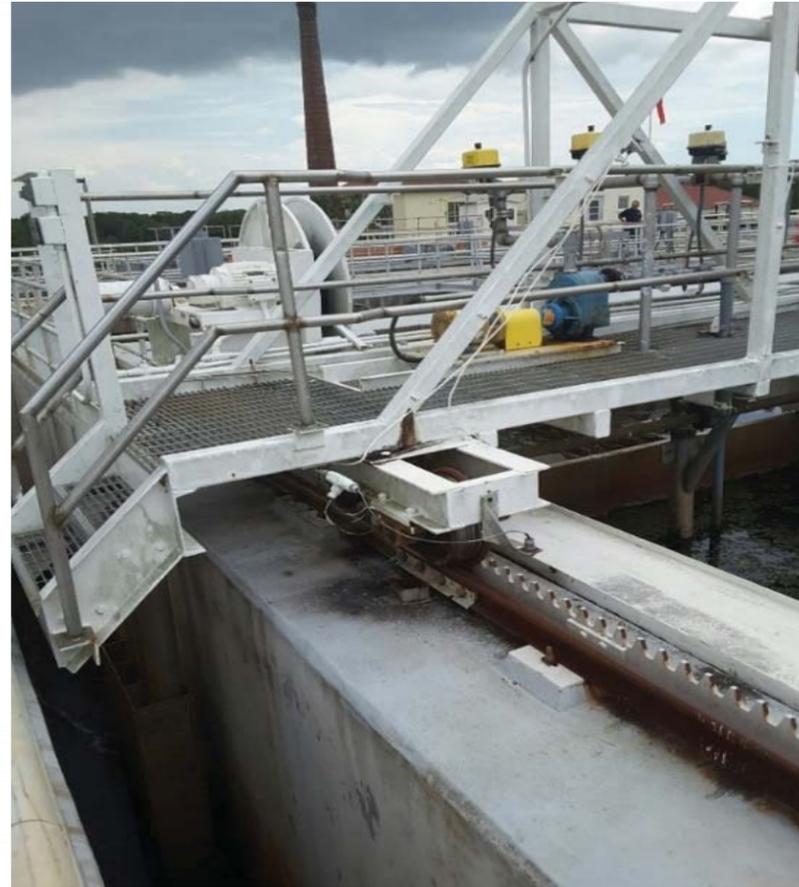
Photo
Bridge Equipment for Trains 7 & 8.

The motors associated with the sludge collection siphon were replaced in 2015. The electrical cable reels for Bridge 7 and 8 are in poor condition. As was stated for Trains 5 and 6, replacing these sludge collectors with a chain and flight or scraper type is recommended. See Table 2.14 for additional information.

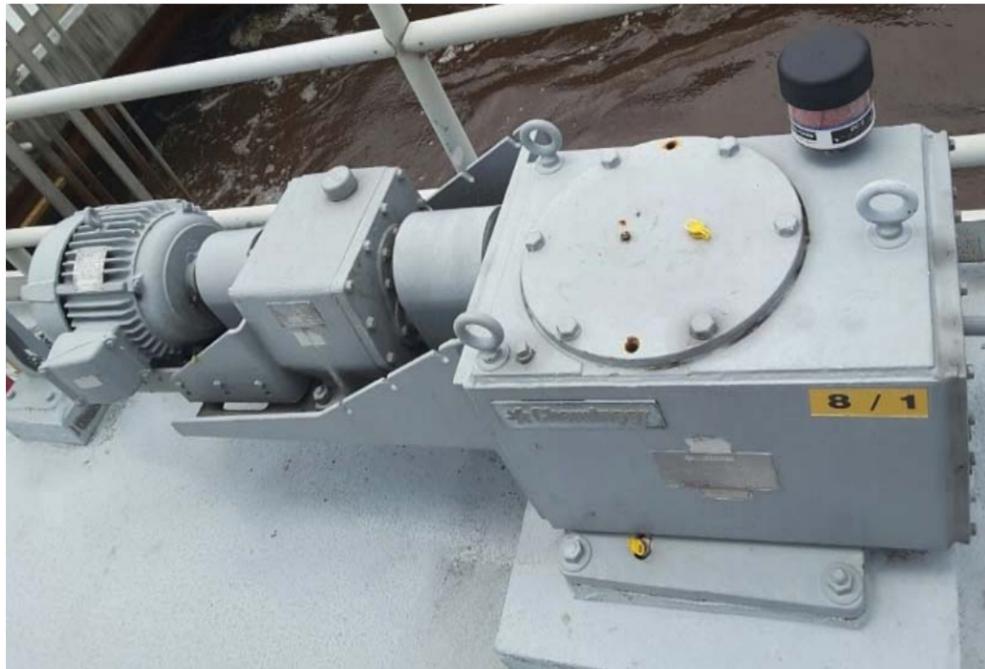
The flocculation basins are also in fair condition structurally. Like Trains 5 and 6, the flocculators associated with Trains 7 and 8 have rotating scheduled maintenance and are in similar condition. As Table 2.13 shows, the eight flocculators (four for each train) are in fair condition because they have rebuilt motors, VFDs, and components. The original gearboxes have not been rebuilt because they are in good condition. Staff noted the stainless steel flocculators are also in good condition. Figure 2.7 shows flocculator 8-1.

Photo
Flocculator 8-1 servicing Train 8 Flocculation Basin.

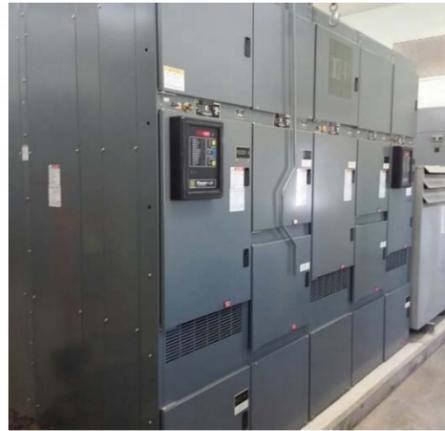
Photo
Above: Ozone switchgear.
Top Right: Ozone MCC A.
Right: HVAC Unit for PSUs.

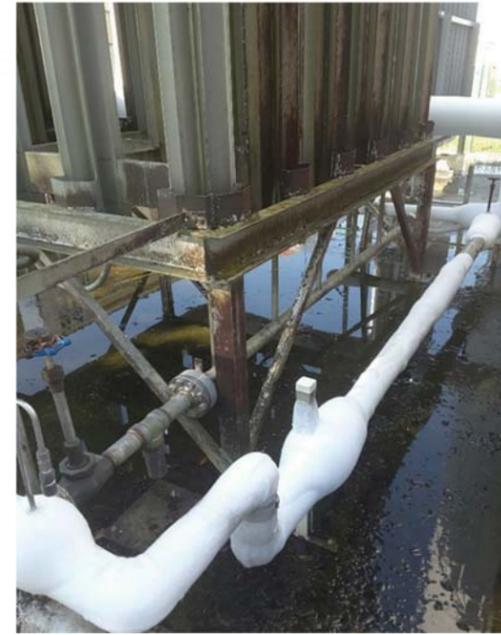
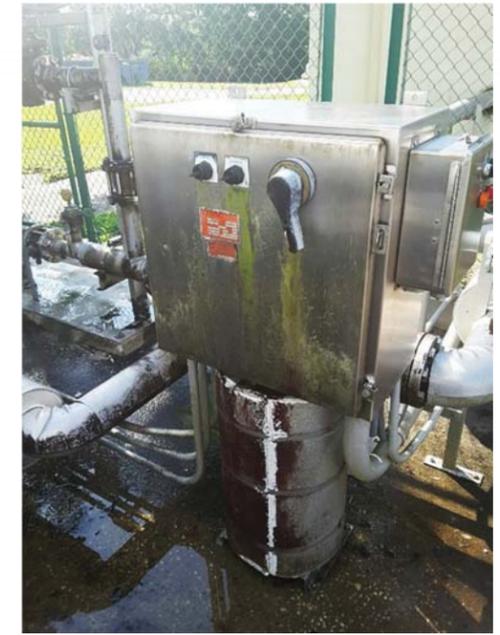
The three 13,000 gallon liquid oxygen (LOX) tanks are in fair condition. Because they have ample redundancy, they are of minor criticality. Paint failure and corrosion were observed at the legs of each tank, and moisture had accumulated on the concrete foundation, as shown in Figure 2.8.

Photo
Top Left: LOX Tanks.
Above: Moisture accumulations causing concrete degradation.
Left: Paint failure and corrosion at LOX tank leg.

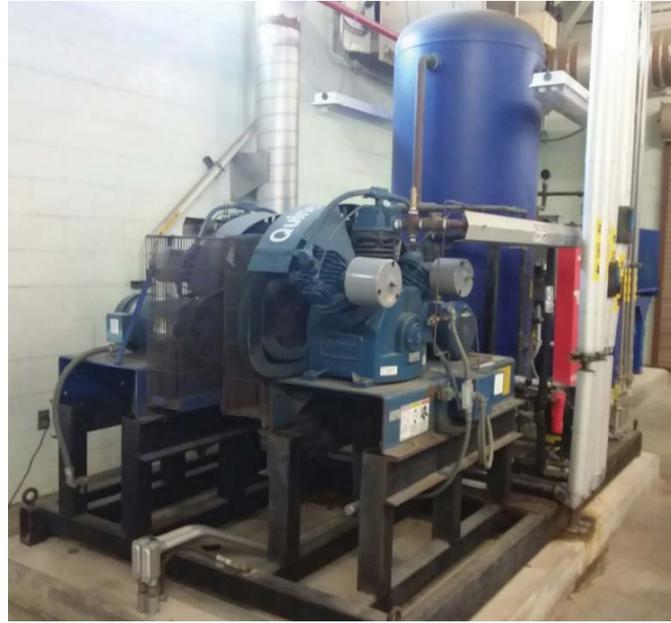
Photo
Above: Nitrogen Boost air receiver tank, filters, compressors, and dryers.

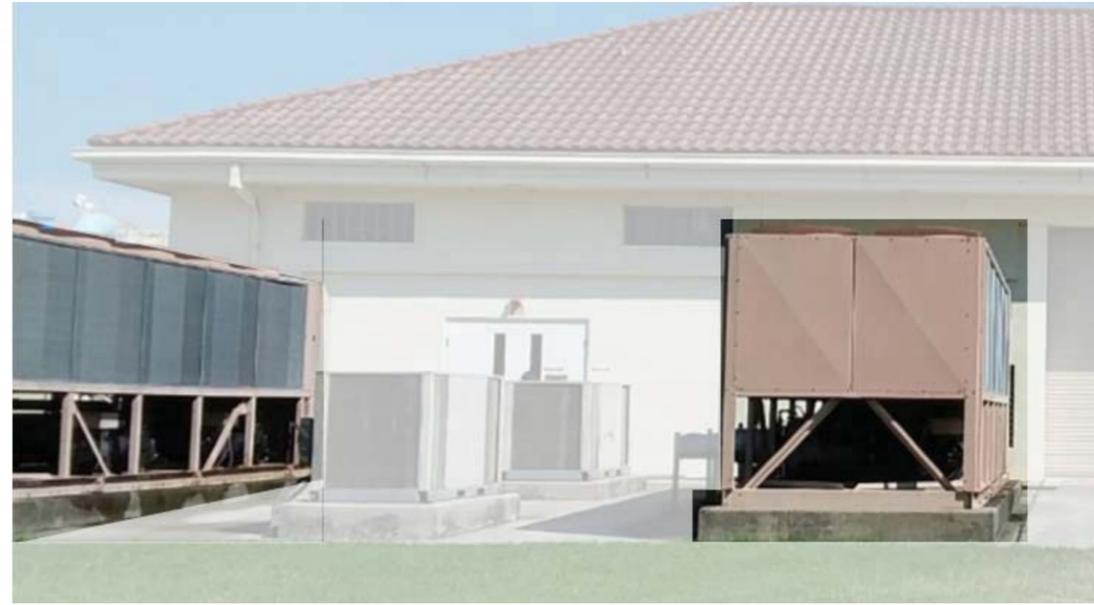
Photo
 Ozone Chillers and PSU HVAC Units (located in between chillers).

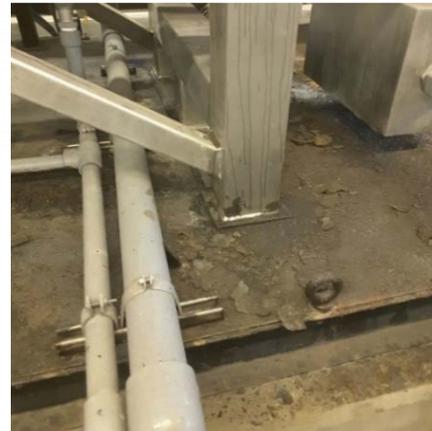
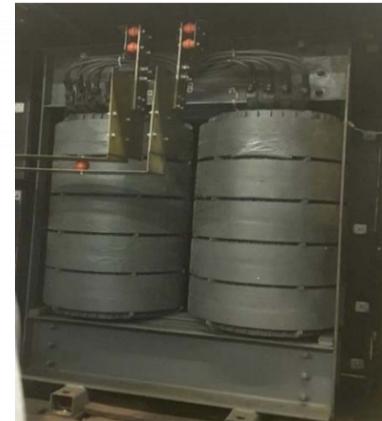
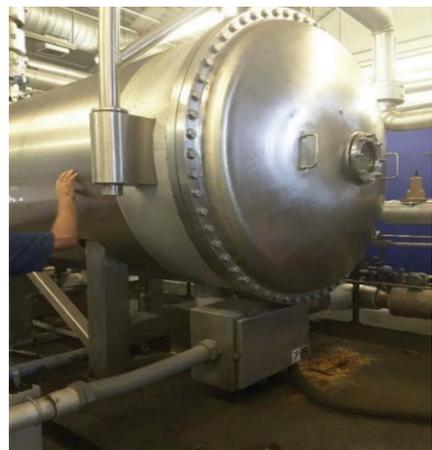
Photo
Top Left: Ozone Generator Shell.
Right: Concrete pad deterioration due to moisture from contactor.
Bottom Left: Ozone Generator PSU internal components.

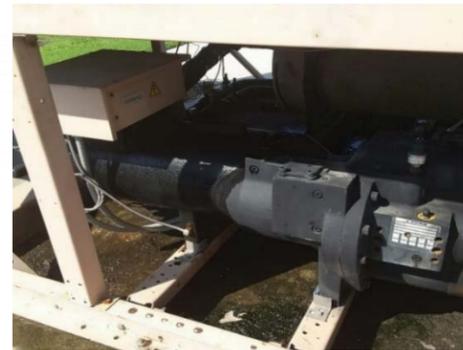
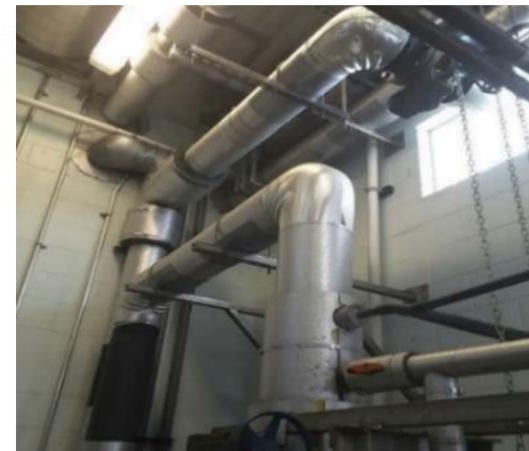
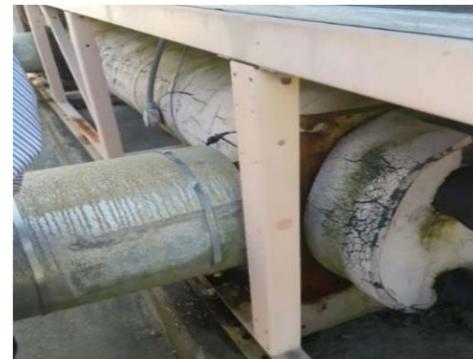
Photo
Top Right: Chiller #1 Compressor.
Top Left: Chilled water piping.
Bottom Left: Insulated chiller piping deteriorating.

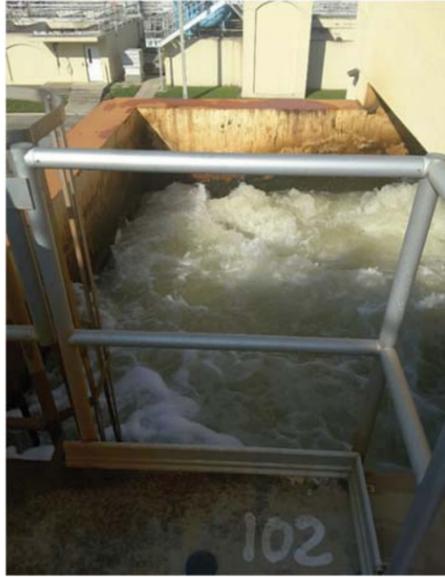
Photo
Splitter box
servicing ozonation
process.

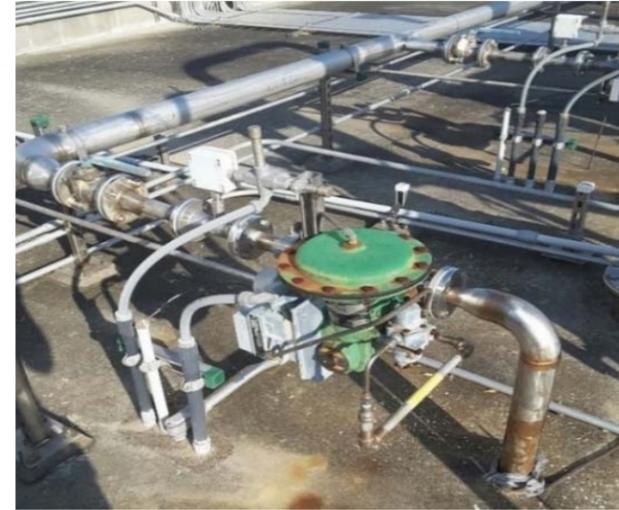
Photo
Above: Valve actuator in good condition.
Right: Ozone feed piping in good condition.

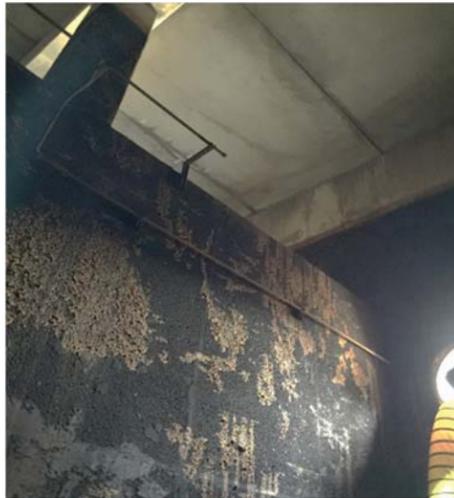
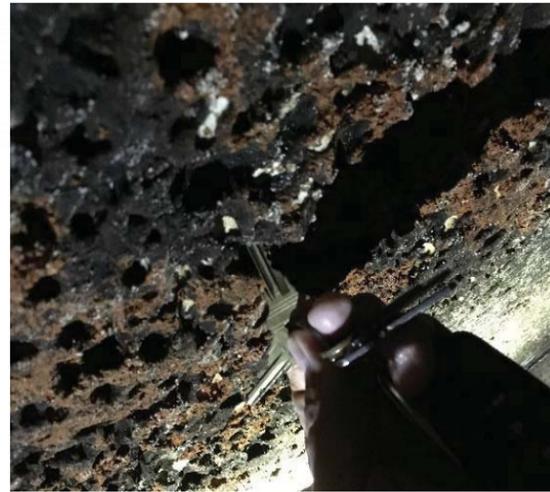
Photo
Left: Inside wall of contactor with concrete spalling.
Right: Significant spalling of concrete in interior of contactor.

These surfaces should be repaired before further degradation occurs and reinforcing bars become exposed. To accomplish this, sandblasting and repairing with shotcrete are recommended. Although costly, shotcrete provides added rebar protection and allows for quick return to service because of its short cure time.

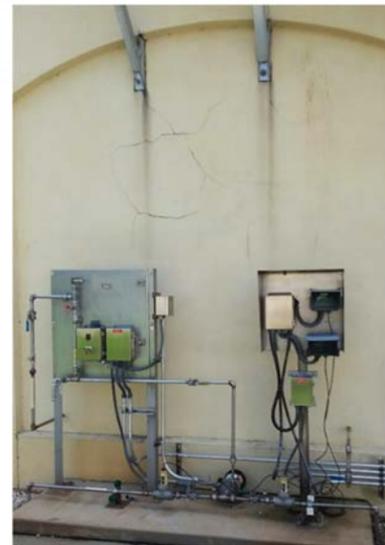
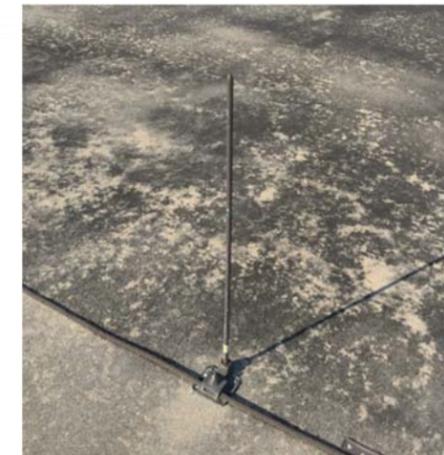
The outside structure of the contactors is in fair condition, and concrete cracking was noted in the North and West walls of Contactor No. 1.

Photo
Left: Concrete cracking on walls of
Contactor #1.
Right: Lightning rod on roof of
contactor where plant staff
regularly access

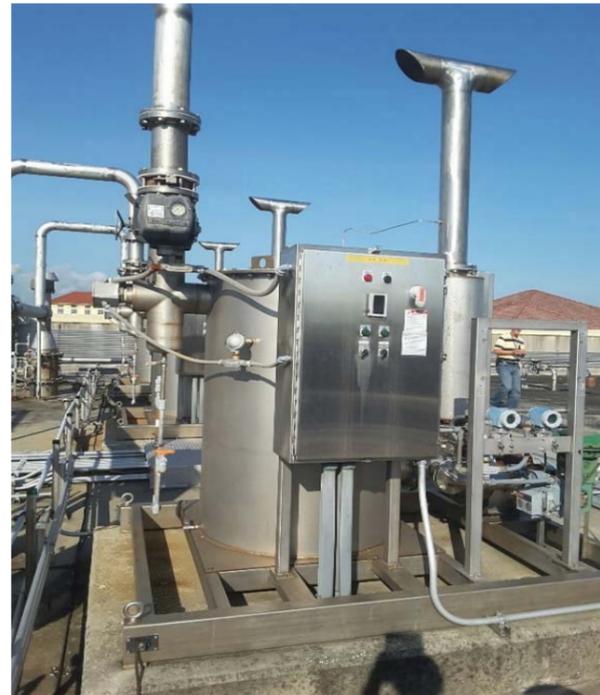
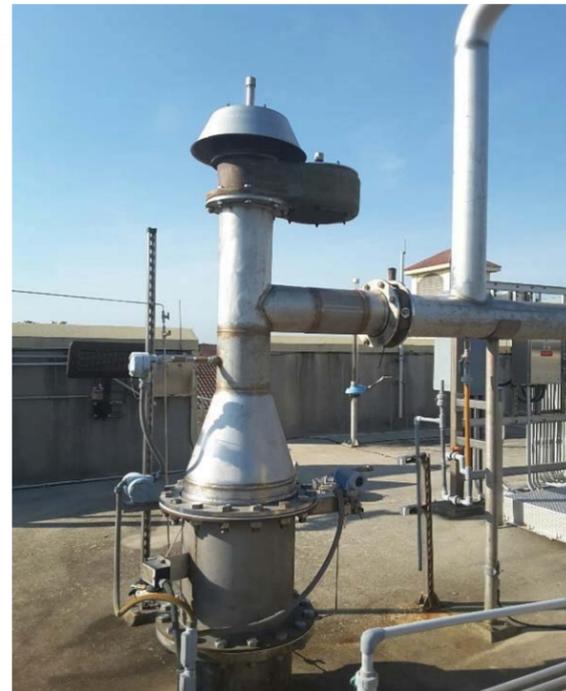
The three ozone destruct units are in fair condition, as shown in Figure 2.11. Because of their redundancy, they have minor criticality.

Left: Ozone Destructor #3.

Right: Destruct unit pressure/vacuum relief valve.

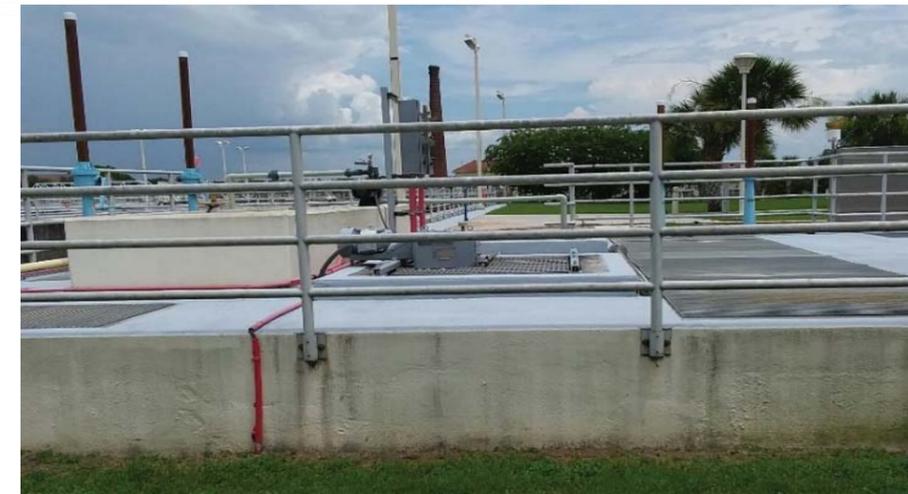
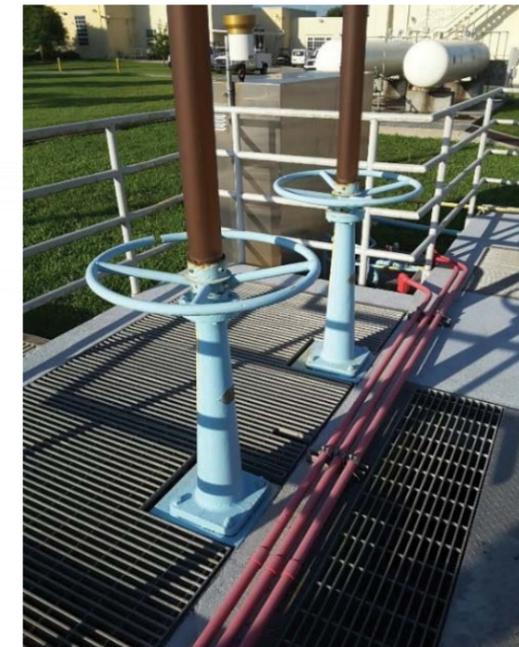
Left: Stainless steel gate at box.

Concrete cracking was noted in the structure, as shown in Figure 2.11. The stainless steel gates were reportedly installed approximately 30 years ago and are assumed to be in fair condition; however, staff have noted the inability to operate the gates recently. Therefore replacement of these gates is included in the CIP. Overall, the structure is in fair condition, as noted in Table 2.22.

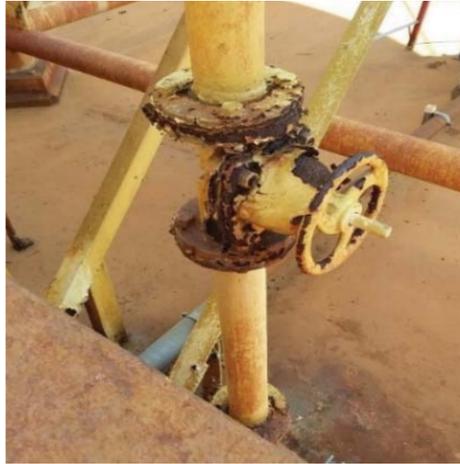
Left: Valve at Ferric Storage Tank deteriorating.

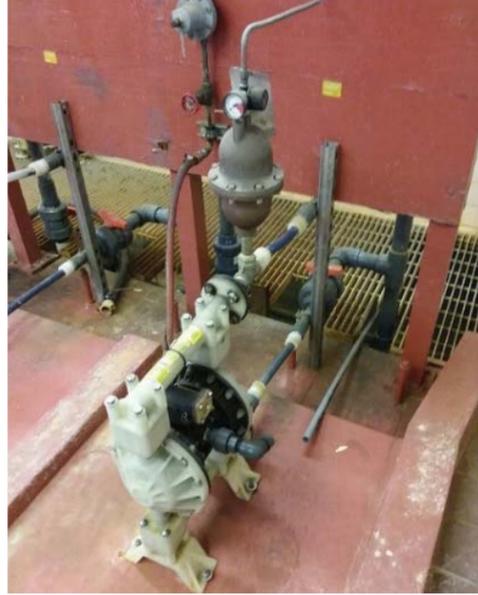
Right: Ferric feed pump in good condition.

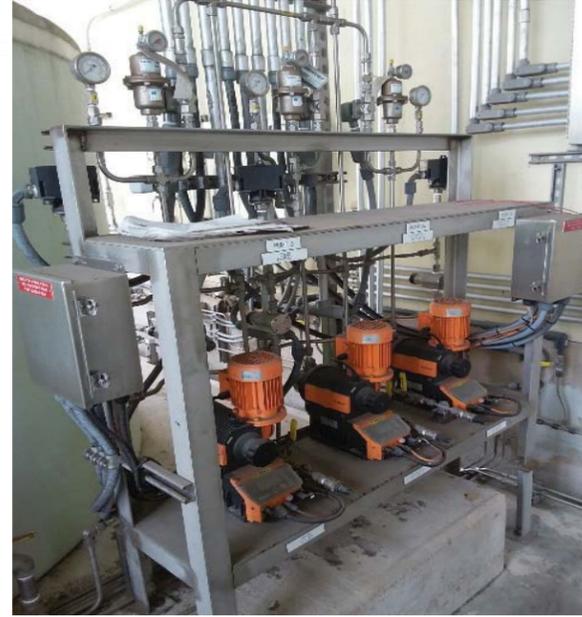
Left: Hydrogen Peroxide feed pumps in fair condition.

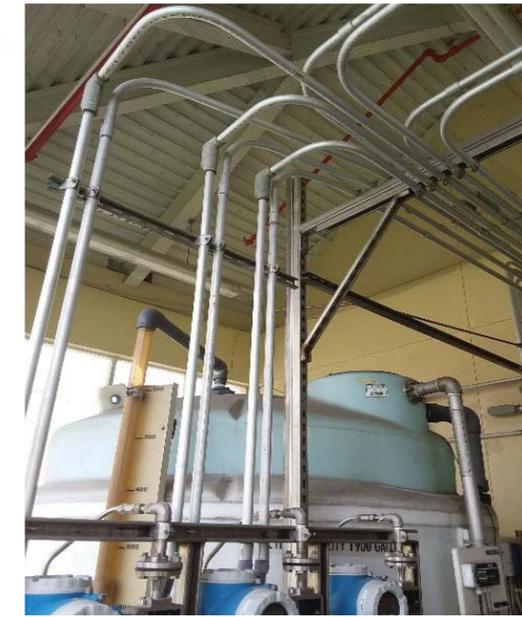
Right: Associated piping and valves in fair condition.

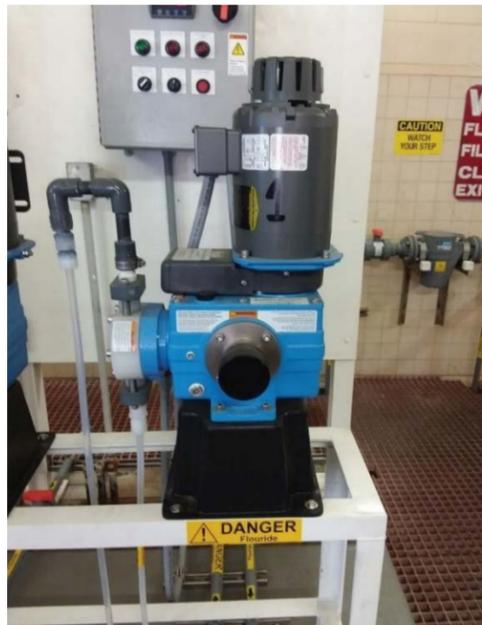
Left: Fluoride feed pump in very good condition.

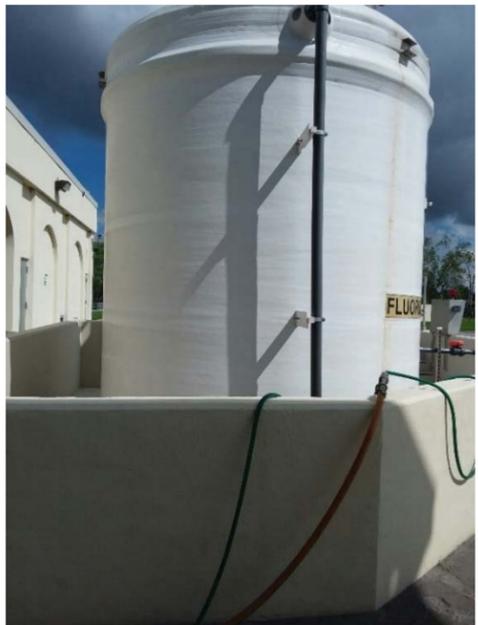
The fluoride day tank is serviced by the 10,000 gallon vertical fiberglass reinforced plastic bulk storage tank, with both in very good condition structurally. The system has no impact to plant capacity since fluoride is not required in water treatment under the Safe Drinking Water Act. Figure 2.12 shows the condition of selected features.

Right: Fluoride bulk storage tank in very good condition.

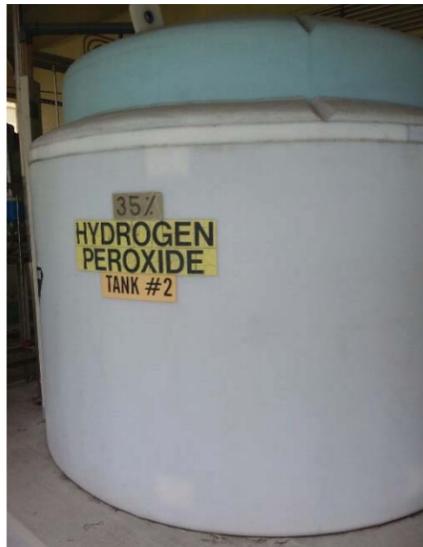
Left: Hydrogen Peroxide storage tank in fair condition.

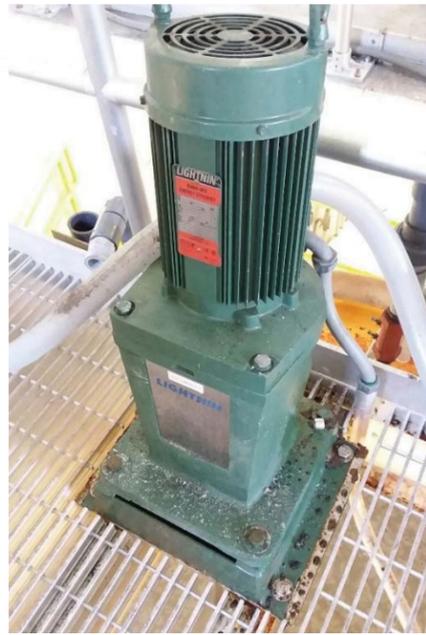
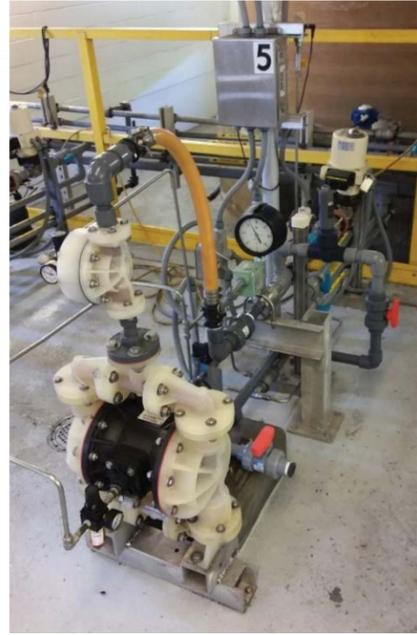
Photo
Left: Polymer mixer motor with corrosion at base.
Right: Polymer metering pump in good condition.

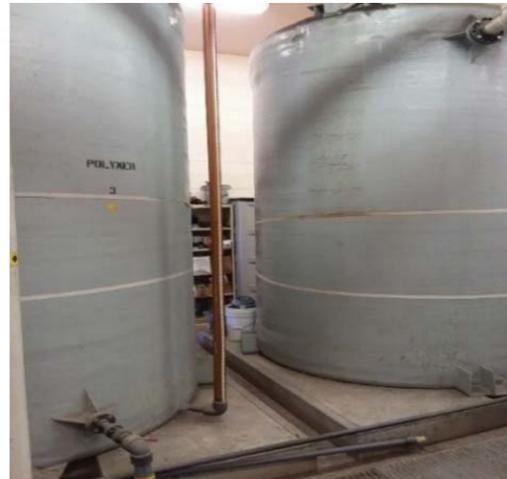
The two dry polymer storage bins each have a capacity of 250 pounds and are in fair condition. The two vertical fiberglass reinforced plastic mix tanks are 10 feet in diameter and are each rated for 3,000 gallons. They are also in fair condition. Figure 2.13 shows the condition of selected features.

Photo
Left: Dry polymer storage bins.
Right: Polymer mix tank #2 with minor deposit build up at base.

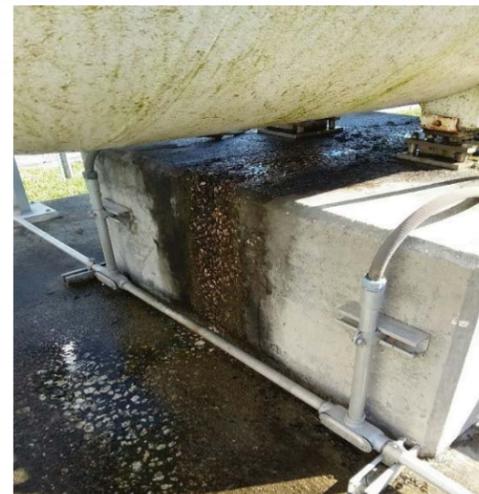
The two ammonia tanks each have a 2,000-gallon capacity. Inspected in 2011, they were determined to be in good condition. However, as Figure 2.13 shows, spalling was noted in the pad for Ammonia Tank 1. Immediate replacement of these tanks is not recommended unless replaced with new ammonia system for process reasons.

Photo
Left: Concrete spalling at base of storage tank.
Right: Ammonia storage tank (one of two).

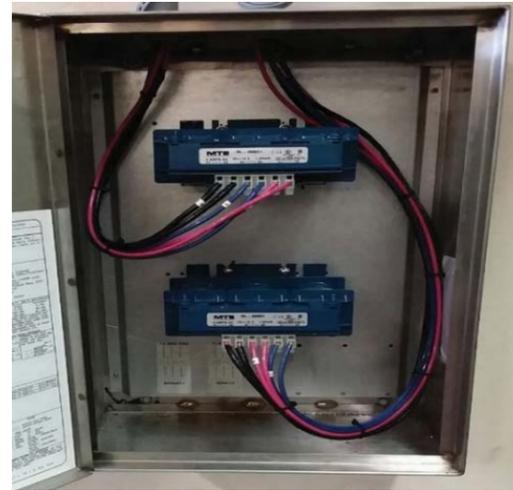
Photo
Left: Electrical in good condition.
Right: Sulfuric acid feed pumps.

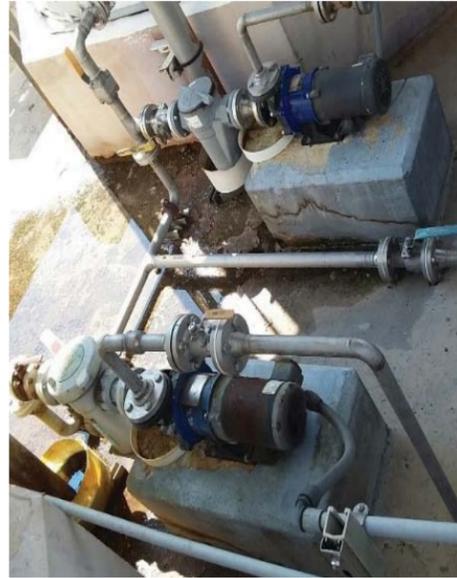
Photo
Left: Caustic feed pump in new condition.
Right: Electrical components in good condition.

Installed in 2015, the three caustic feed pumps and process piping are in very good condition, with overall good reliability, functionality, and spare parts availability. Shown in Figure 2.14, the caustic system's electrical components are in good condition, with minor criticality.

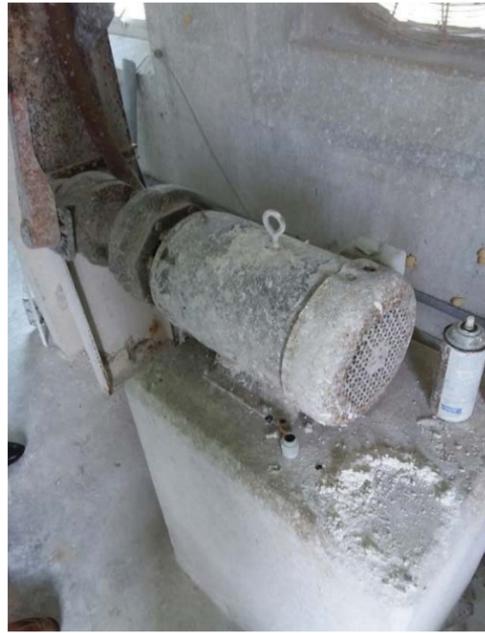
Photo
Chlorine booster pump in fair condition with corrosion.

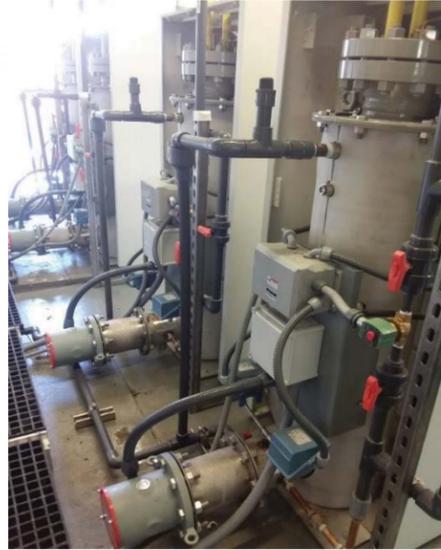
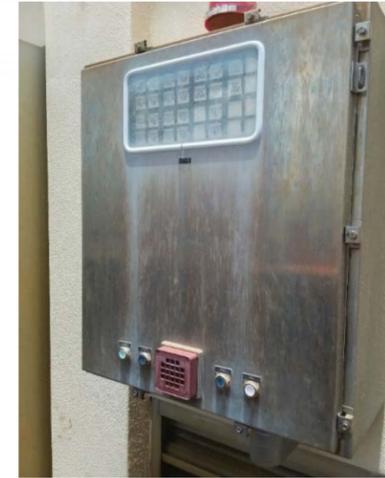
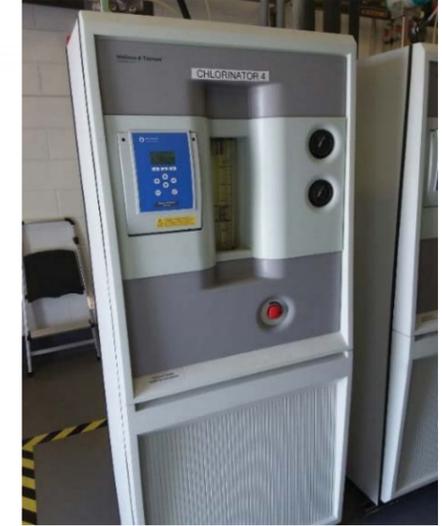
Installed in 2015, the four evaporators were each designed to process 10,000 pounds per day of chlorine. The evaporators, shown in Figure 2.15, are all in very good condition. The electrical annunciator panel and associated electrical components are in fair condition, as Table 2.30 shows.

Photo
Left: Chlorine Evaporators.
Middle: Annunciator Panel with corrosion.
Right: Chlorinator in new condition.

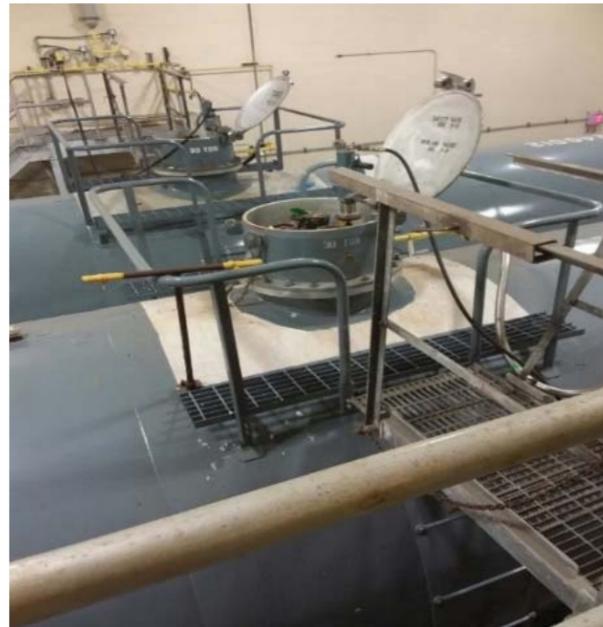
Chlorine is delivered via two rail cars (shown in Figure 2.15) and stored in the chemical building. The two steel platforms are in fair condition. The three ventilation fans in the rail car room are in poor condition and could pose a safety hazard. Thus, they are recommended for replacement immediately.

Photo
Chlorine rail cars and unloading piping.

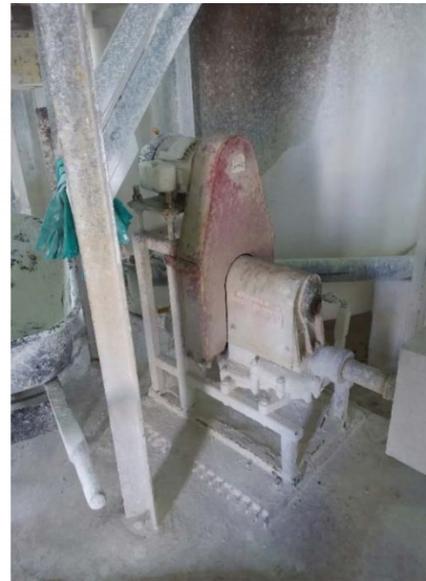
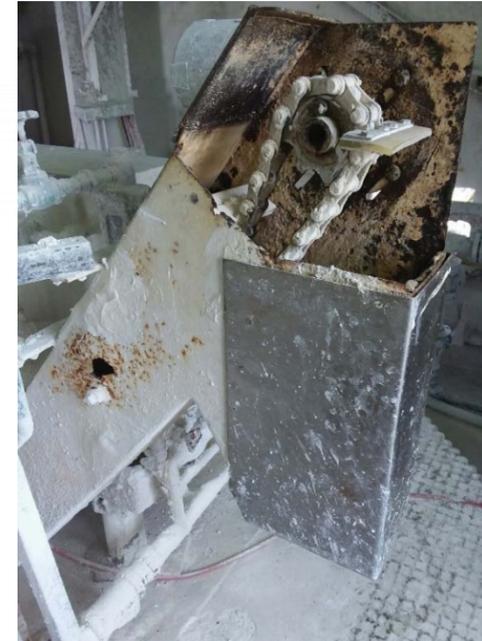
Photo
Left: Lime slurry discharge pump with corrosion and deposit buildup.
Middle: Grit Discharge from Slaker.
Right: Lime Hopper and Slaker.

The lime slaking system ranged from poor to fair condition, as shown in Figure 2.15. The Tekkum feed system is stainless steel and is in good condition. Slaker No. 1 is approximately 30 years old and in need of replacement. Slaker No. 2 was installed in 2001.

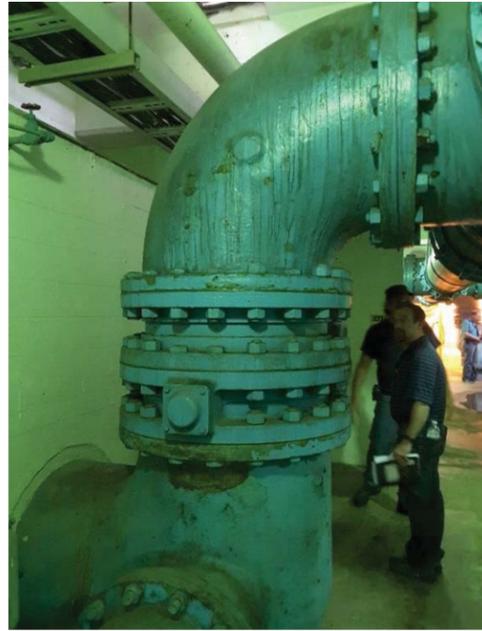
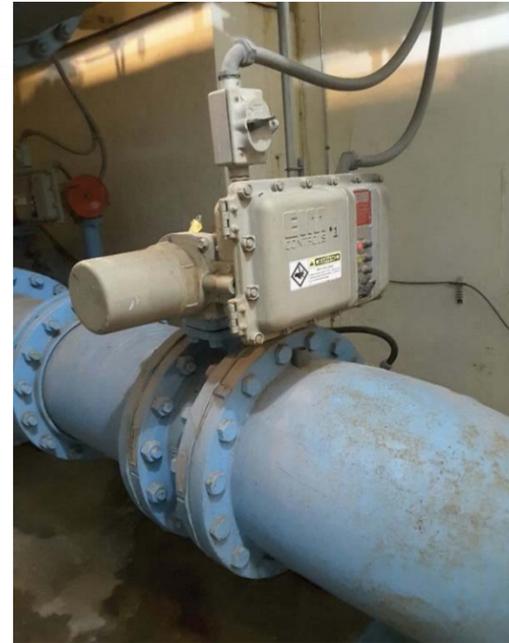
The filtration system piping is located inside the filter gallery. Its condition ranges from poor to fair given its age. Replaced in 2000, the valve actuators are in fair to poor condition because of age and actuator contact failure, as shown in Figure 2.17.

Left: Interior piping in the Filter gallery with minor corrosion.
Right: Valve actuator for filter #1.
