TAMPA WATER WORKS

The David L. Tippin Water Treatment Facility Master Plan

July 2018
Volume 1 of 2

DAVID L. TIPPIN WATER TREATMENT FACILITY MASTER PLAN

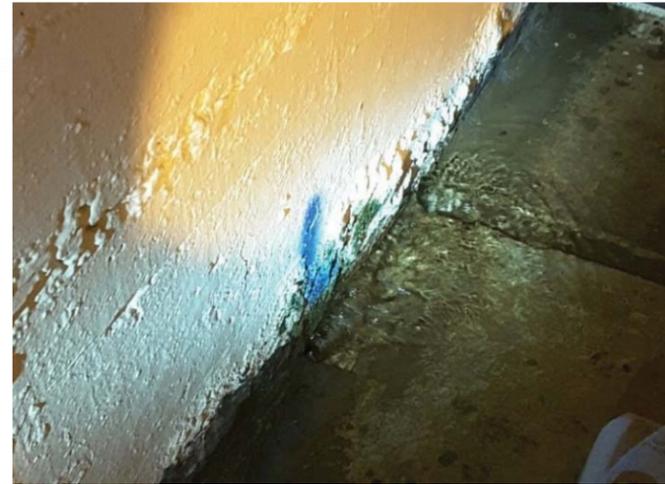
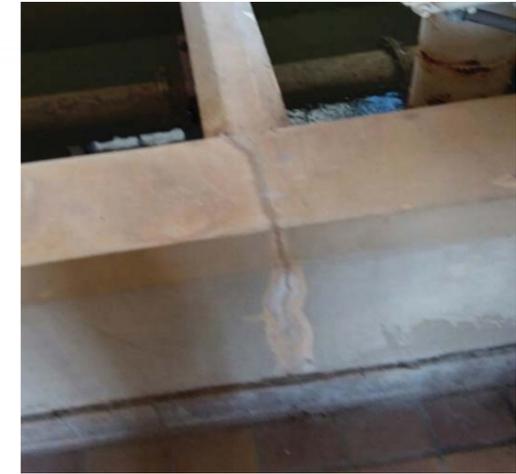
Left: Water infiltration and concrete deterioration at filter gallery floor.
Right: Hairline crack in concrete at top of filter.

Structural issues include minor concrete cracking of filter walls for Filter No. 14, 16, 21, 23, and 24. Additionally, there is spalling of the concrete slabs below the locker rooms. The spalled concrete was caused by corrosion of the bottom mat of reinforcing steel. There is concrete spalling and deterioration in the filter gallery due to water infiltration from the filtered water flume, as shown in Figure 2.17. Hydraulic recommendations to mitigate this issue are included in Chapter 4.

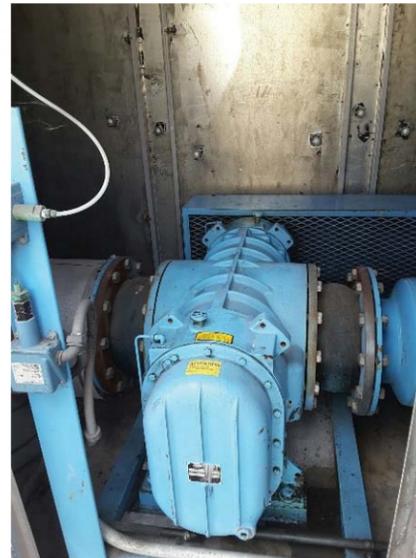
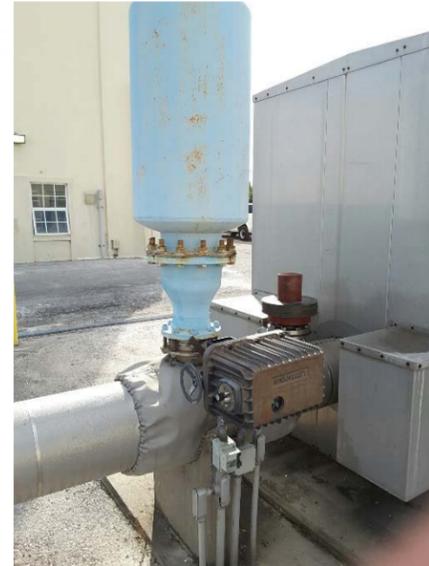
Left: Air Scour Blower 1.
Right: Air scour pressure relief valve and insulated piping.

Two positive displacement air scour blowers are available, one duty and one standby. Each is rated for an air volume rate 2,560 standard cubic feet per minute (scfm), and both are in fair condition (as shown in Figure 2.17).

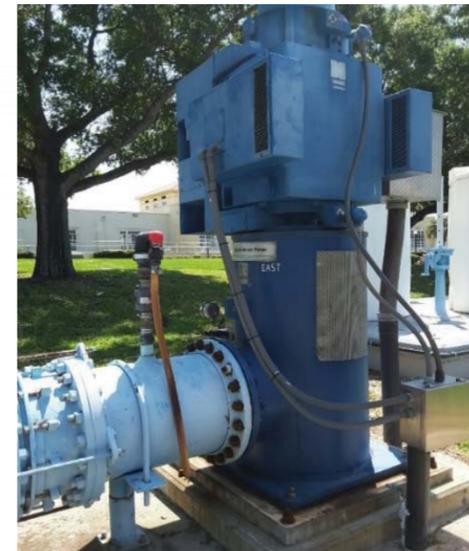
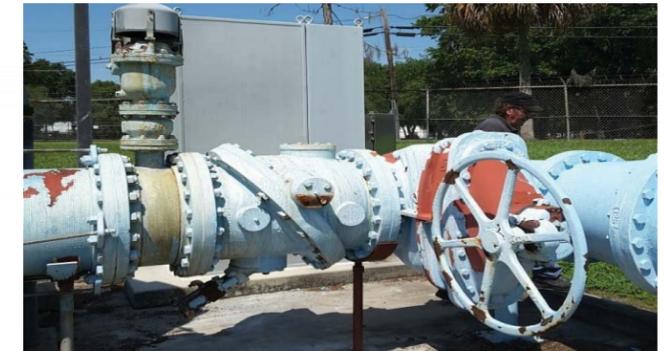
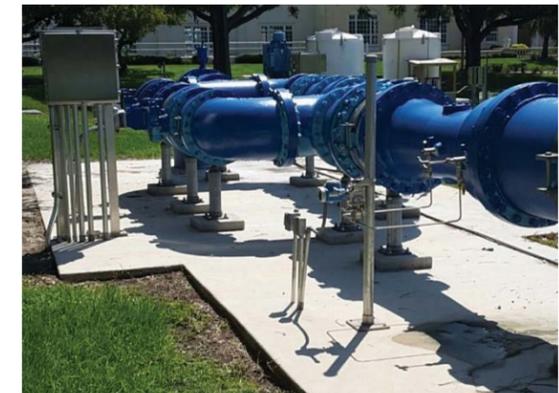
Left: Washwater Pump 1.
Top Right: Washwater Pump 2 piping and valves in poor condition.
Bottom Right: New washwater valve assembly.

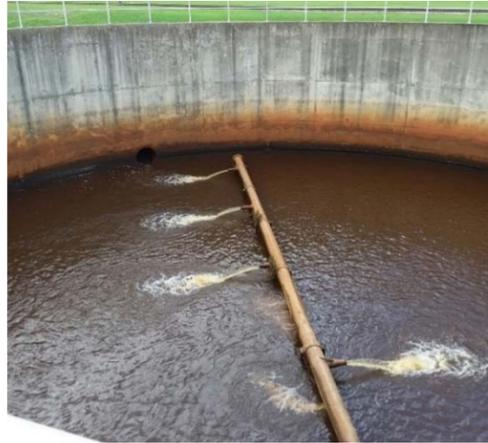
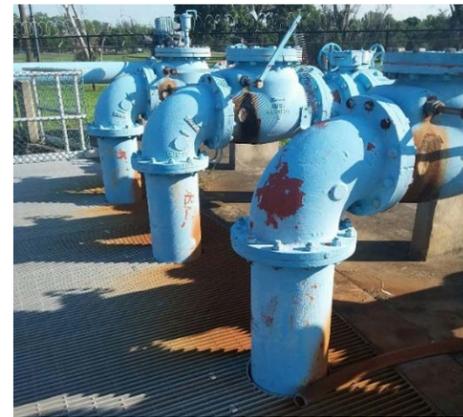
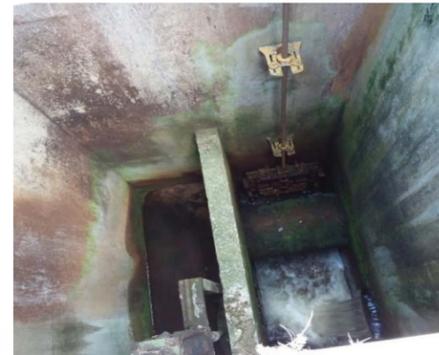
Photo
Top Left: Surge tank and water jets in fair condition.
Top Right: Piping and valves for surge pumps.
Bottom Right: Junction box servicing surge tank.

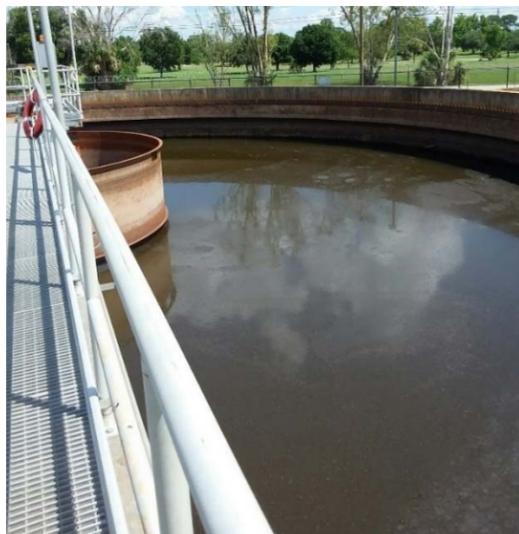
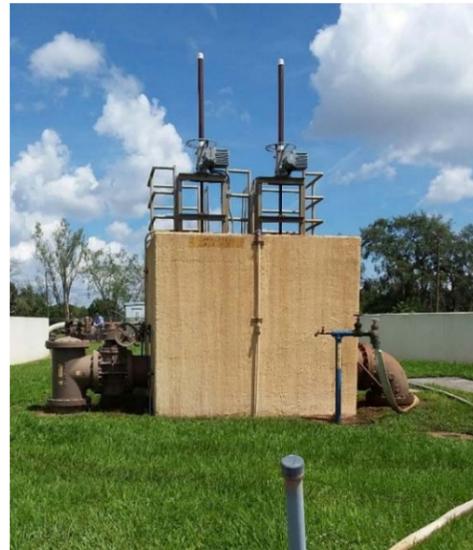
Photo
Left: Gravity Thickener #4 in fair structural condition.
Right: Splitter Box 1 and 2 in fair structural condition.

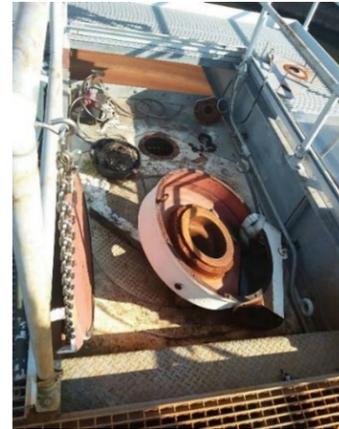
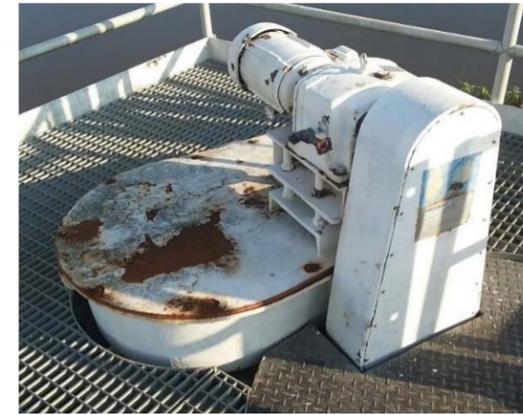
Photo
Left: Mechanism #4 out of service.
Right: Mechanism #1 in good condition mechanically.

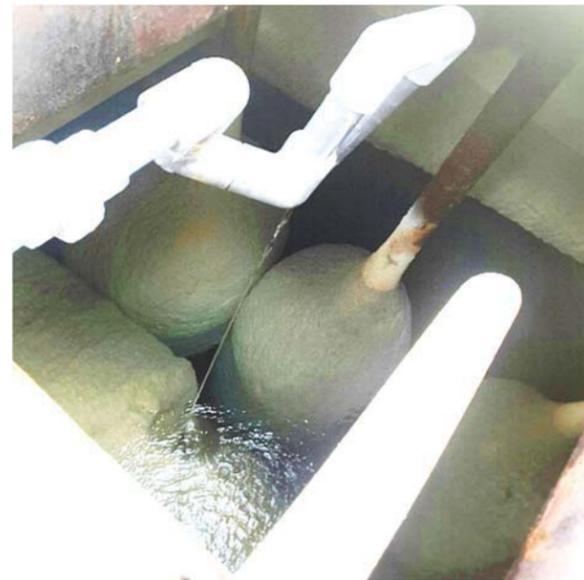
Hawkey Box mixer shafts and blades with significant buildup of deposits (since been removed)

The structure is in poor condition because of the plant hydraulic issues associated with the structure, which are further defined in Chapter 4. The chambers have mixers that are not in use because of significant deposit build-up, as shown in Figure 2.21. Since removing these mixers, plant staff has noted subsequent hydraulic improvements. Table 2.40 shows the structure's overall condition.

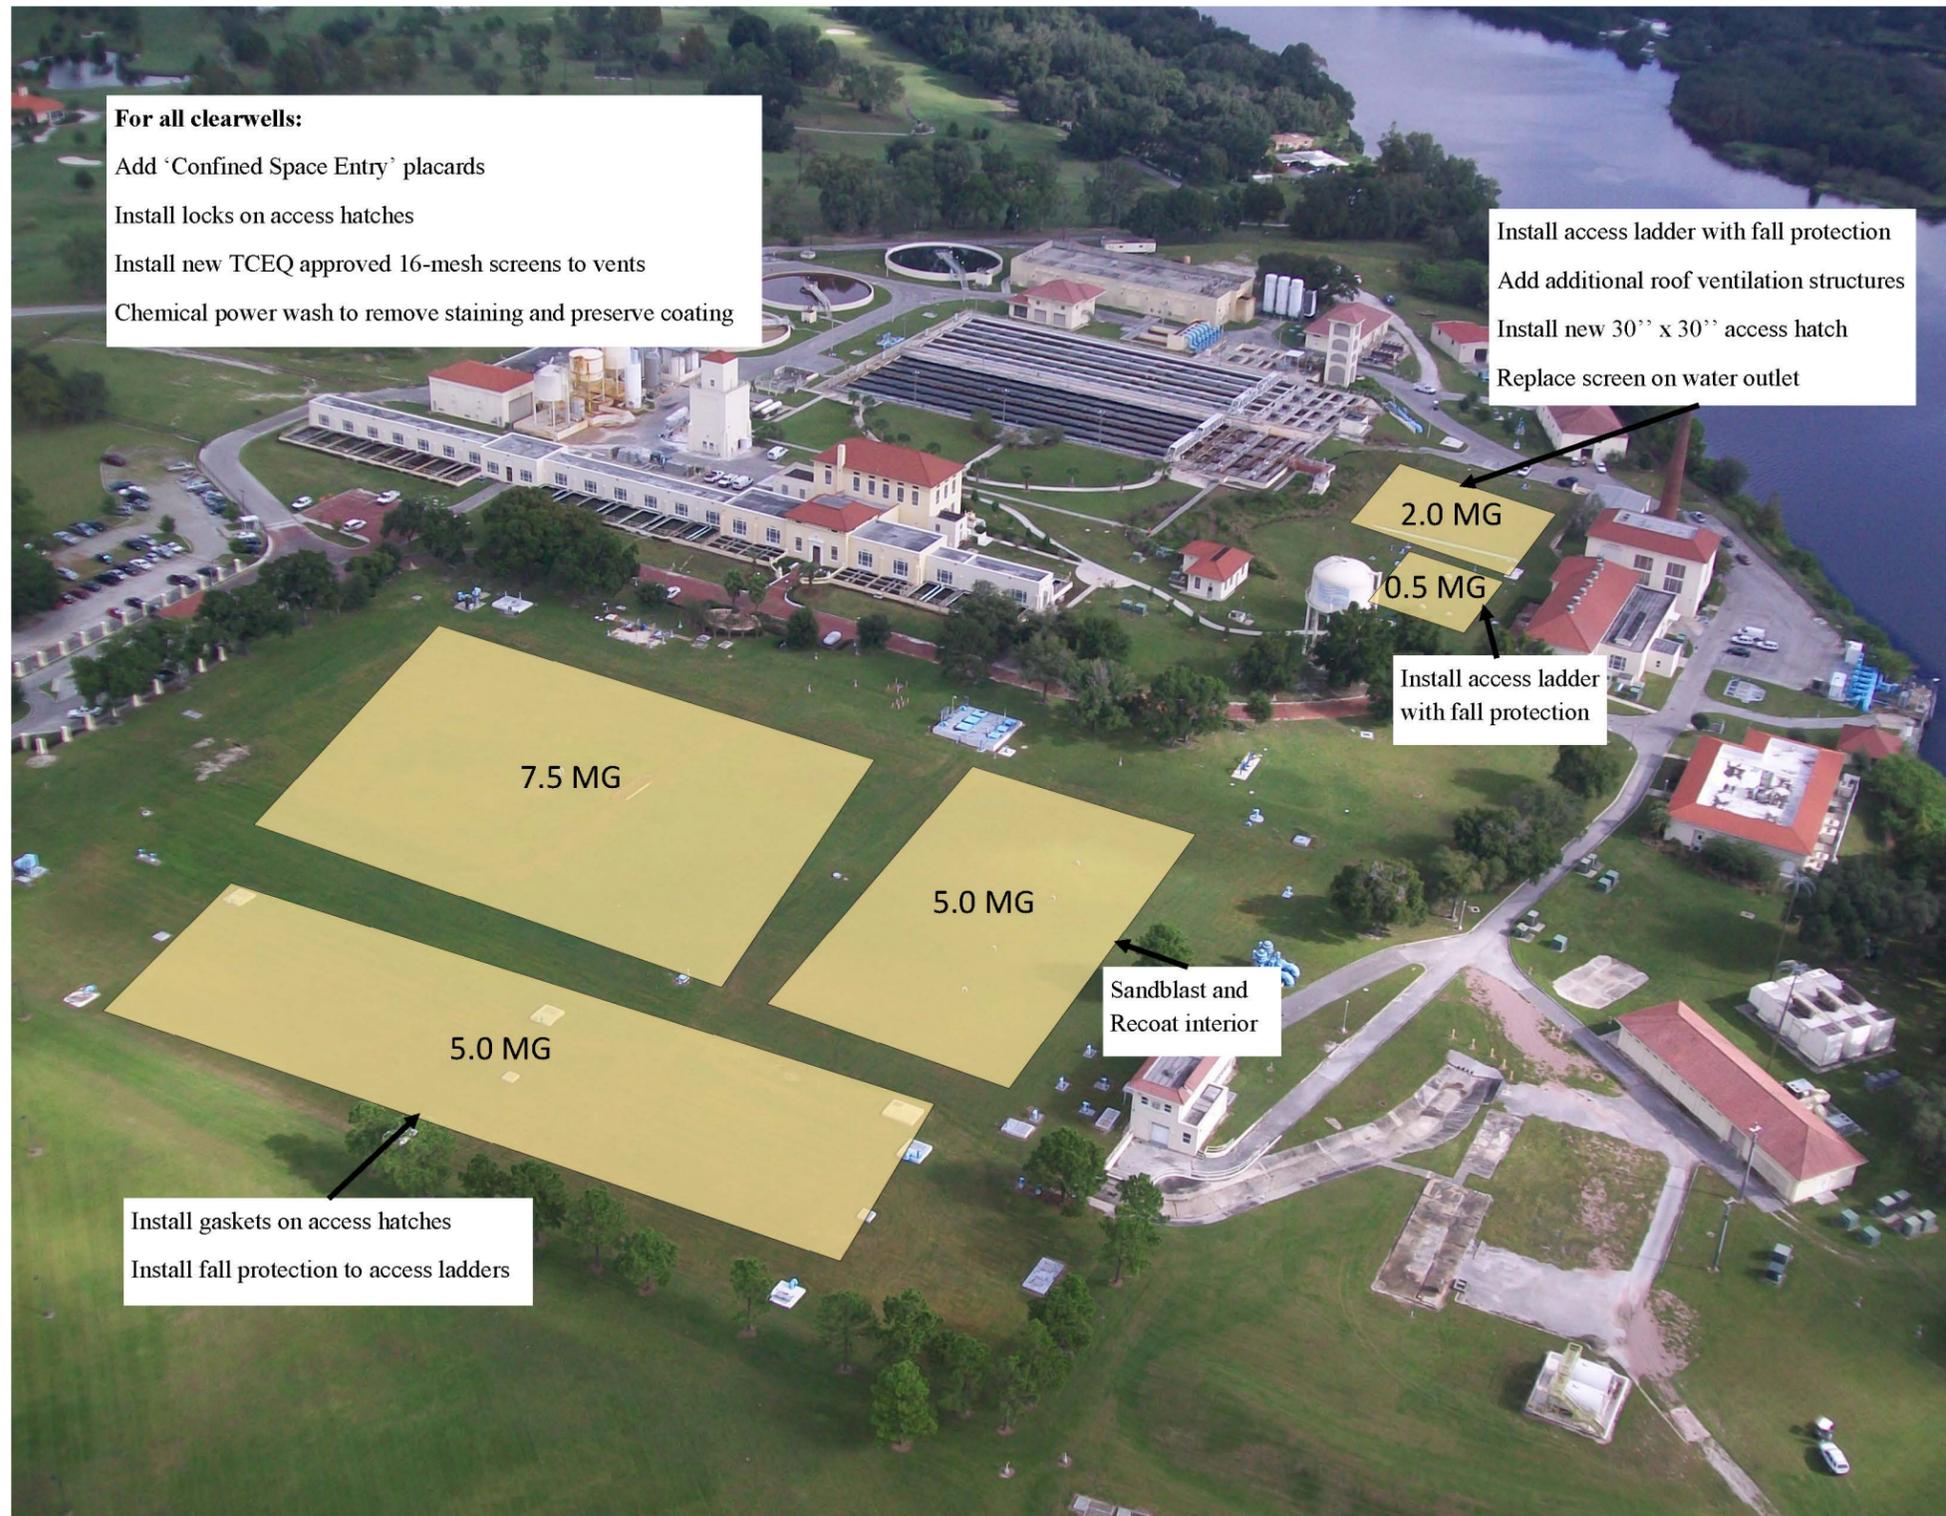
CLEARWELL RECOMMENDATIONS FROM PREVIOUS STUDIES

The interior of these clearwells was not accessible. Instead, photos from previous inspections conducted in 2007 and 2012 were used to evaluate the structures. Figure 2.22 contains the results and recommendations from these inspections. Chapter 4 includes hydraulic recommendations for the 7.5 MG clearwell.

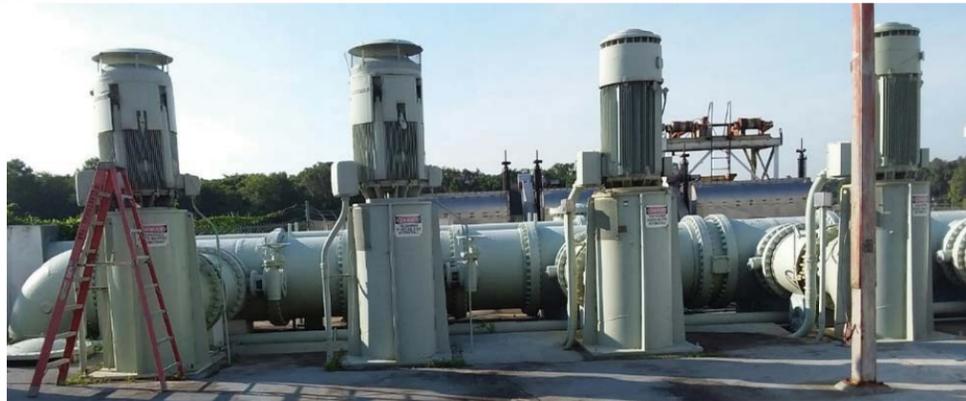
However, the VFDs are in very poor condition and are currently inoperable, which affects the pump station's intended operation. Additionally, operational considerations for hydraulics are included in Chapter 4.

Photo
Raw Water Pumps #1-4.

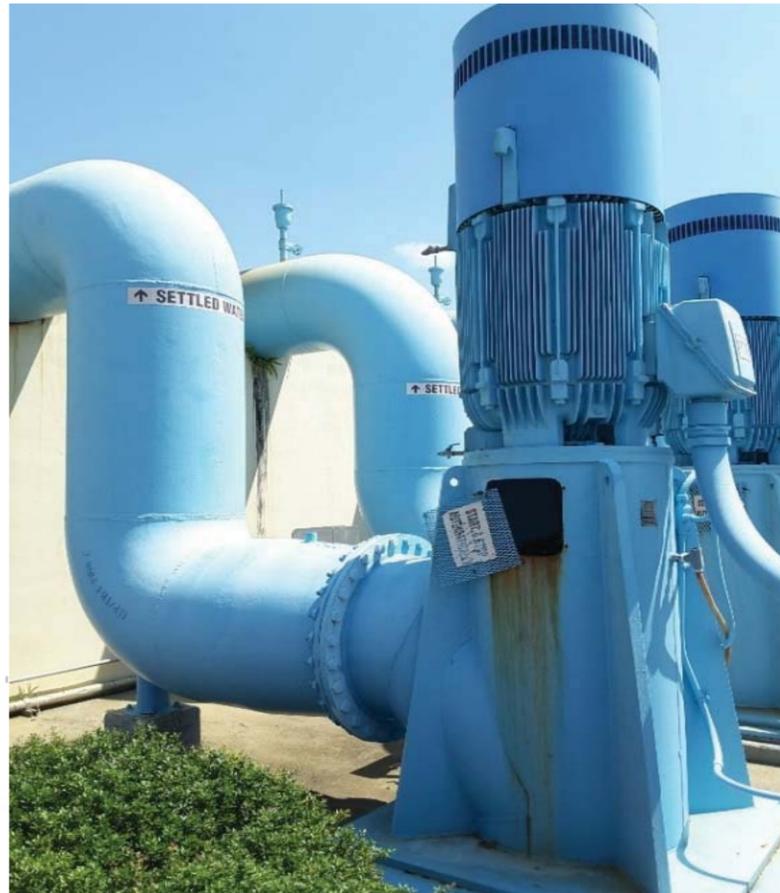
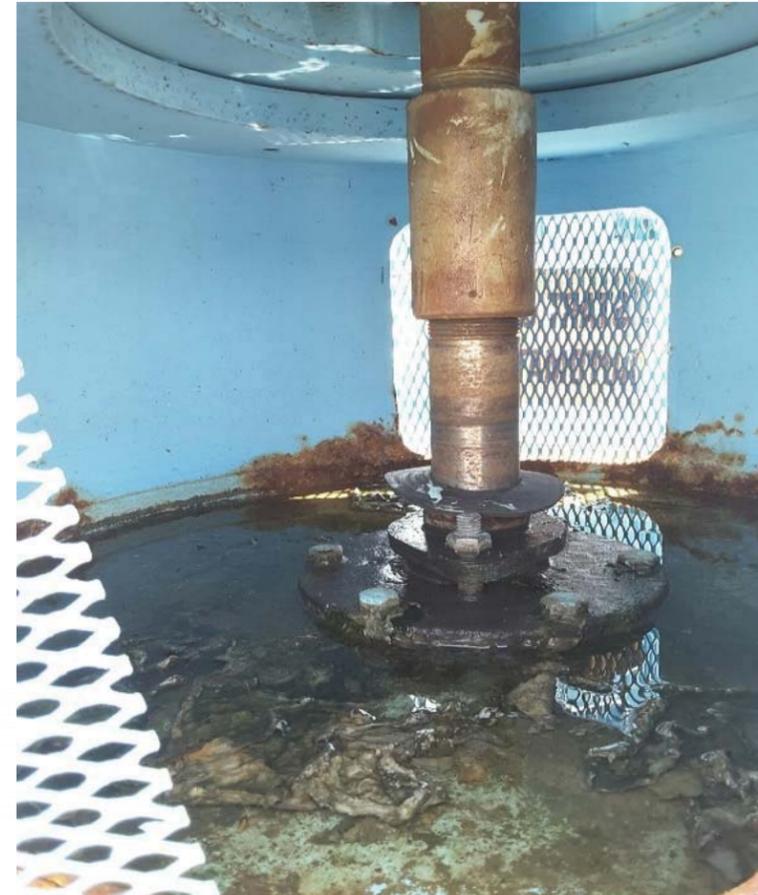
The pump station basin is in fair condition structurally, with minor concrete cracking noted in the center wall. Because the solid state starters were replaced recently, the electrical components for Pumps No. 2, 3, 5, and 6 are in good condition. Controls improvements, such as adding VFDs to constant speed pumps, could improve reliability, operational redundancy, and operating characteristics, including energy and cost savings. To restore normal operation, the inoperable VFDs should be replaced immediately. Figure 2.24 shows photos of select components.

Left: Low Lift Pump No. 6 not in operation at time of assessment.

Right: Low Lift Pump No. 6 showing minor corrosion internally.

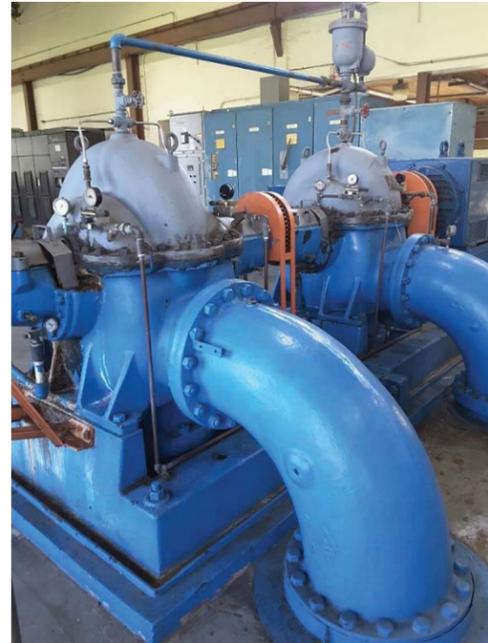
Left: High Service Pump #3 not in operation.

Right: High service discharge piping showing deterioration and corrosion.

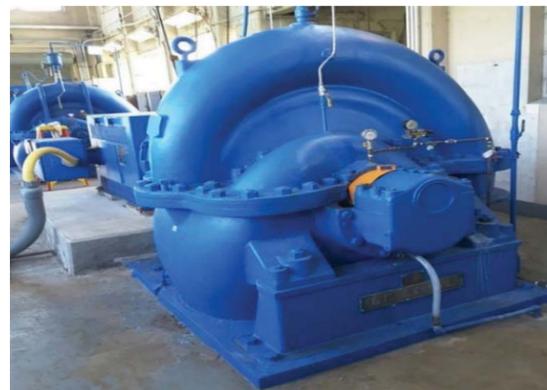
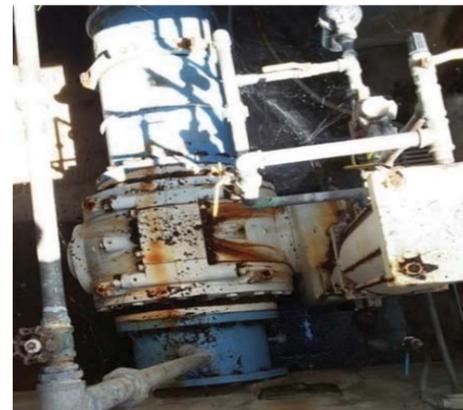
Left: High Service Pump #5.

Although the pumps were originally installed in the 1960s, they are in fair condition. However, they have not been rebuilt for over 10 years. The vibration report noted rough vibration for Pump No. 6. The overhead crane system is in overall good condition.

The pumps' associated ball valves and piping coatings are in poor condition and require sand blasting and repainting. Transformer TRC01-2, associated with Pump No. 6, is in good condition. However, leakage through the valve was noted, and the transformer needs a new actuation device or valve. The transformer for Pump No. 5 (TRA01-1) is in good condition.

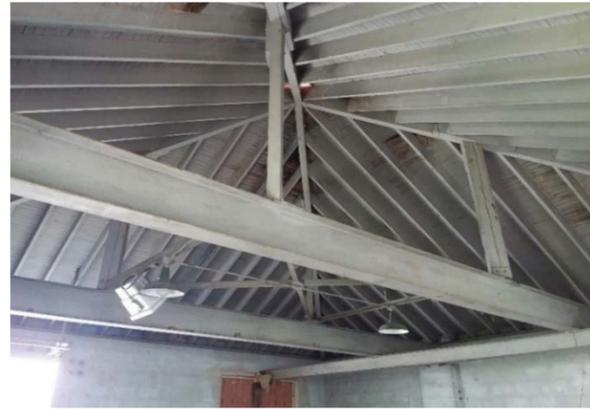
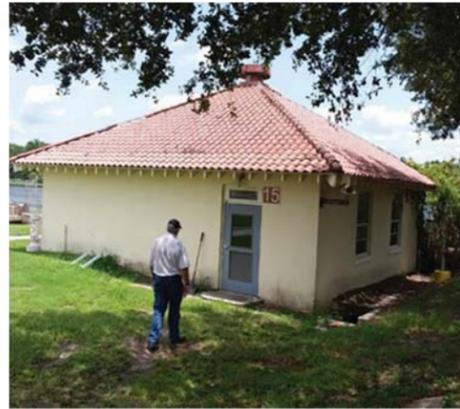
The Old Raw Water Building's superstructure, shown in Figure 2.27, has a concrete dry well foundation with a masonry wall and a wood frame supported by steel beams. The interior floors are concrete, and the shell walls are masonry. The existing roof system is clay barrel tile, and the decking is wood.

Left: Roof with daylight and rotting.

Right: Old raw water pump building superstructure.

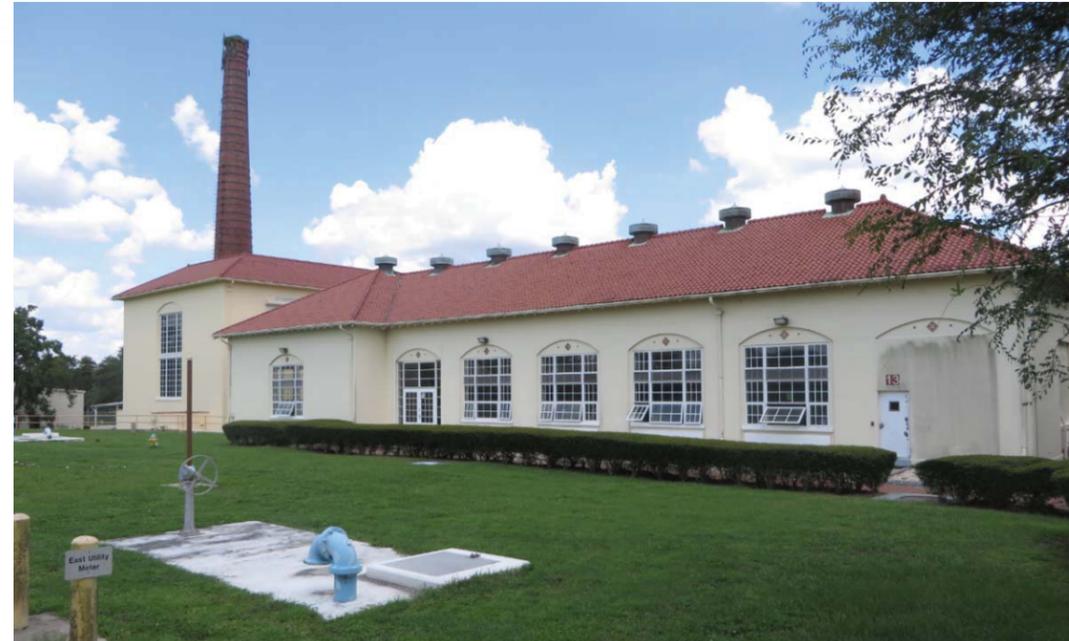
The High Service and Raw Water Pumps share a common superstructure, shown in Figure 2.27. This structure has a cast-in-place concrete frame with a slab steel support pump and a wood ceiling. The upper portion of the building serves the High Service Pumps No. 1 through 4, while the lower floor houses the Raw Water Pumps No. 6 through 9 as well as suction and discharge piping for the High Service pumps. Inside the building, the floors are also cast-in-place concrete. The few interior partitions are wallboard on stud framing.

High Service and Lower Floor Pump Room Building.

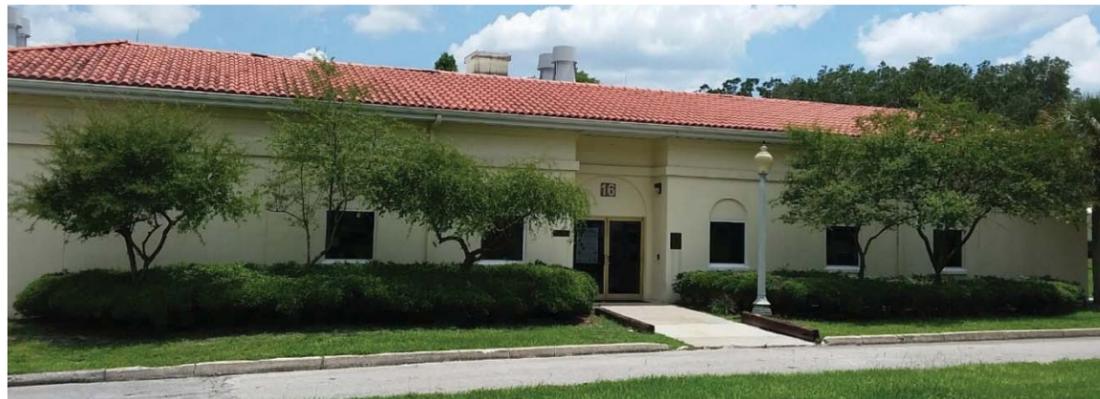
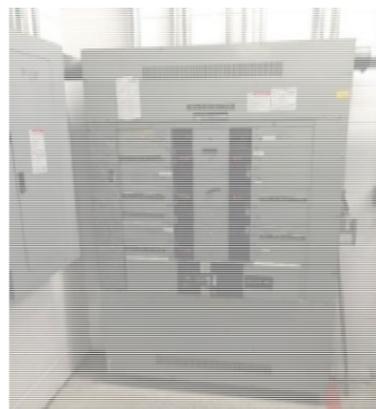
The building's interior was completely renovated in 2015. However, the main electrical panel was not upgraded and was in poor condition. The exterior light fixtures attached to the building are also in poor condition. The light switches/controls and interior light fixtures are in good condition. The power distribution equipment including panels, shown in Figure 2.27, are in good condition, although the main panel (PP1) had considerable wear and it should be considered for replacement in the next 5 to 10 years.

Top: Lab Building.

Left: Power distribution panel.

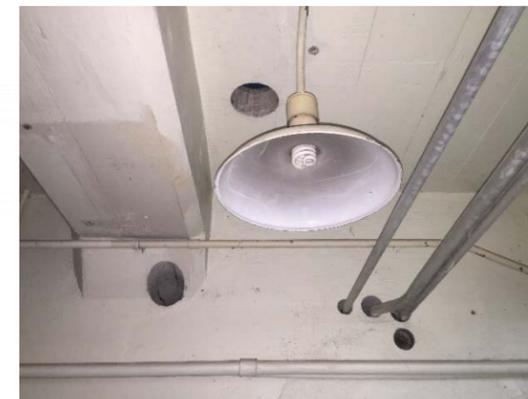
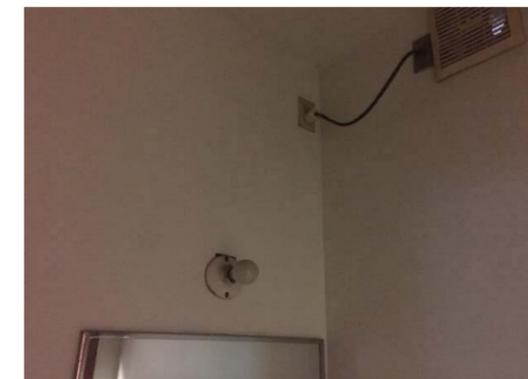
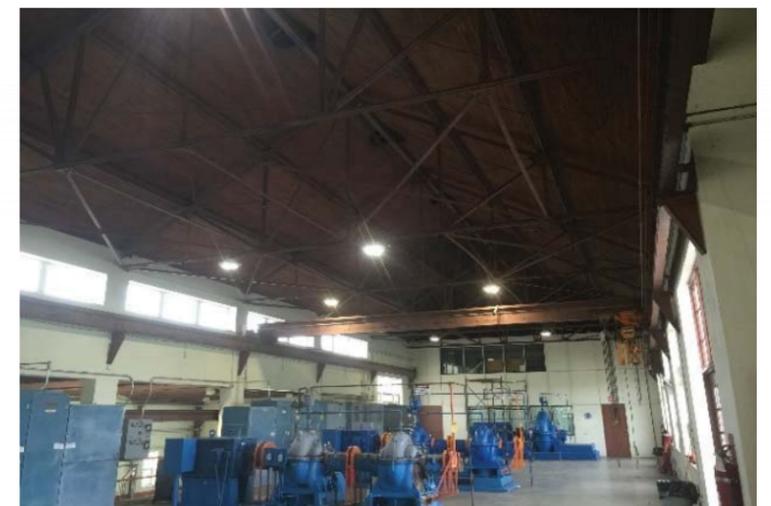
Top & Bottom Left: Outdated light fixtures.

The electrical is in fair to good condition and varies throughout the space. For example, LED, incandescent, CFL, and fluorescent lighting is found in various locations throughout the building, as shown Figure 2.27.

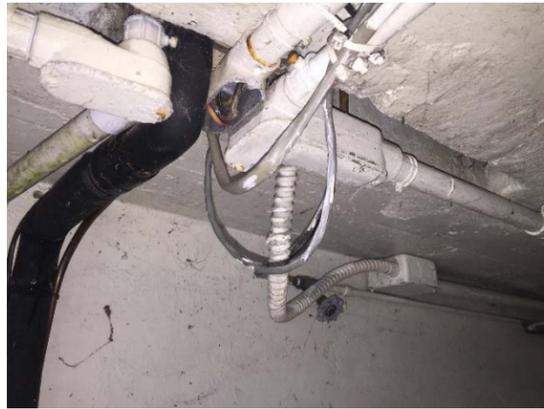
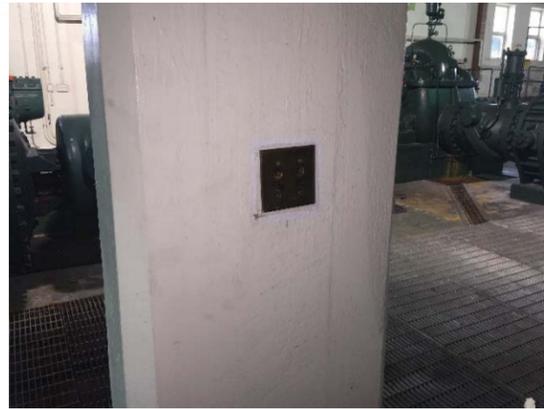
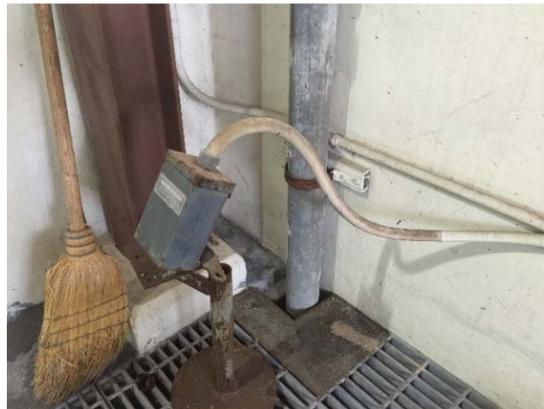
The exterior attached light fixtures, the interior light fixtures, and the light switches/controls are in fair condition overall. However, updated fixtures are needed in the lower level of the building shown in Figure 2.28. Upgrading the interior finishes and renovating the conditioned spaces and lower level lavatories are also recommended.

Photo
High Service and Lower Floor Pump Room Building
Top & Bottom Left: Electrical conduit in poor condition.
Top Right: Outdated light switch panel.

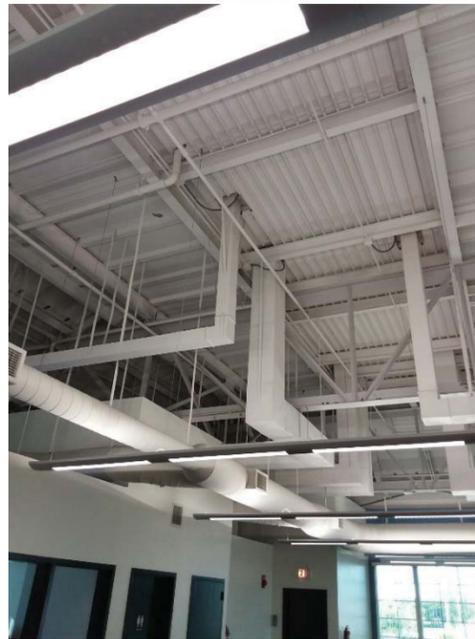
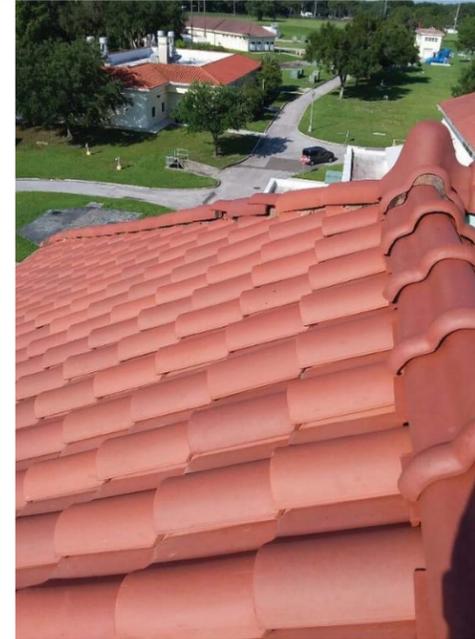
Photo
Maintenance Building
Left: Exposed ceiling on third floor.
Right: Maintenance Building Roof.

Overall, the Maintenance Building is good condition. However, the frame, shell roof (shown in Figure 2.27), and signage are in fair condition. Furthermore, the adjacent smoke stack structure is in very poor condition although plant staff noted that this structure was inspected in 2011. Staff also reported a leak near the hatch in the center of the building at the built-up roof. The leak should be covered under the existing warranty.

Inside the building, most of the ceiling is exposed, with no ceiling system in place. Areas with ceiling systems are in good condition as shown in Figure 2.27. On the egress stair, paint is peeling.

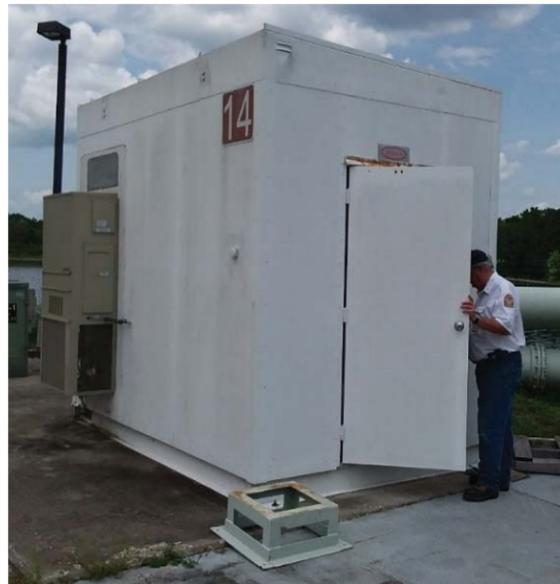
The Raw Water VFD Building's superstructure has a prefabricated foundation and houses VFDs for Raw Water Pumps No. 2 and No. 3. Its frame, interior floors, and roof are insulated metal panel construction. Overall, the building is in good condition, as shown in Figure 2.28.

Photo
Raw Water VFD Building.

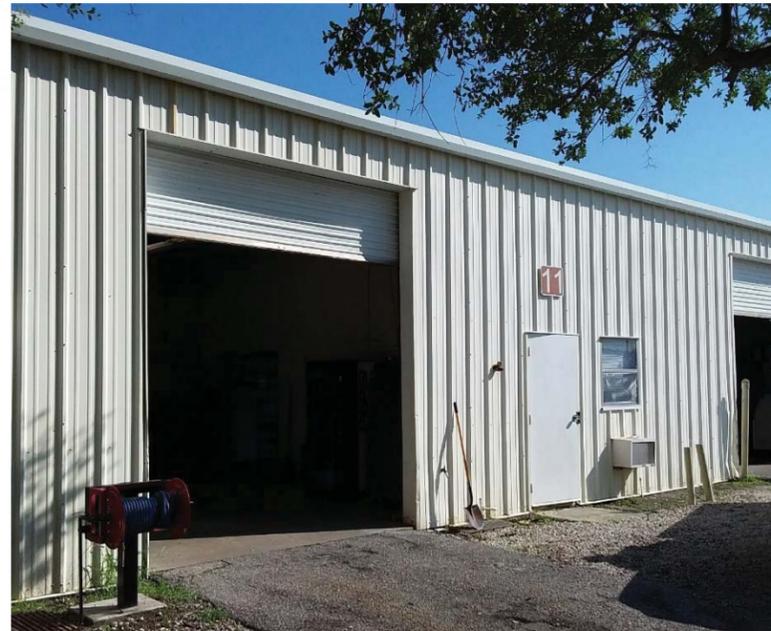
Photo
Utility Building.

This building is in overall fair condition, as shown in Figure 2.28. Although the bathroom and office have ceilings, the building's main interior space does not. Furthermore, the foundation, frame, interior ceilings and floors, shell doors, roof, and walls, signage, and structure are in fair condition. The interior walls are in poor condition.

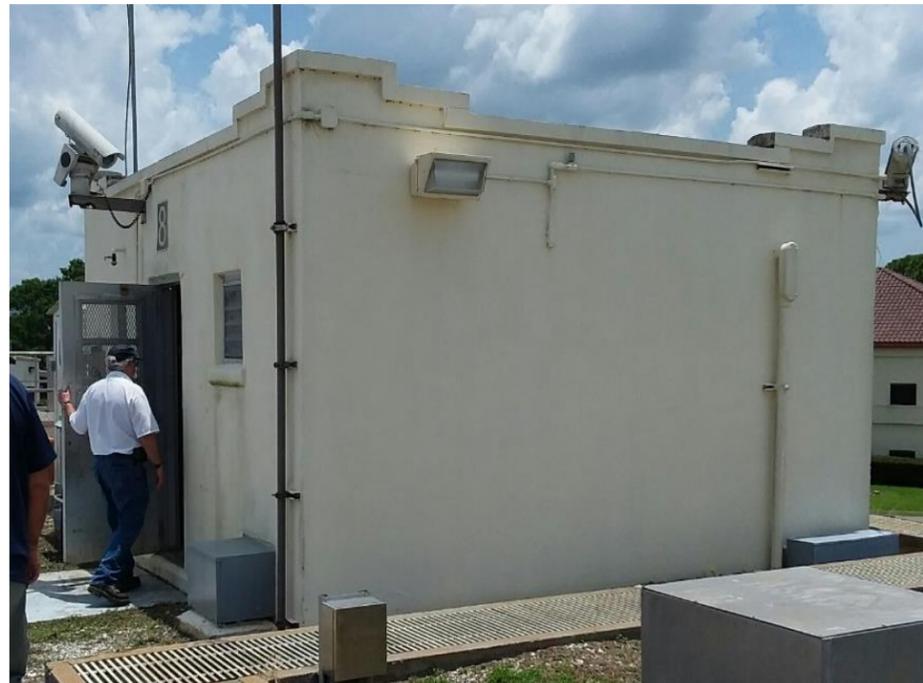
The building's foundation, frame, and shell windows are in fair condition. The shell doors and interior floors are in poor condition.

The Basin Control Building electrical lighting and receptacles are in poor condition. Thus, replacing them with LED type lighting is recommended.

Photo
Basin Control Building.

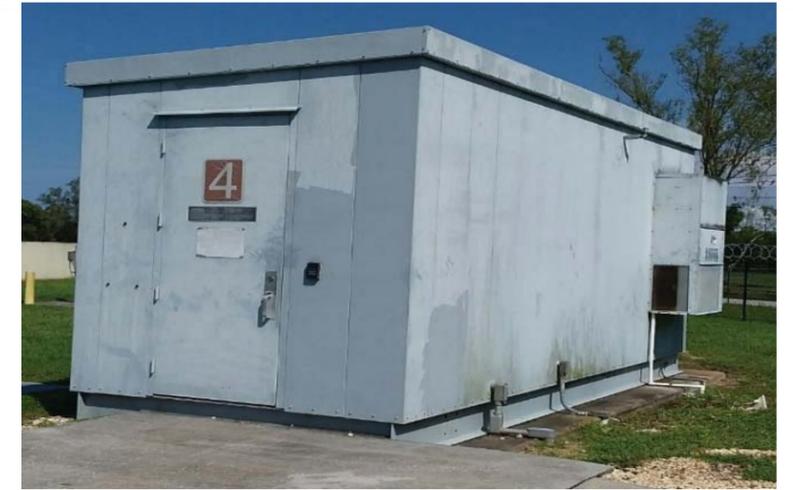
The E House Building, shown in Figure 2.30, has a prefabricated frame with steel walls roof panels. The interior floors and main roof are part of the prefabricated unit. Overall, the building is in good condition. It does not have exterior light fixtures, and the electrical is in good condition.

Photo
E-House Structure.

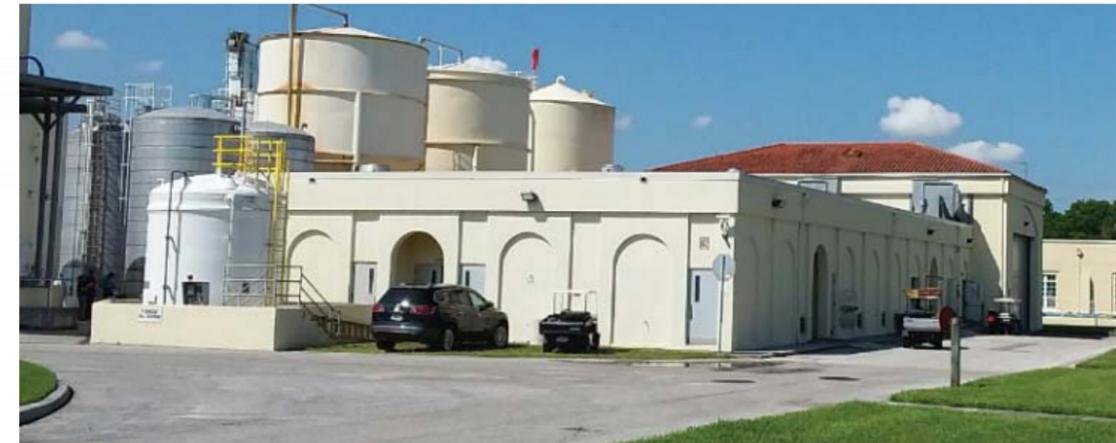
The Chemical Building's frame, constructed in 1991, is made of masonry walls with precast joists and a concrete deck roof slab. Installed in the year 2000 with a 30-year warranty, the roof is a flat built-up roof with barrel tile, as shown in Figure 2.30. The building's structure is made of concrete.

Photo
Chemical Building Structure.

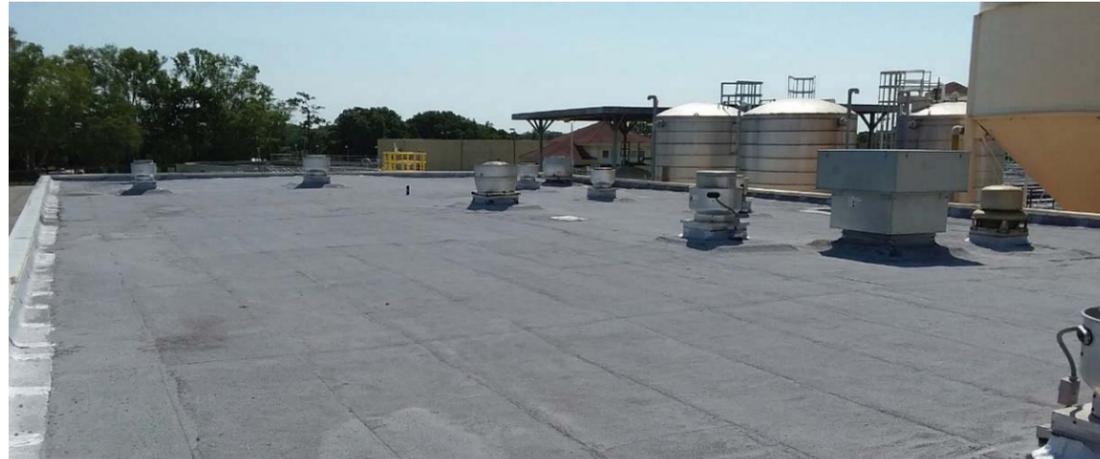
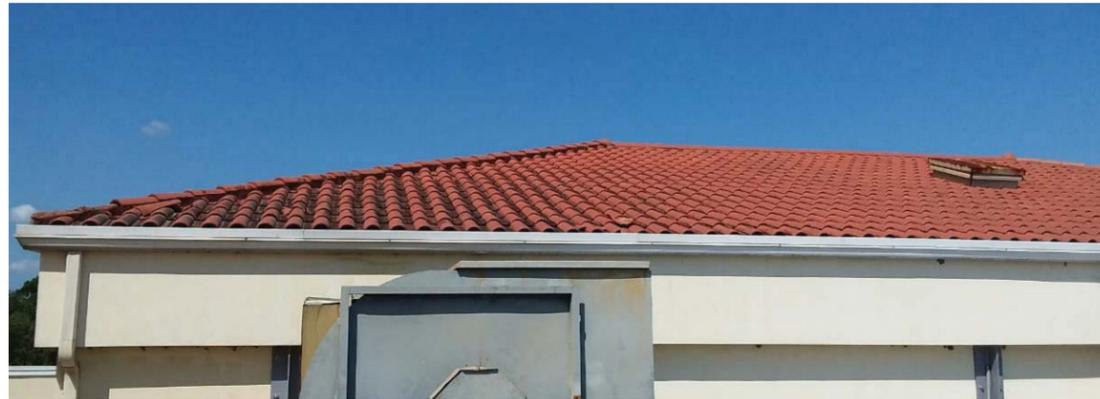
Photo
Chemical Building
Top: Low flat roof system.
Bottom: Upper clay tile roof system.

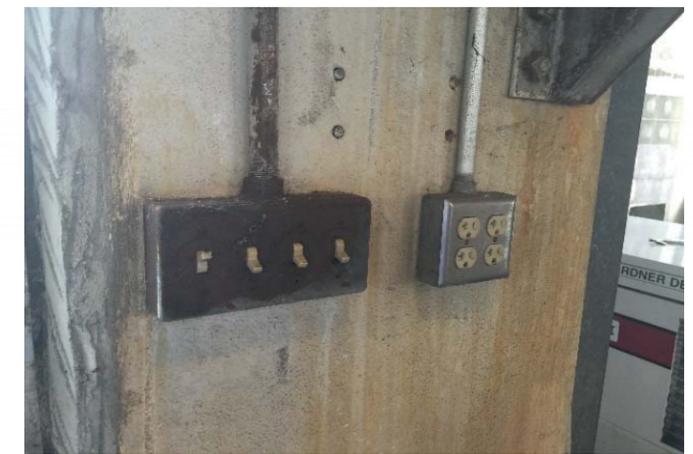
Photo
Accelerator Building lighting, switches, and electrical panels in poor condition.

The electrical systems are in poor condition. The SCADA Improvements project will address the building's electrical issues and use it as the breaker building for the administration building filters, with added redundancy. Under this project, the compressors will be relocated to another area. New windows will also be installed, and some air conditioning improvements will be made.

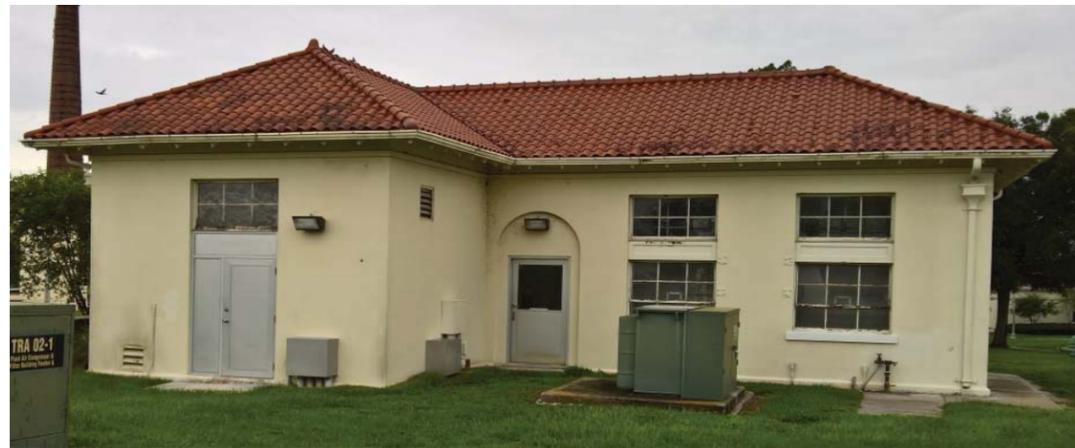
Photo
Accelerator Building Structure

Overall, the Accelerator Building is in poor condition. The cement plaster ceilings are cracking in some areas. The shell windows are in poor condition; the steel frame windows are old and in need of major repair or replacement. The foundation, frame, interior floors and walls, and signage are in fair condition, and the interior ceilings and shell windows are in poor condition. To prevent further deterioration, renovating the building within the next 5 years should be considered. The building's function is being reconsidered, possibly to house switchgear.

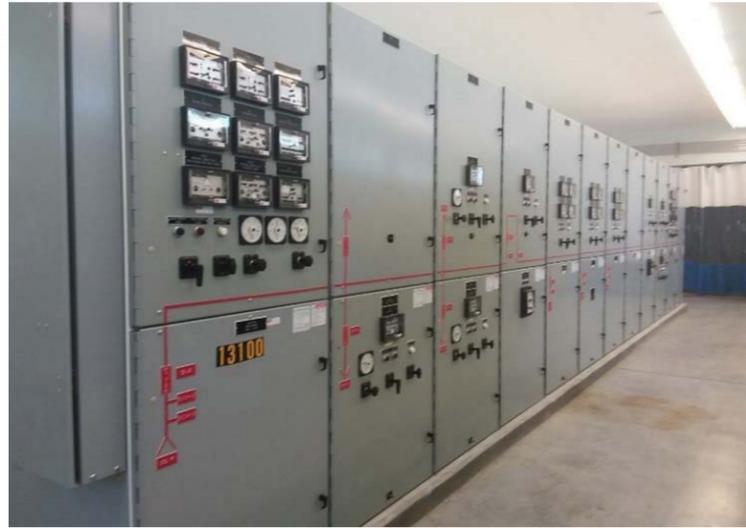
Two TECO 13.2KV feeders serve the DLTWTF, identified on-site as 'A' (#13100) and 'C' (#13260). The main switchgear, as shown in Figure 2.34, is in good condition. As such, no recommendations are made within the 15-year planning horizon.

Photo
Main switchgear in good condition.

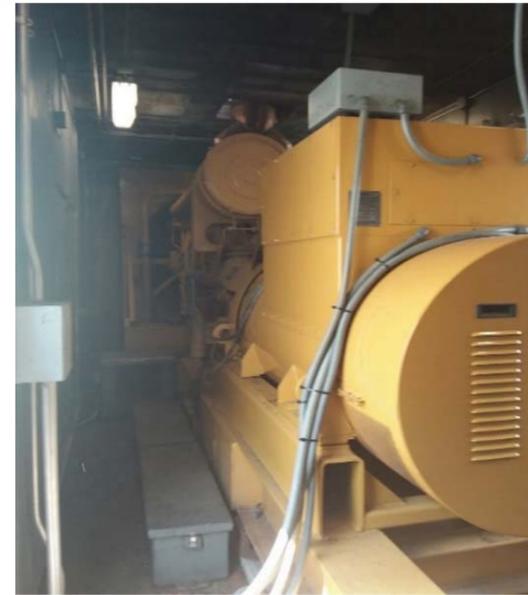
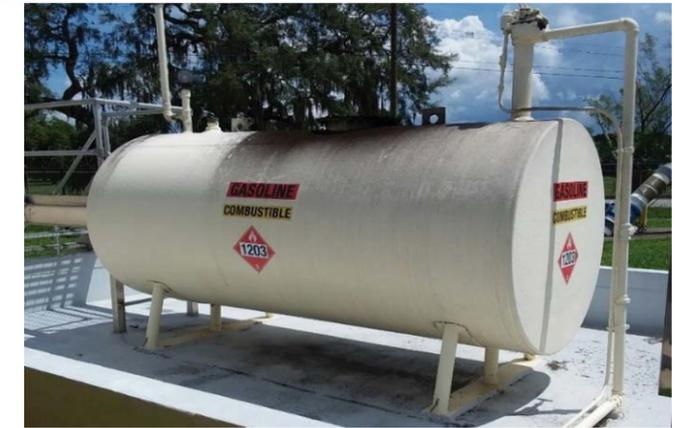
Generators 1, 2, and 3 are in good condition, with moderate criticality. No oil leaks were visible, and continuing routine maintenance is recommended for oil changes, filter changes, battery/charger testing, etc. The generator switchgear is in good condition.

The fuel storage tanks, as shown in Figure 2.34, are also in good condition with severe criticality. A project is currently in place to add a fourth generator and replace the pumps in the fuel storage tanks.

Photo
Left: Generator (one of three).
Right: Fuel Tank.

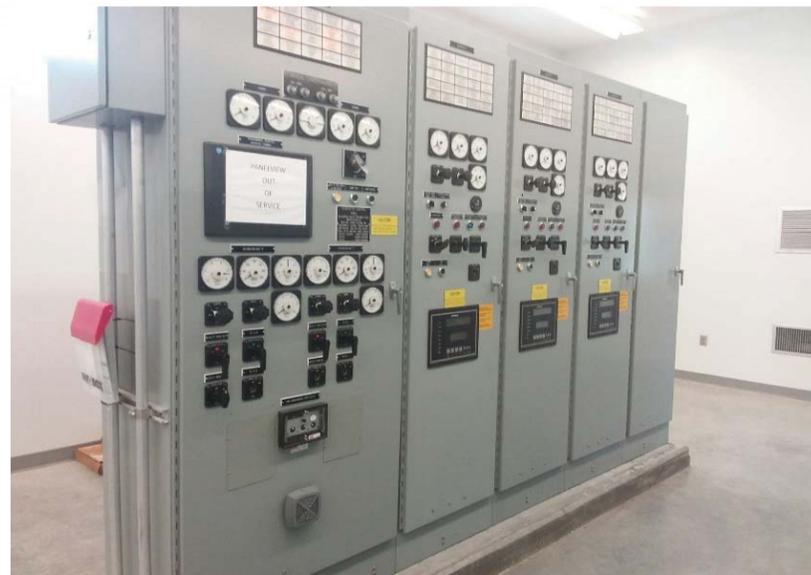
Photo
Generator switchgear panel.

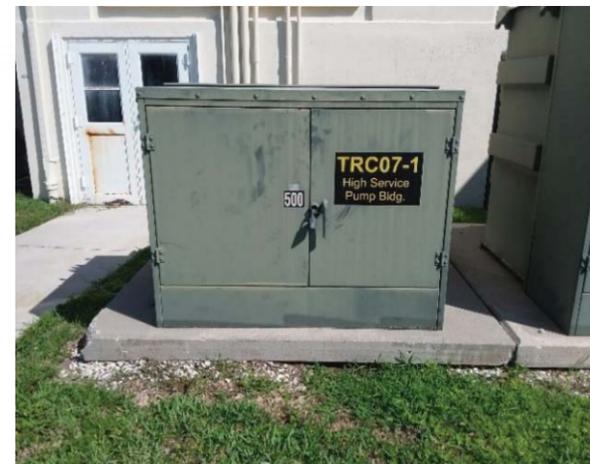
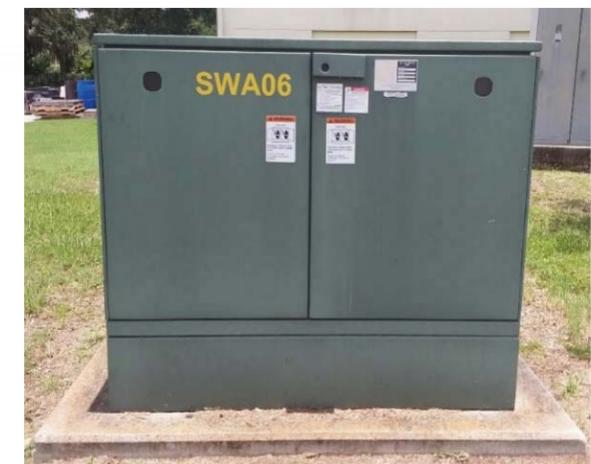
Photo
Left: TRC07-1.
Right: SwitchSWA06.

The looped primary around the site has nine sectionalizing switches for each feeder (A and C). Switches SWA01 through SWA09 and switches SWC01 through SWC09 are in good condition, with moderate criticality.

Most of the pad-mounted transformers were installed in 2000 and are recommended for cleaning and washing. Replacing renewal parts, such as gaskets, oil, etc., plant-wide is also recommended to continue as preventative maintenance to help prevent failures or leaks.

The following transformers should be changed: TRA02-1, TRA03-1, TRA06-1, TRA07-1, TRC02-1, TRC03-1, TRC07-1 and TRC08-1. Figure 2.34 shows photos of TRC07-1 and SWA06.
