TAMPA WATER WORKS

The David L. Tippin Water Treatment Facility Master Plan

July 2018
Volume 1 of 2

DAVID L. TIPPIN WATER TREATMENT FACILITY MASTER PLAN

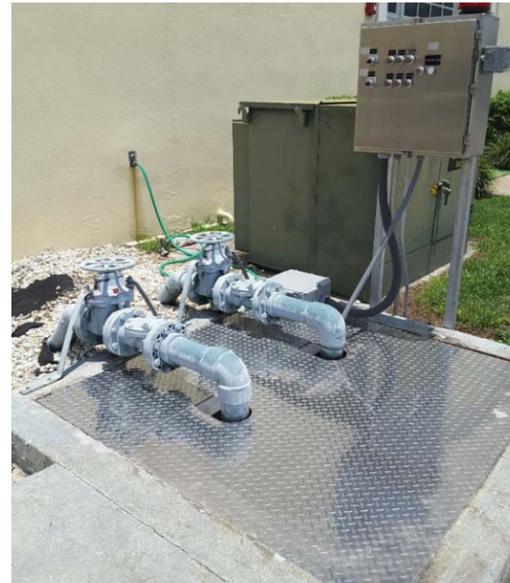
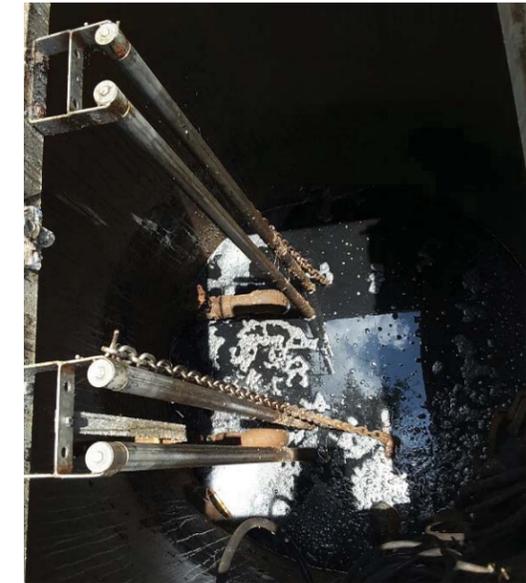
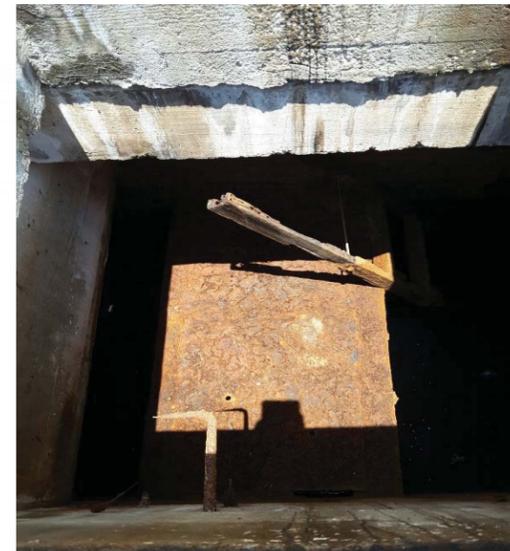
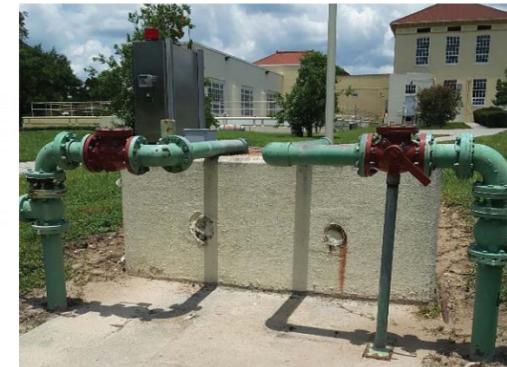
The maintenance wastewater lift station located just outside of the maintenance building is in fair condition, with pumps recently installed. Thoroughly assessing the interior of this structure is recommended.

The main wastewater lift station, located just south of the Administration building, is in good condition, with new pumps and check valves. The structure needs cosmetic attention due to minor corrosion and spalling concrete. The Parts Wastewater Lift Station, consisting of a duplex pump station, is in good condition.

Photo
Top & Bottom Left: Maintenance Lift Station with interior in fair condition.
Top Right: Parts Lift Station in good condition.
Bottom Right: Main Lift Station with new valving.

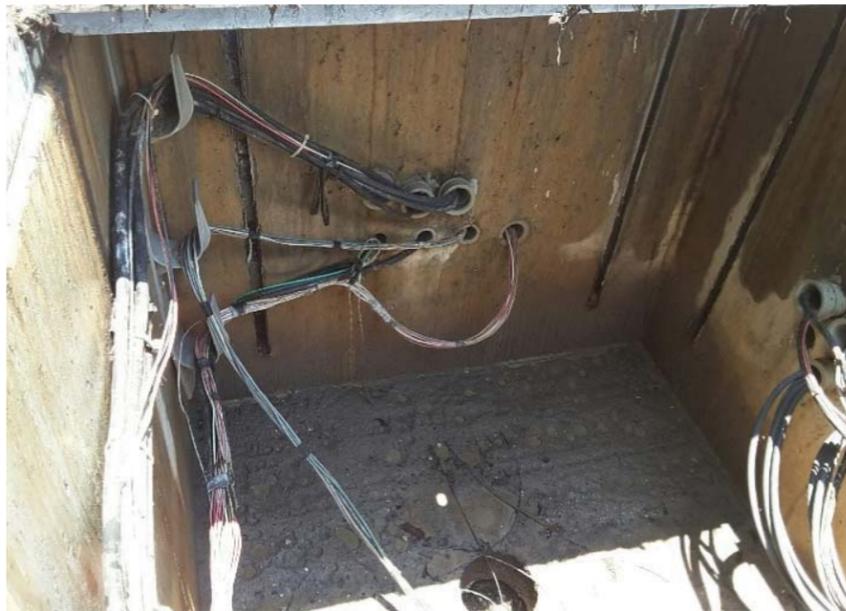
The chemical manholes throughout the site were inaccessible. However, they are assumed to be in fair condition because of their age. The site-wide electrical vaults are in good condition, with no notable issues.

Photo
Electrical Vault in good condition.

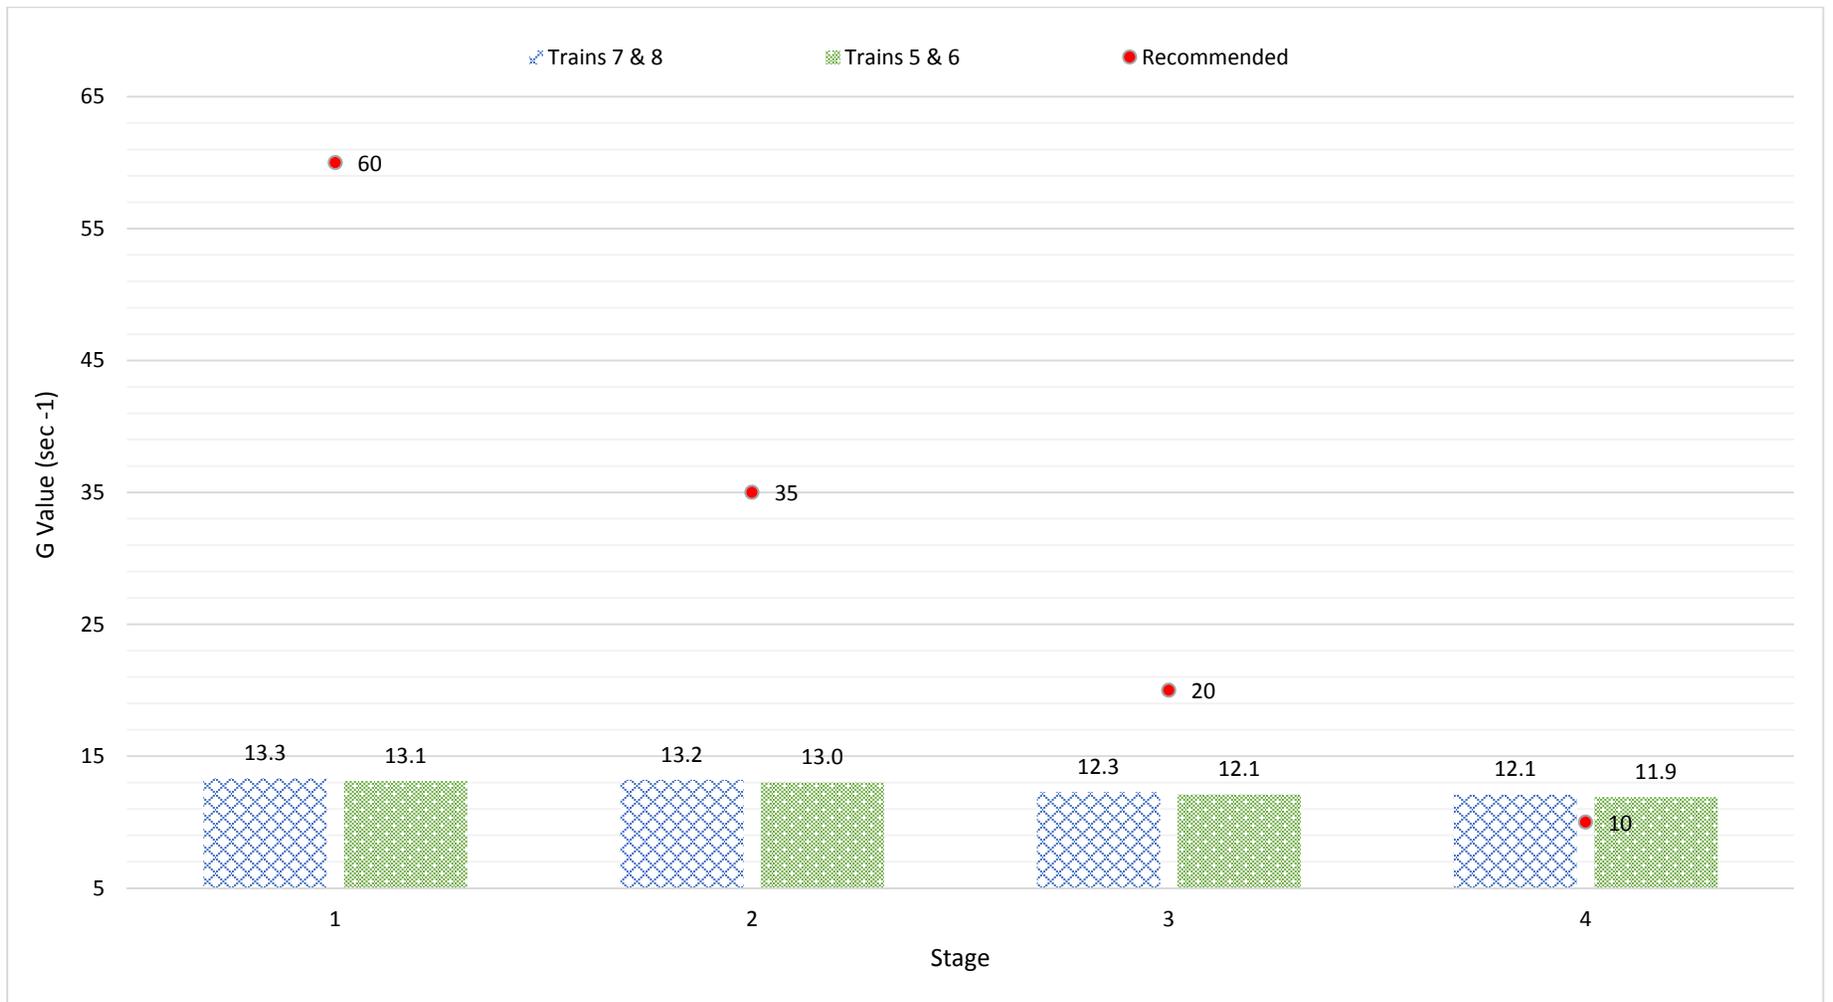
FIGURE 3.6

The mixing energy for all stages is too low. Also, floc sedimentation is reported in the flocculation basins, further reducing the theoretical detention time. A pitched blade flocculator has more shear than other lower shear flocculators (like hydrofoils or paddles), and the selected G value is likely a balance between shearing floc and too much settling, especially after polymer is added. Settling reduces the volume in the flocculators, effectively making the floc basins smaller and reducing the detention time. Figure 3.6 shows the recommended range for each stage compared to the actual mixing energies.

At lower coagulation doses, mixing energy within the flocculation basins becomes more vital to proper floc formation because, with less floc in the water, more collisions are required. Low mixing energy can cause sludge accumulation in the basins and further reduce the volume available for flocculation.

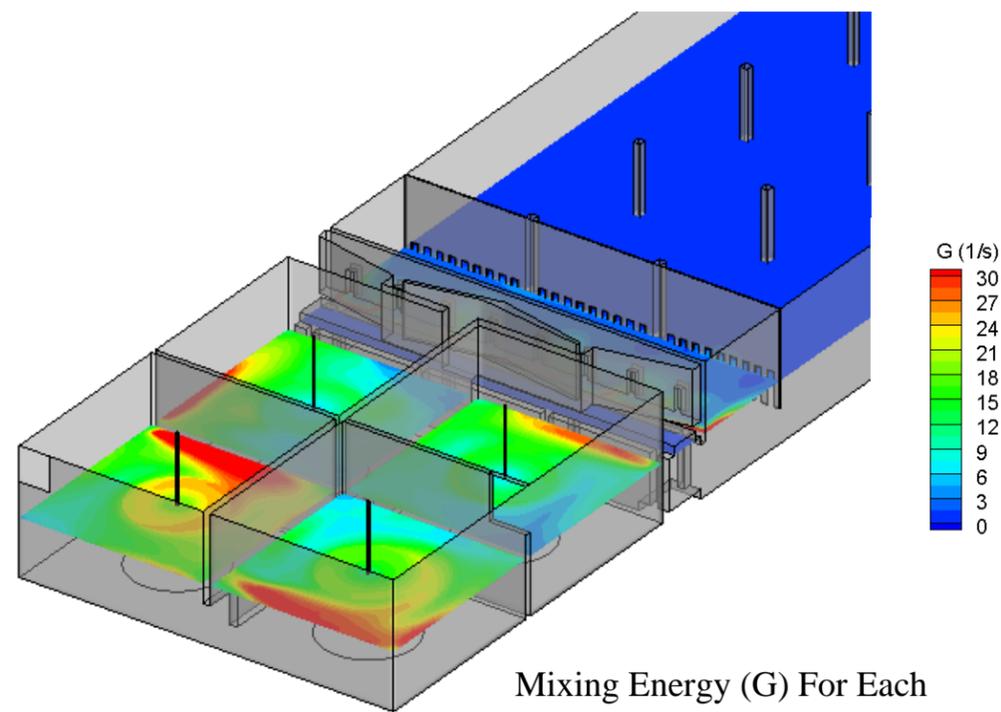
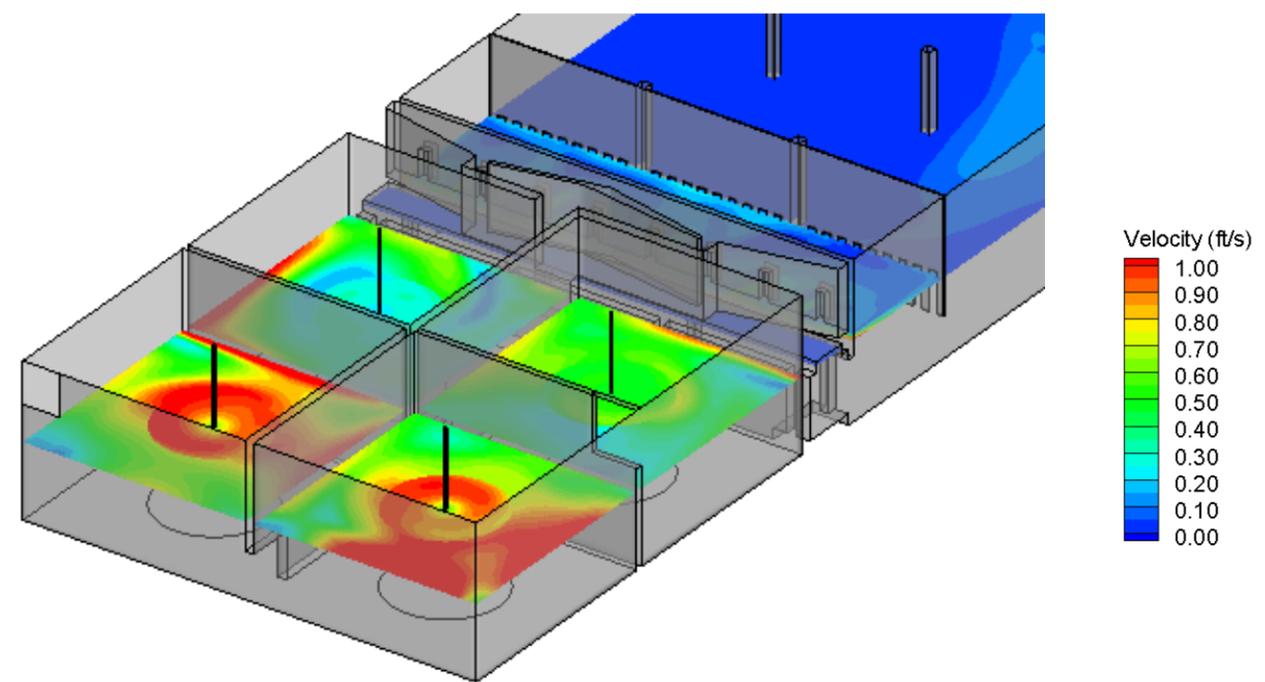
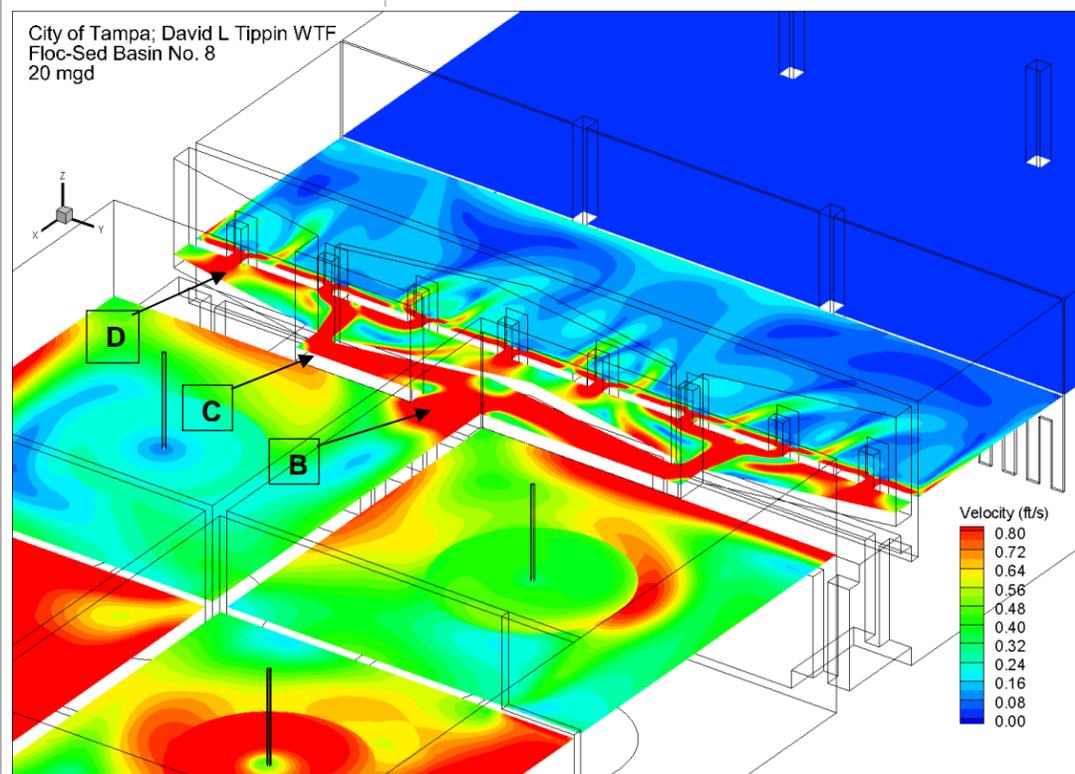
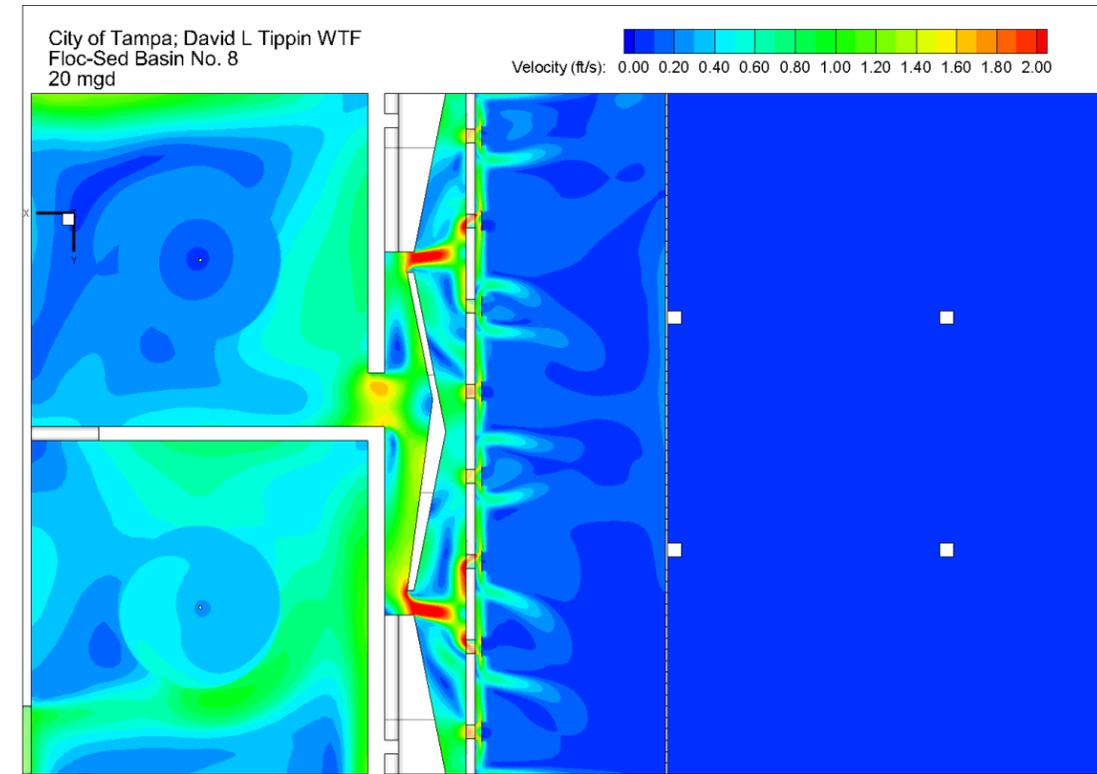
FIGURE 3.10

Figure 3.10 shows the flow distribution, velocities, and mixing energies for the flocculation basins and ports to the sedimentation basin via plan view. As shown, the mixing energy varies from 12 to 20 sec⁻¹ for most of the basin. The mixing energy is lower than recommended and is also not significantly tapered (decreasing from stage to stage). Higher energies and velocities are realized at various locations in the basin and can signify short-circuiting.

Overall, the CFD modeling supported previous assertions about issues with short-circuiting, insufficient mixing, sludge accumulation, high port velocities, and poor distribution in the existing system.

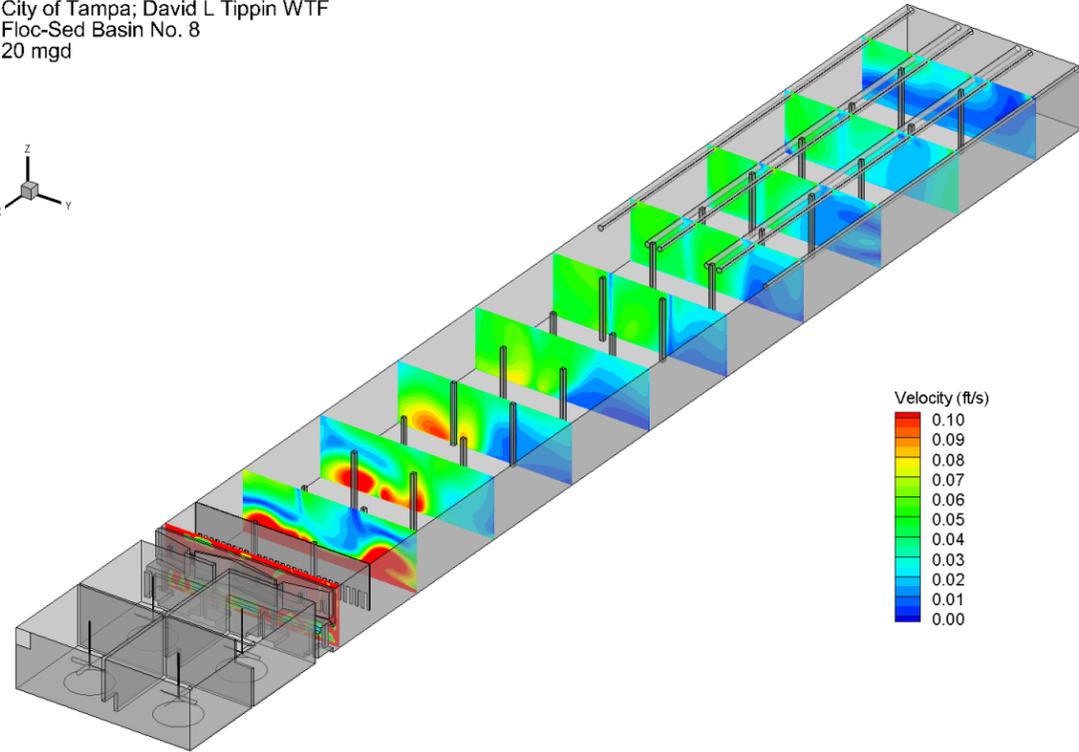
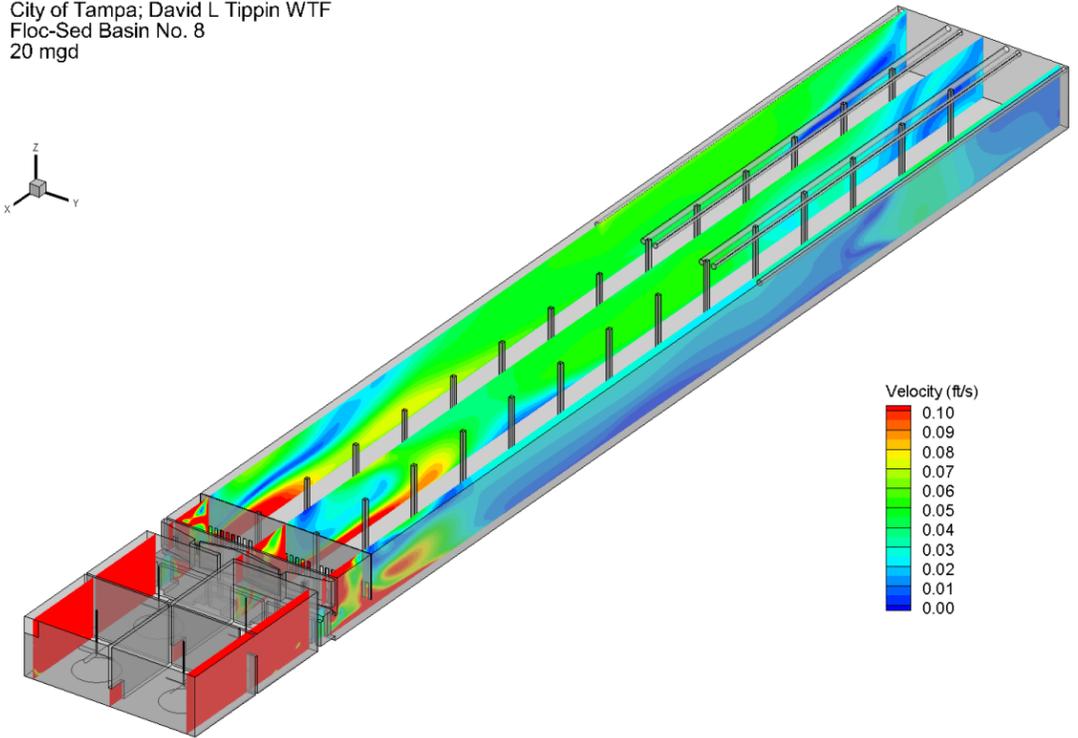
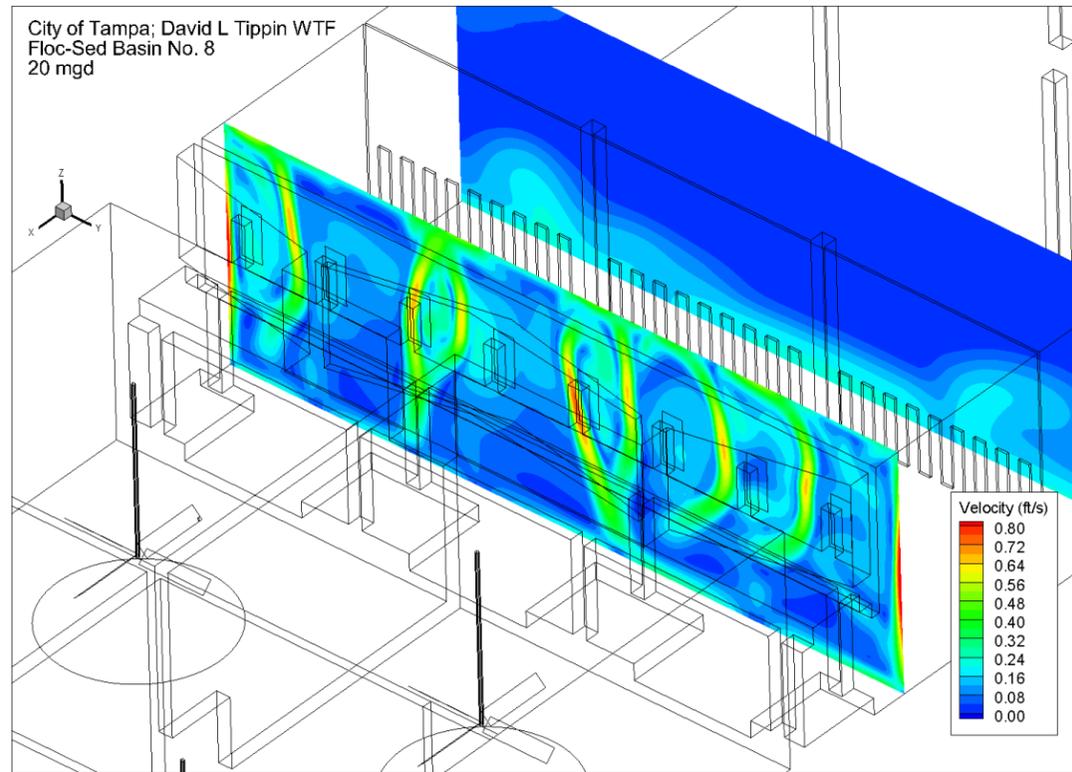
FIGURE 3.11

Figure 3.11 shows the profile view results. As the figure shows, poor distribution in the sedimentation basin is occurring, where velocities on the left side of the basin are higher than the right side. Higher velocities at the bottom of the basin are also likely causing resuspension of previously settled floc.

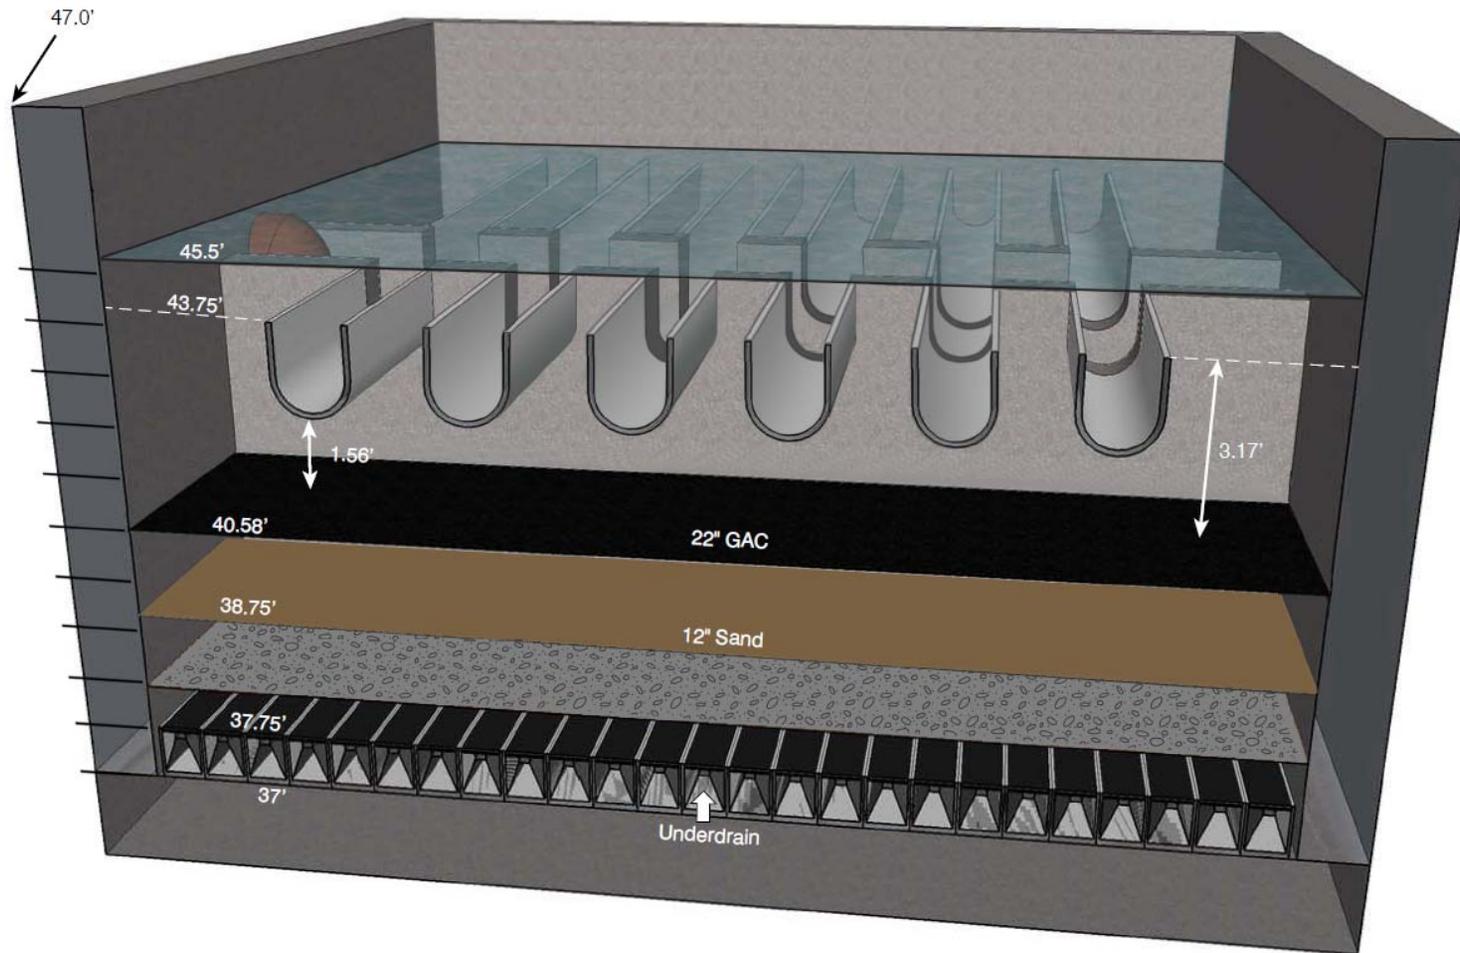
FIGURE 3.13

The filter box for all of the filters is 10 feet deep, which meets the Ten States Standard requirement of 8.5 feet deep, although industry standards typically recommend 13 feet. A 10-foot deep box can be effective, given the optimization of the box's dimensions. Figure 3.13 and Figure 3.14 show the filter box's dimensions and critical aspects of the filter layout. Table 3.19 compares the actual dimensions with the optimal dimensions.

The distance from the operating water level to the top of the media provides the driving force through the media which is currently over one foot shorter than the optimal distance. This reduces driving head and limits the allowable head loss. Ultimately, this limits the filter run time if head loss controls filter backwashes.
