Department of TRANSPORTATION AND STORMWATER SERVICES STORMWATER ENGINEERING DIVISION

DITCH STABILIZATION PROJECT

CONTRACT NO. *16-C-00029*

COVER SHEET

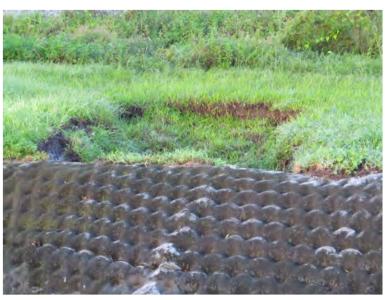
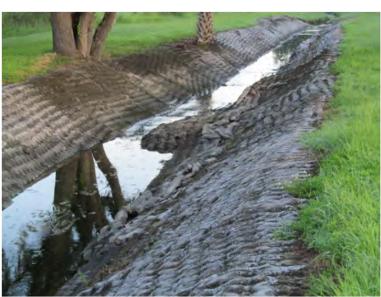
Overflow Caused Erosion Under the Concrete Mat

Flow Under Mat Moved from West to East

Many years ago much of this ditch was lined with fabric formed concrete. In recent years the CSX railroad has not maintained the ditch running along the east side of their tracks and as a result runoff accumulates in the ditch. During major storm events this water overflows out of the CSX ditch into the City's ditch. This overflow has found its way under the fabric formed concrete, eroding under the formed concrete approximately 350 feet north to the river, until it meets an intersecting lined ditch. At this point it has burst through the formed concrete, leaving a trail of broken and displaced formed concrete in its wake.

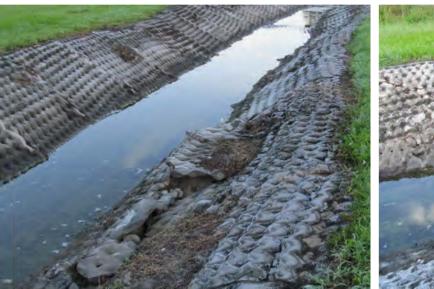
Flow Under Mat Displaced and Broke Mat

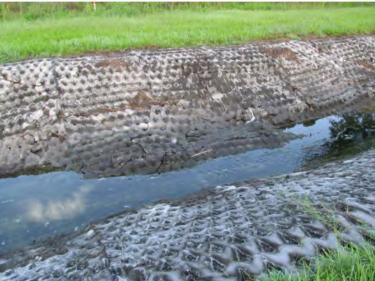
Flow Under Mat Displaced and Broke Mat

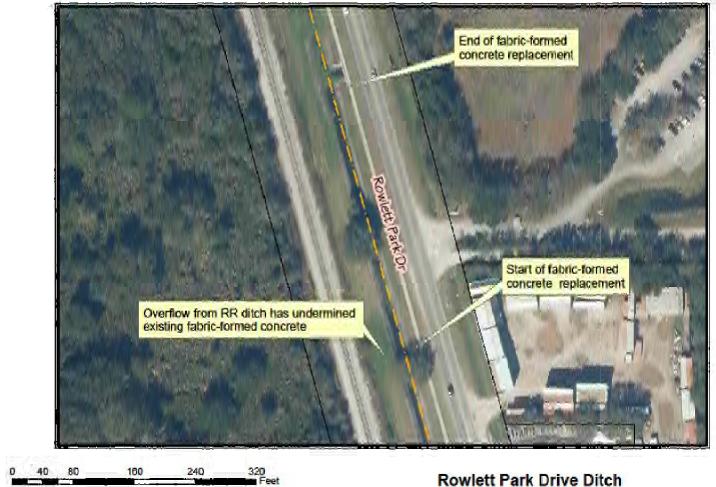
Rowlett Park Drive Ditch

This project will replace the damaged fabric formed concrete with new formed concrete such as Hydrotex Filter Point FP400. The existing formed concrete will be removed and disposed of off-site. No topographic survey has been conducted and the original construction plans are not available in the city archives. The ditch bank and bottom will be filled and graded to provide a continuous grade between the limits of the work. Side slopes will be a maximum of 1:1 and the bottom width shall be comparable to existing ditch width downstream (approximately 9 feet wide). At the location where the CSX ditch overflows into the City ditch, a new swale will be constructed to intersect with the City ditch and lined with fabric formed concrete. All fabric formed concrete will be placed atop of a filter fabric such as Mirafi 170N nonwoven geotextile and installed per manufacturer's guidelines. Contractor will notify CSX of work schedule and all work will be performed outside the CSX right of way. All disturbed area not covered with the concrete mat shall be sodded with Bahia grass.

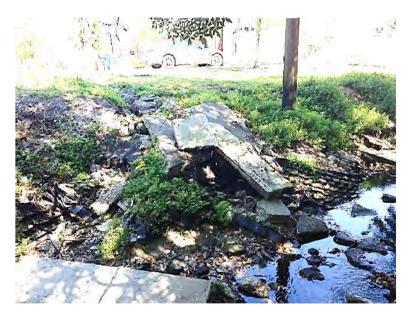
Terminus at N. Lincoln Ave.

At the Lincoln Ave location there is evidence of a cellular confinement erosion control system installed years ago which has been compromised and exposed. Subsequent maintenance work at this location was limited to randomly placing rubble rip-rap. The terminus of N. Saint Vincent is subject to the same type of erosion, but this location has no evidence of erosion control. Presently the erosion at this location is isolated to the west side of the roadway and appears to be held in check so far by the tree roots.

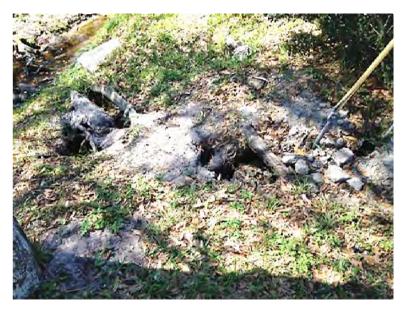
Terminus at N. Saint Vincent Ave.

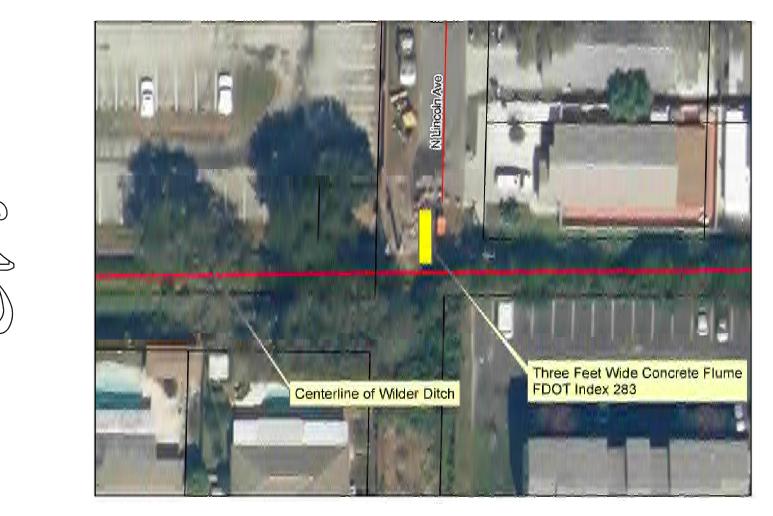
Figure 2 - Wilder Ditch at N. Lincoln Ave.

This project will address the existing condition of the northern ditch bank at the terminus of both streets: N. Lincoln Ave. and N. Saint Vincent Ave. The scope of the project will include removal of existing rubble rip-rap and cellular confinement erosion system at Lincoln Ave. and installing a concrete flume from the edge of pavement to the bottom of the ditch as shown on Figure 2. At the terminus of Saint Vincent Ave. a concrete flume will be constructed as shown on Figure 3. Proposed flume shall conform to FDOT Index 283 and 8" - 12" sized rubble rip-rap shall be installed in the ditch bottom at the flume outfall. Disturbed areas at both locations will be filled with soil, graded to restore the slope, covered with a turf mat such as VMax C350 by Tensar, and sodded with Bahia sod. Contractor shall remove all debris from the site, except the rubble rip-rap which may be used at the base of the flume in the ditch to minimize scour. Proposed system to stabilize the ditch bank shall minimize impact to existing trees and shrubs on the bank and shall not alter the flow capacity of the ditch. Work shall be conducted within the limits of existing easement and right of way, unless adjacent property owners grant temporary access to the contractor.

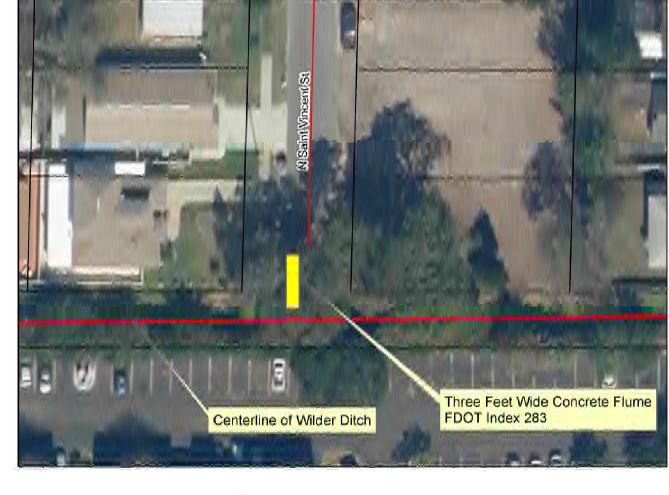
o 15 30 60 90 Feet Figure 3 - Wilder Ditch at N. Saint Vincent Ave.
