Residential and Neighborhood Commercial Rehabilitation

Statements of Intent of Zoning Ordinance

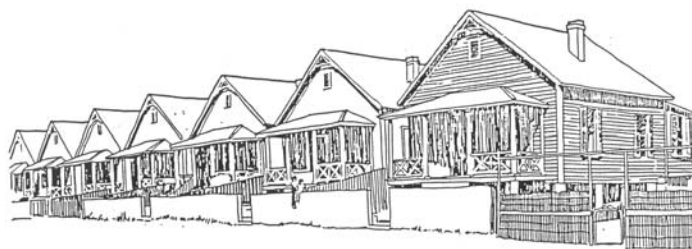
Constructed of wood balloon framing on open brick pier foundations, the houses are characterized by covered porches, horizontal lapped siding, paneled doors and double-hung sash windows.

Typical residential street

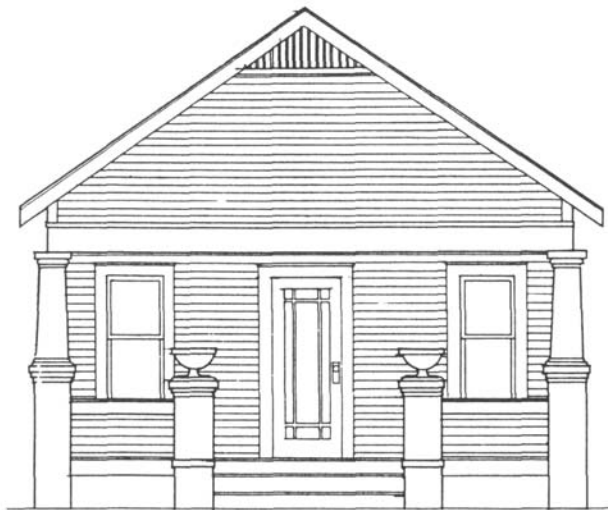
The residence on the left has retained the original structural and decorative elements which make it a distinctive, historical house. Windows, doors, porch supports, decorative urns and exterior siding are suitable for the style and age of the house.

Appropriate residential rehabilitation

The illustrations on this page contrast a residence which has been sympathetically rehabilitated with one which has lost its visual integrity to rough inappropriate modernization.

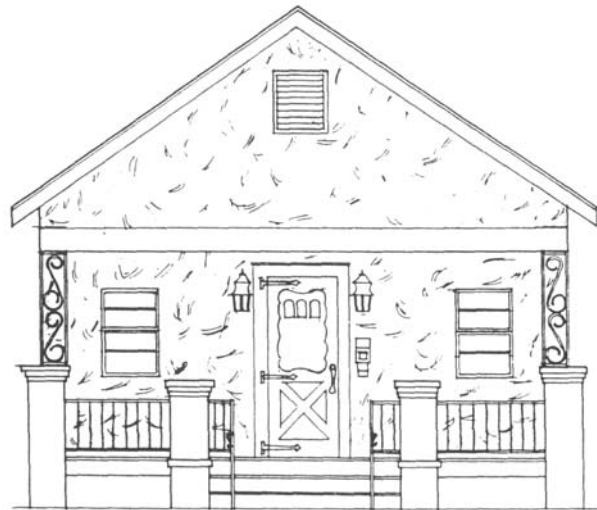
The residence to the right has been modernized with a combination of inappropriate building materials and decorative items which detract from its historicity and charm rather than enhance or refurbish it. Inappropriate replacement windows, doors, porch supports, railings, exterior siding and decorative lamps and door hinges have altered the houses appearance without improving it.

Inappropriate residential rehabilitation

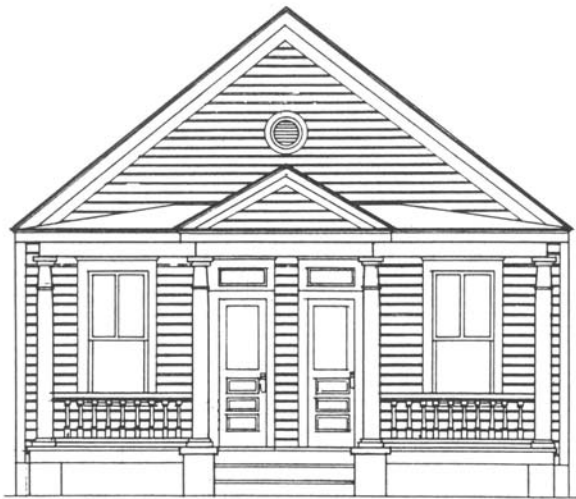
Appropriate residential rehabilitation

The duplex structures shown on this page contrast a proper, sympathetic rehabilitation and one that strips the structure of all interest and appeal.

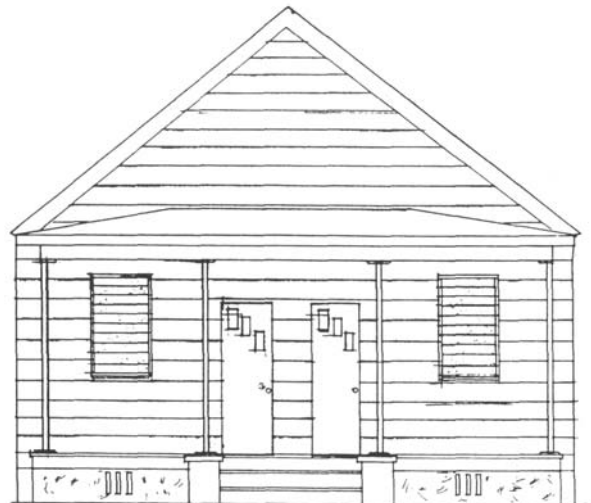
The loss of the porch pediment, the vent in the gable, the wooden columns which support the porch roof, and the turned porch railings deprive the house of needed style and ornamentation. The replacement of original doors and windows with flush doors and jalousie windows detracts from the appearance, as does the stucco material used on the foundation.

Inappropriate residential rehabilitation

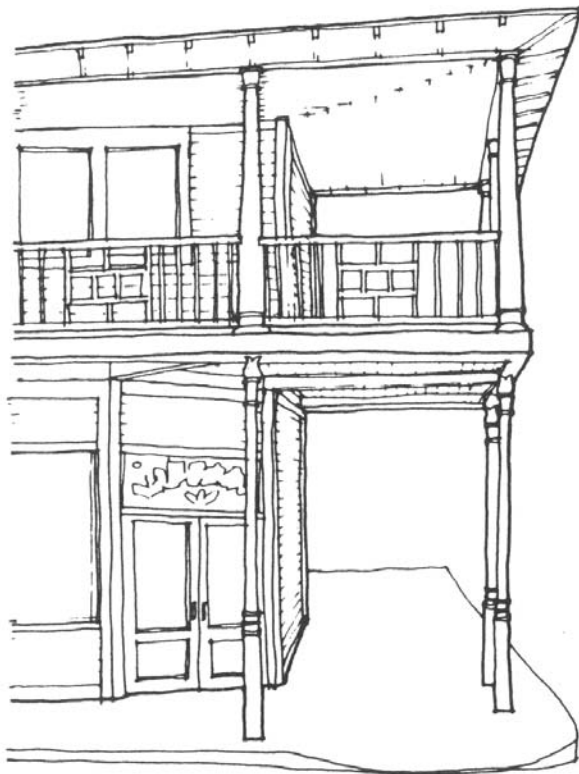
The two-story wood frame commercial buildings on this page illustrate the drastic difference between properly and improperly rehabilitating a structure of this type. The building on the left has retained many of its original elements: horizontal wood siding, slender, articulated columns, wood railings, and the original fenestration.

Appropriate neighborhood commercial rehabilitation
