RFQ: 15-C-00027
EAST HANNA AVENUE MUNICIPAL BUILDING
RENOVATIONS - DESIGN-BUILD SERVICES
DESIGN CRITERIA PACKAGE

The City of Tampa has prepared the Design Criteria Package for RFQ: 15-C-00027 for Design-Build Services related to the East Hanna Municipal Building Renovations. The scope shall include, but not be limited to the following:

Total Project Budget: \$10 million.

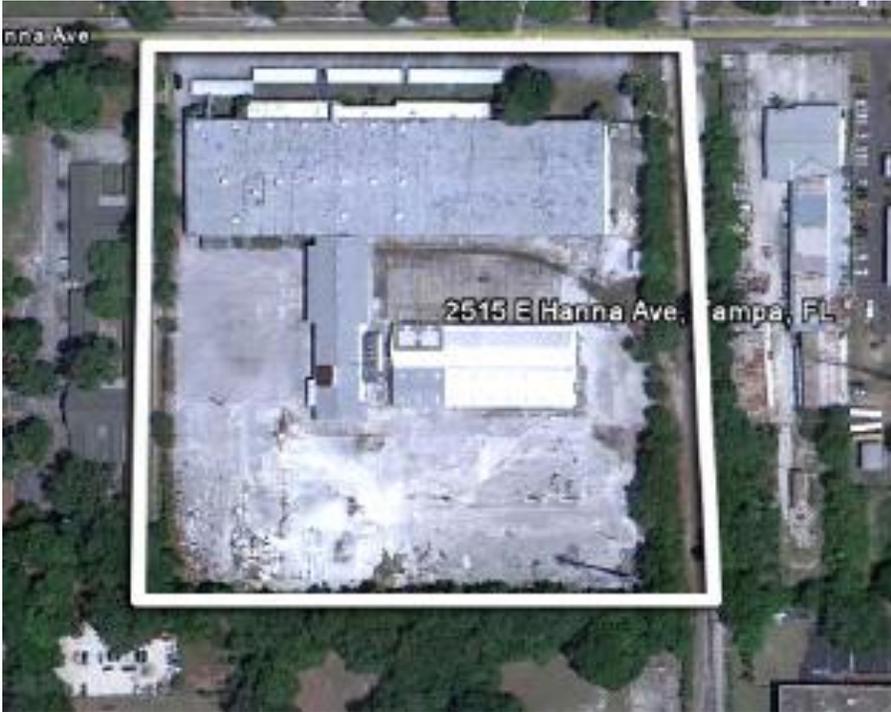
Site Information:

- 135,432 sf facility
- 11.2 acre site

- Hanna Site (aerial) with supplemental site information.
- Proposed Facility Layout (dated 3/12/14, prepared by City of Tampa Facility Management). Provided for general information only.
- Phase I Environmental Assessment Report (dated May 5, 2014) prepared by OHC Environmental Engineering, Inc.
