RESOLUTION NO. 2015-710

A RESOLUTION APPROVING AN AGREEMENT FOR PROFESSIONAL ARCHITECTURAL/ENGINEERING CONSULTING SERVICES IN THE AMOUNT OF \$675,000 BETWEEN THE CITY OF TAMPA AND PROGRESSIVE ENGINEERING & CONSTRUCTION, INC. IN CONNECTION WITH CONTRACT NO. 15-D-00028; HANNA AVENUE SITE REMEDIATION; AUTHORIZING THE MAYOR OF THE CITY OF TAMPA TO EXECUTE SAME; PROVIDING AN EFFECTIVE DATE.

Section 1. The Agreement for Consultant Services between the City of Tampa and Progressive Engineering & Construction, Inc. in connection with Contract 15-D-00028; Hanna Avenue Site Remediation as detailed in said AGREEMENT, a copy of which is attached hereto and made part hereof, is authorized and approved in its entirety or in substantially similar form.

Limited Phase II Site Investigation Former General Cable Facility

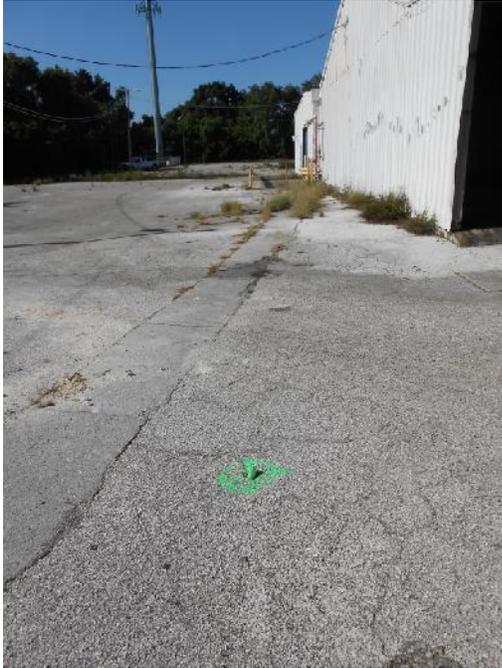
MW-4 – Completed by Others

The intermediate well (MW-4) that was installed in 2011 by PES Associates, Inc. was found in the paved area south of the rail spur (Figure 3). Therefore, no additional intermediate well was installed at this location, and only the planned deep well (DW-1) was installed near the rail spur where MW-4 had previously shown chlorinated compounds in the 30 ft zone. The deep well was installed to 50 ft bls on June 17, 2014.

The existing intermediate well (MW-4) near the rail spur is only 1-inch diameter, and therefore could not be sampled using a submersible pump. Because the depth to water was more than 20 ft (peristaltic pump cannot pull from depths exceeding 20 ft), a bailer had to be used to purge and sample this well. Purging was difficult because there was only about 3 feet of water in the bottom of the well screen, but field personnel were able to obtain one VOA vial for VOC analysis. If the City needs to sample this aquifer zone at this location in future, Progressive recommends that this well be properly abandoned (it is also not properly finished with a protective pad at the surface) and re-installed as a 2-inch diameter monitoring well of sufficient depth to enable purging and sampling with a submersible pump.

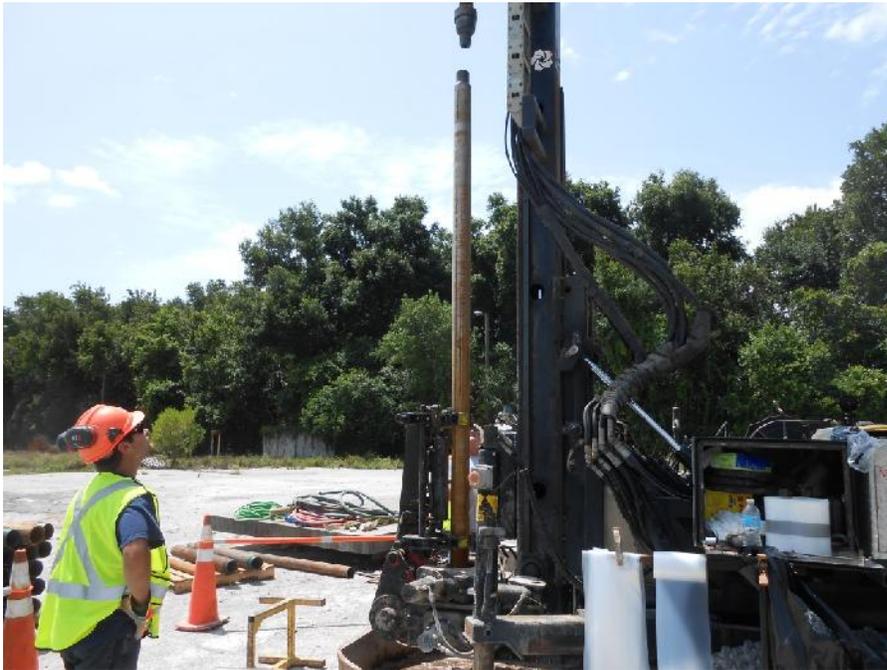
MW-5 Installation

On June 16, 2014, an intermediate well (MW-5) was installed to 35 ft bls near the area where waste oil, waste MEK and raw MEK was formerly stored on the south side of the site. No perched aquifer was observed at this location, and PID readings did not indicate excessive contamination in soil samples collected. Based upon the low PID readings, which decreased in the deeper portions of the borehole, it was not considered necessary to install a deeper contingency well at this location.

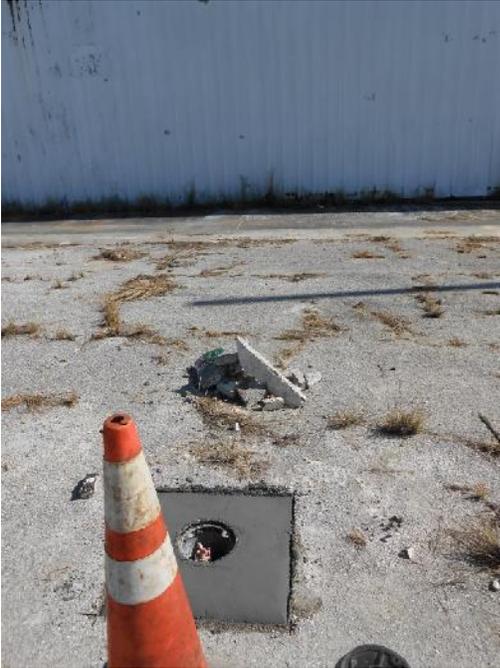
MW-6 Well Pad – Completed

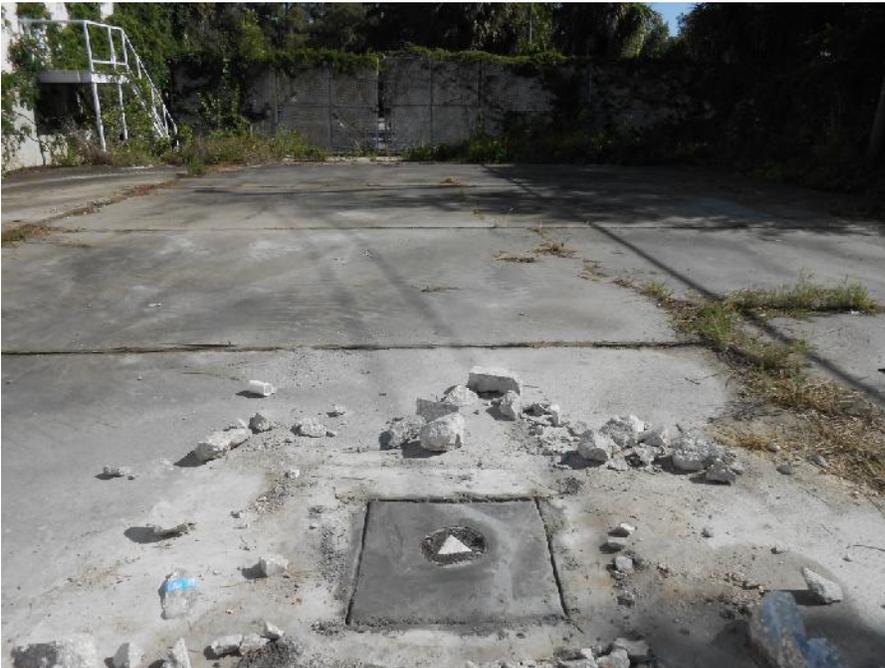
MW-7 Well Pad – Completed

On June 17, 2014, an intermediate well (MW-7) was installed to a depth of 35 ft bls approximately 30 ft east of the main manufacturing building near the location where several piping lines formerly exited the wall of the building and where drawing solution (ink) tanks were formerly known to have been located. No perched aquifer was observed at this location, and PID readings did not indicate excessive contamination in soil. It was not considered necessary to install a deeper contingency well at this location.

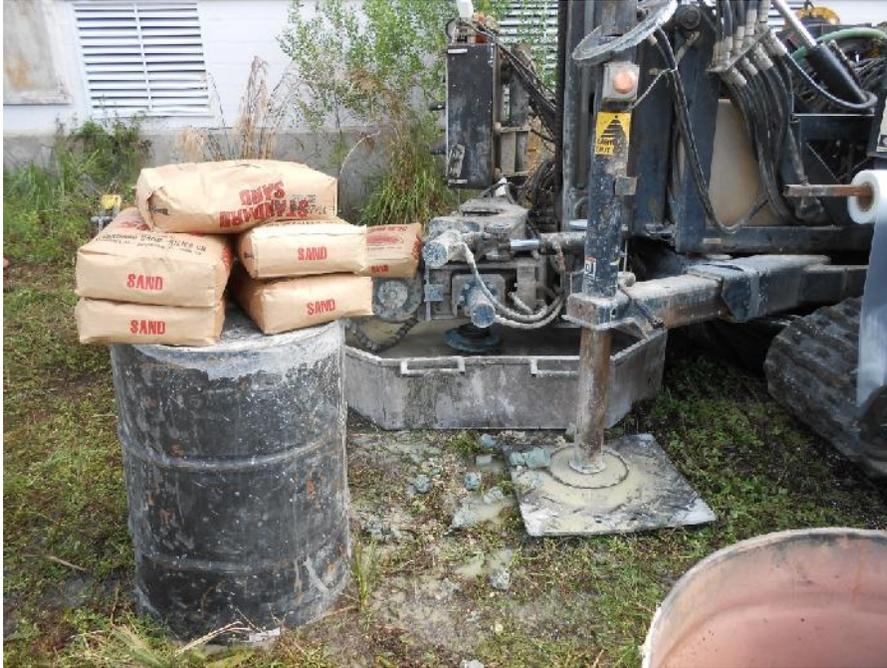
MW-8 Installation

A thick section of clay strata with thin interbedded sands was observed in the western and southern areas of the site where MW-5, MW-8 and DW-2 were installed. Well MW-8, installed at the southwestern corner of the main manufacturing building, contained mostly clay layers from 10 ft bls down to the total depth of the boring of 35 ft. At MW-5 in the southern part of the site, clay strata also dominate from 9 ft bls to 30 ft bls. This well is screened from 25 to 35 ft bls across sandy clays and the top of the weathered limestone (encountered at around 30 ft bls).

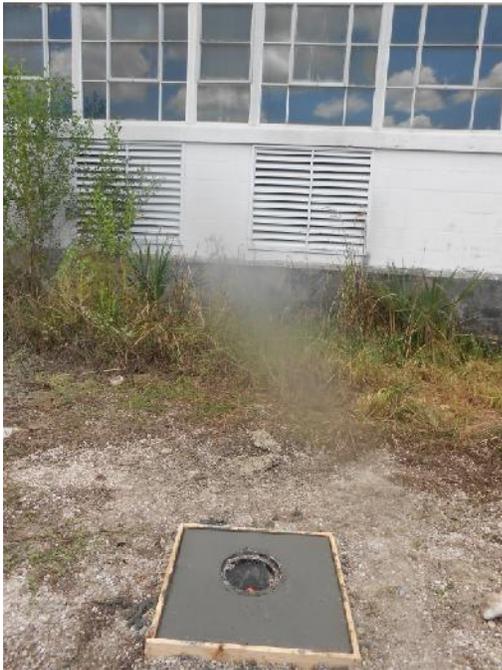
SW-1 Well Pad – Completed

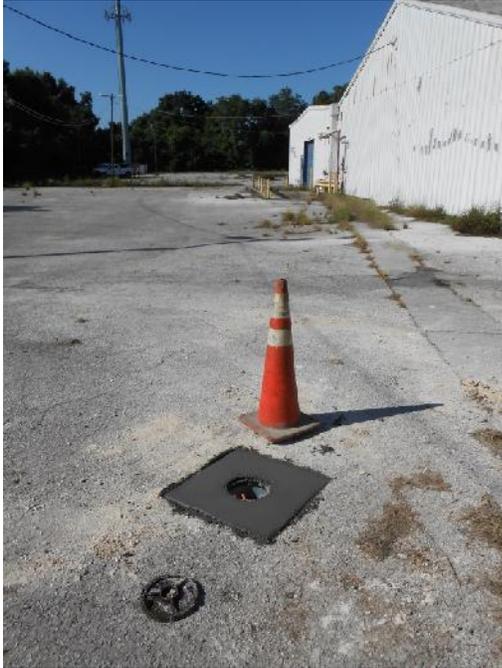
DW-1 Well Pad – Completed

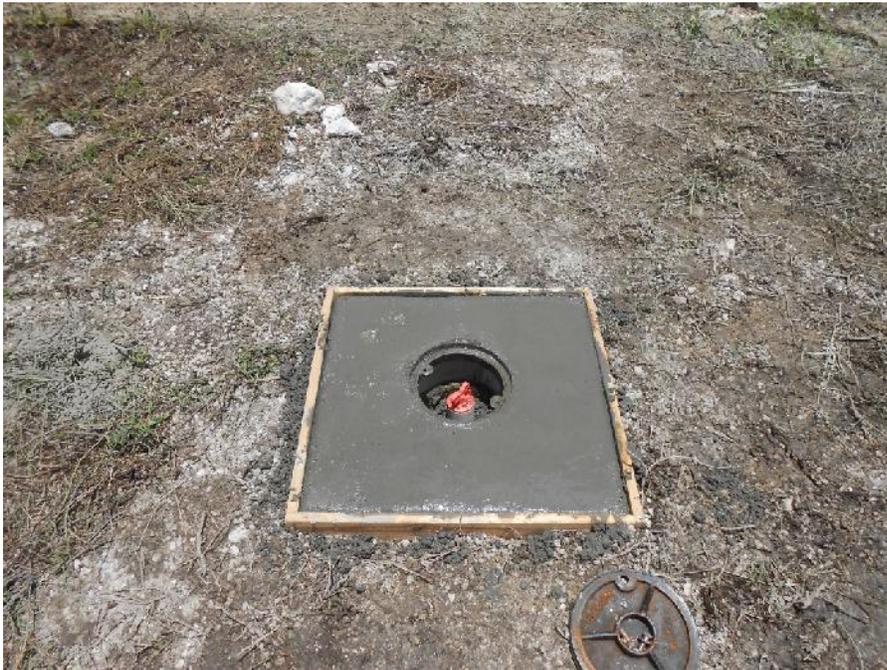
DW-2 Well Pad – Completed
